502 Inspections, Inc.  
(502) 230-7233  
[www.502inspections.com](http://www.502inspections.com)

## Commercial Inspection

1313 Lyndon Ln  
Louisville, KY 40222

Prepared For: [REDACTED]  
Inspected On Mon, Mar 24, 2025 at 9:00 AM

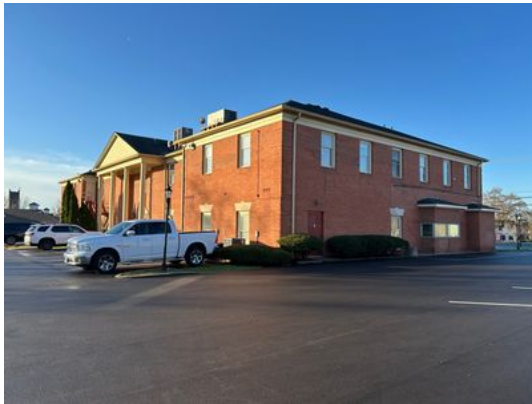
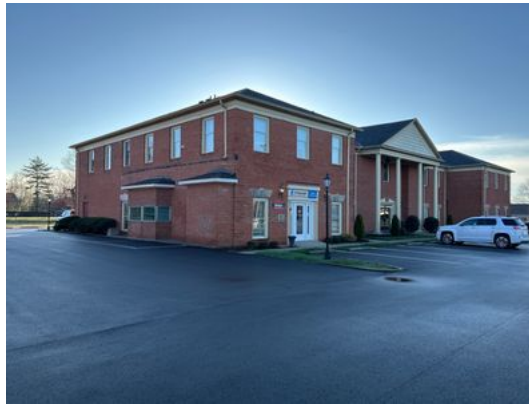
Overview of the exterior.

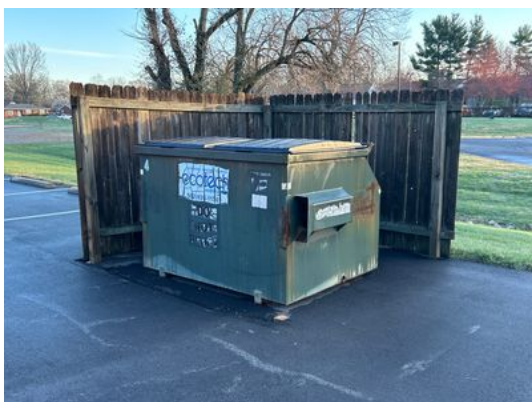
There is no concrete pad beneath the dumpster. Recommend removing the asphalt and creating a concrete approach and placement pad, to prevent deterioration of the surface.

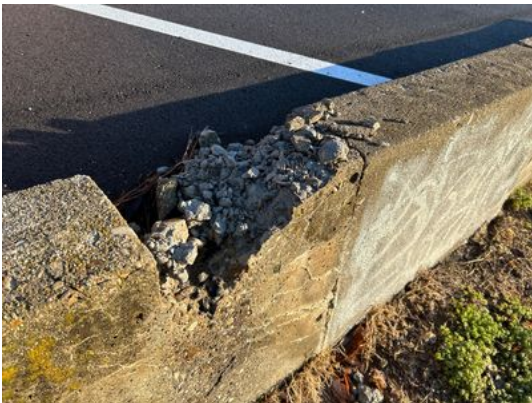
The retaining wall/parking bumper, along the right side, has been heavily damaged in some areas. Have a qualified concrete or restoration specialist repair, as needed, to maintain the integrity of the structure.

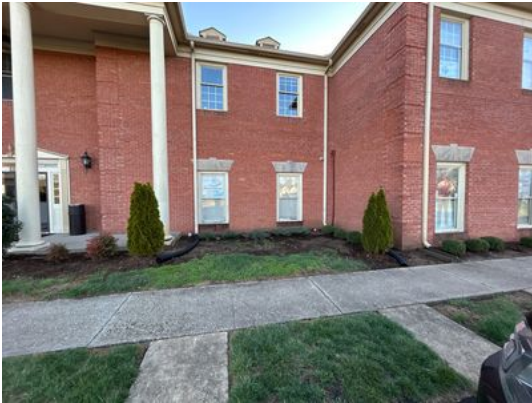
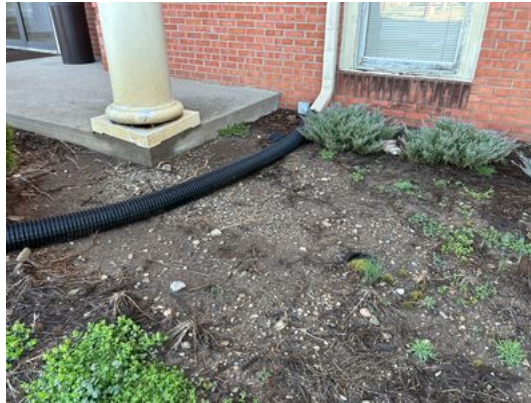
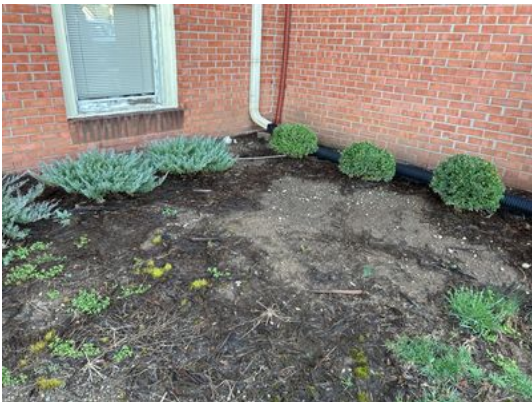
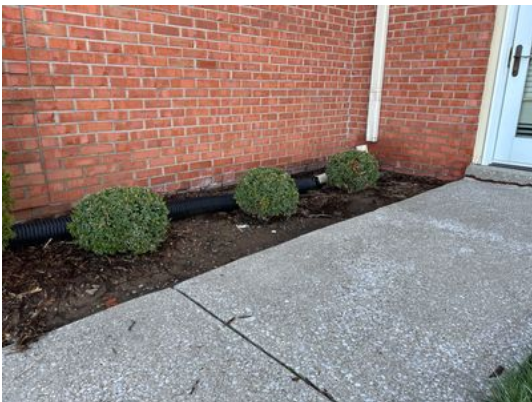
The landscape areas on both sides of the main entry appear to drain poorly. Have a qualified waterproofing specialist evaluate and repair, as needed, in an effort to move water away from the structure. Reconnect all downspouts to extensions and extend any that are not.

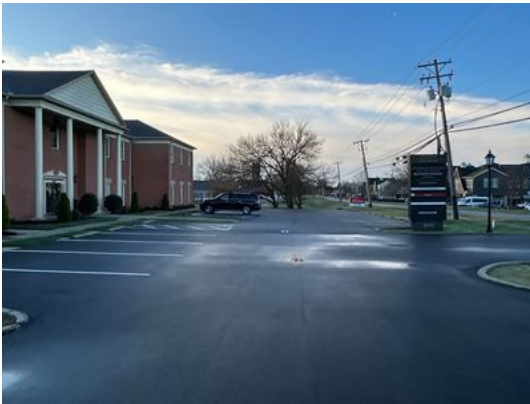
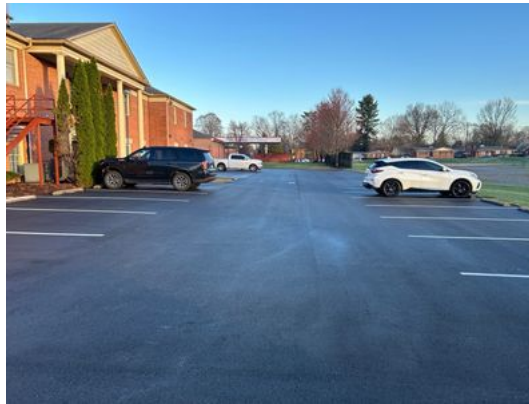
Asphalt parking, driveways and paint striping were in an acceptable condition.

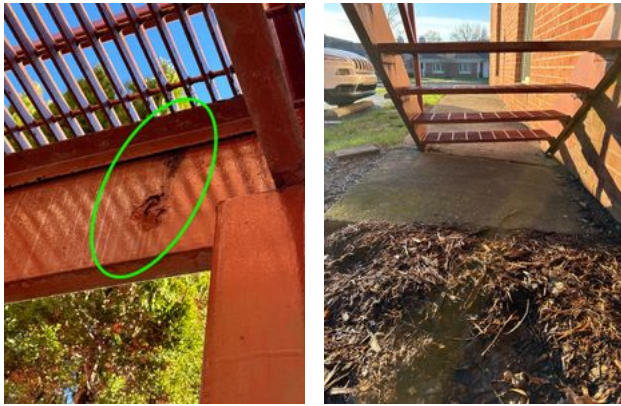
The metal fire escape was in a mostly acceptable condition, with the following exceptions:

- A) Some sections are rusting.
- B) There are openings in the brick at the landing bearing points.
- C) Recommend adding balusters around the guardrail for safety.

Have a qualified professional evaluate and repair all, as needed.

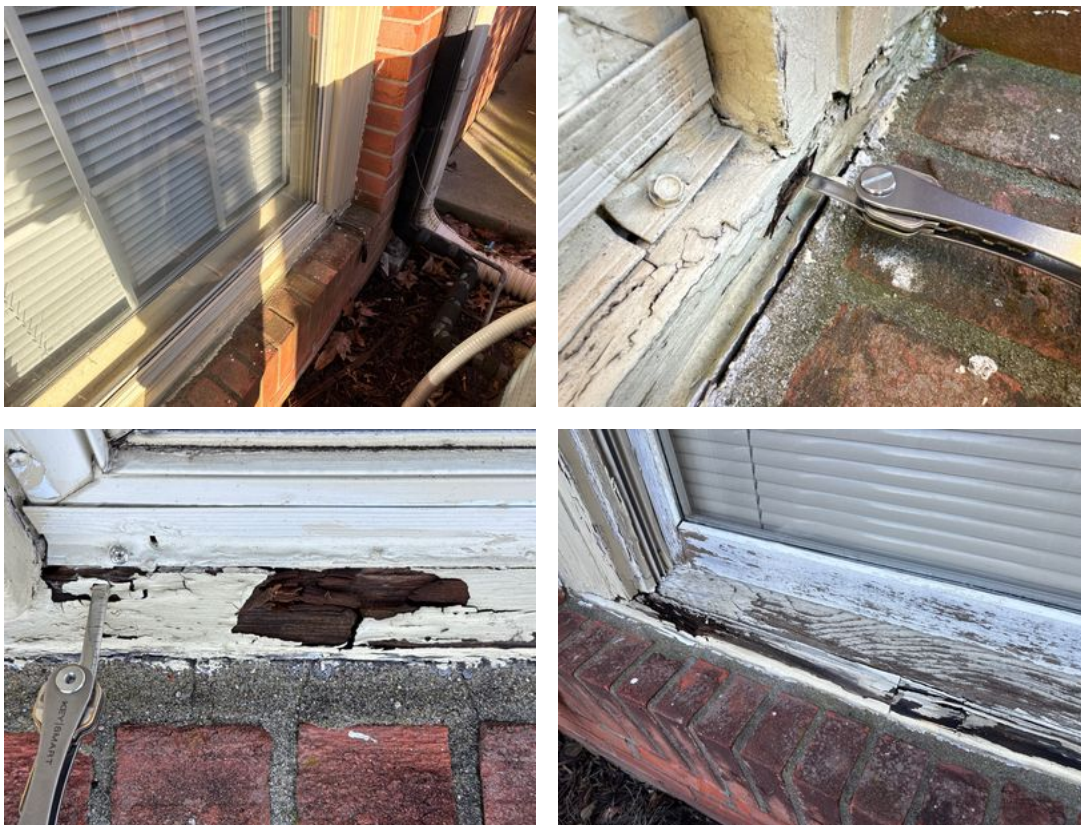
The wood windows were in a mostly acceptable condition, but there is rot or water damage in a number of locations and most were painted shut. Have a qualified professional repair or replace any damaged trim or sashes and make all operable, as needed, if the windows are not budgeted for replacement.

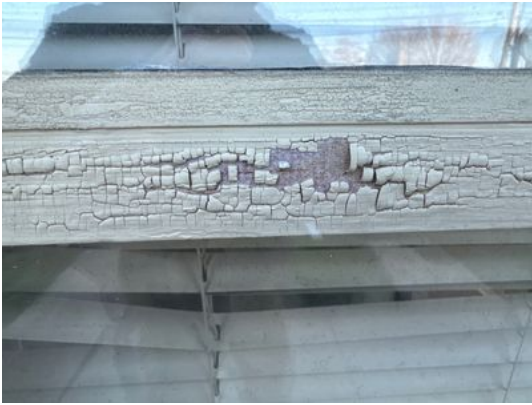
A few of the window sashes need prep and paint. The peeling paint is, most likely, lead-based. Have a qualified painter or other professional, experienced with lead paint removal and old window repairs, evaluate and repair, as needed, if the windows are not budgeted to be replaced.

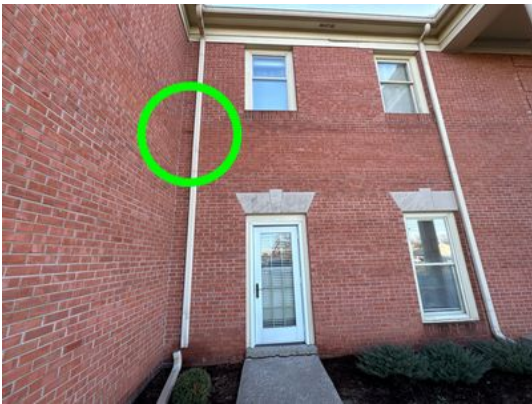
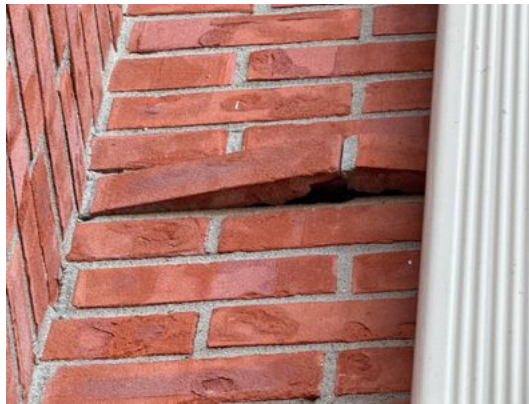
There is a brick out of position on the front wall (leaking downspout?) Have a qualified professional repair, as needed.

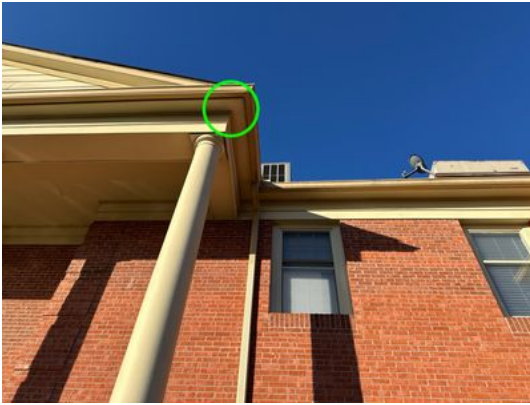
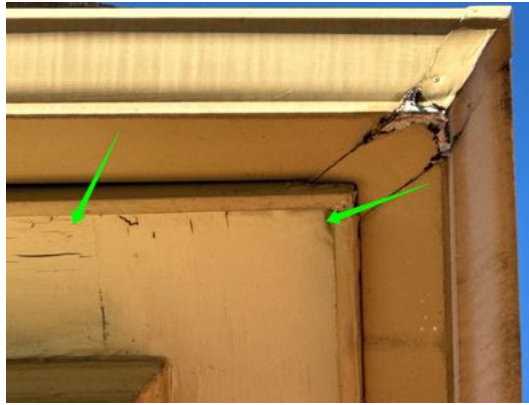
The gutter board and soffit has been damaged by water in a couple of locations (see comments about leaking gutter joints in Roofing section.) Have a qualified professional remove and replace all damaged lumber, visible or not at the time of the inspection, and then paint to match existing.

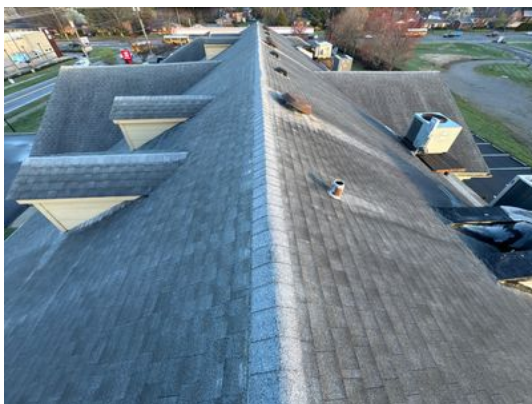
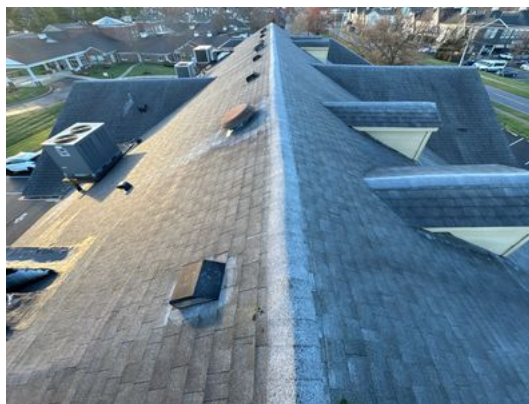
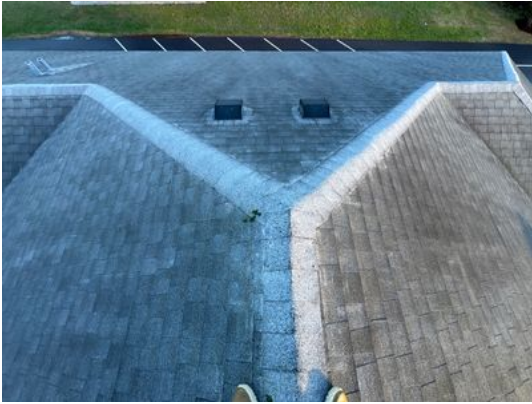
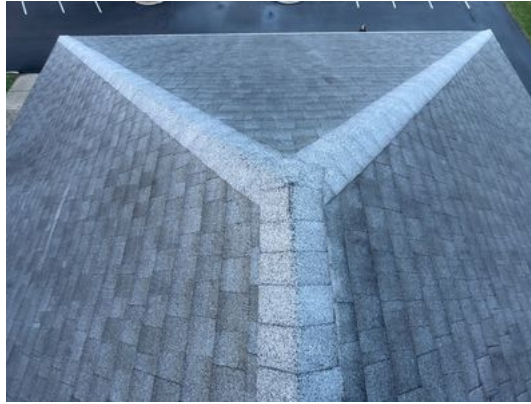
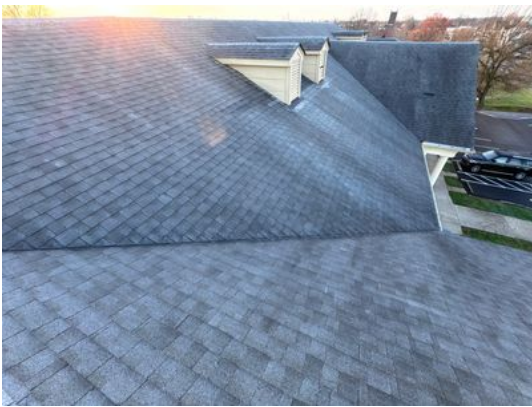
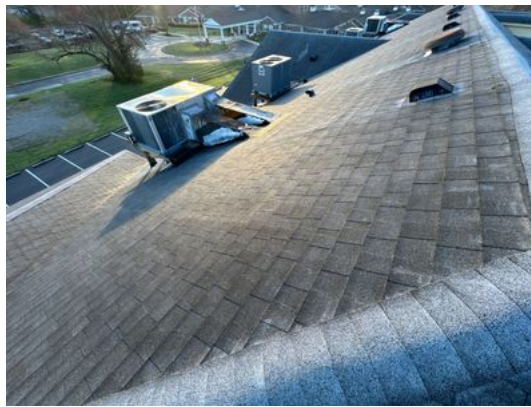
Visible roofing and gutters are nearing the end of their life expectancy. Granules are loosening, the matrix is exposed on some edges (primarily on the windward side) and tabs are very brittle. The areas around the rooftop equipment is more heavily worn from maintenance of the equipment. Recommend budgeting for replacement in the next few years.

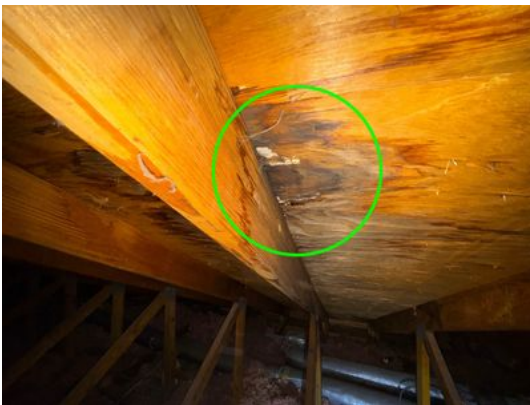
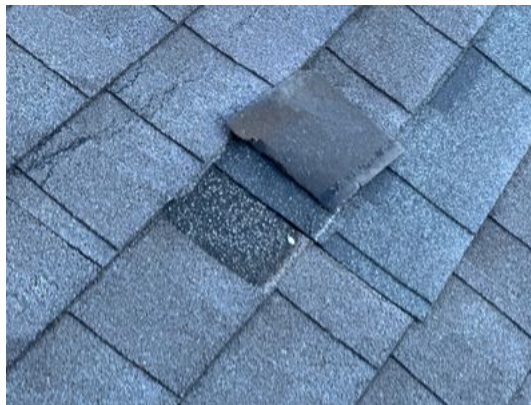
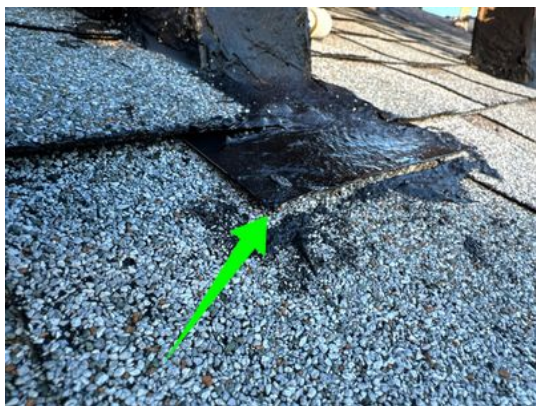
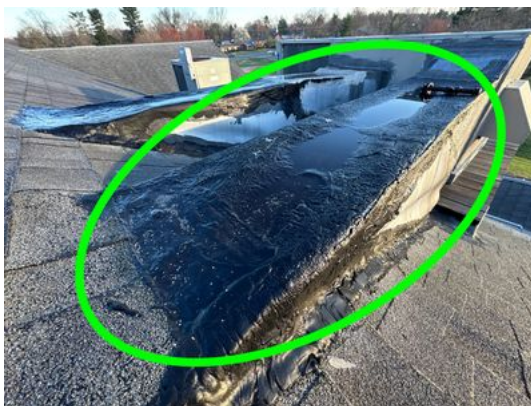
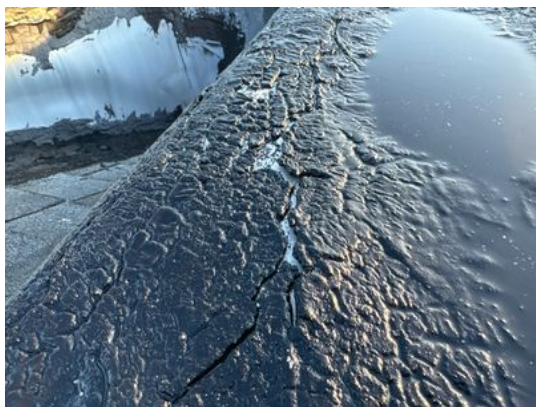
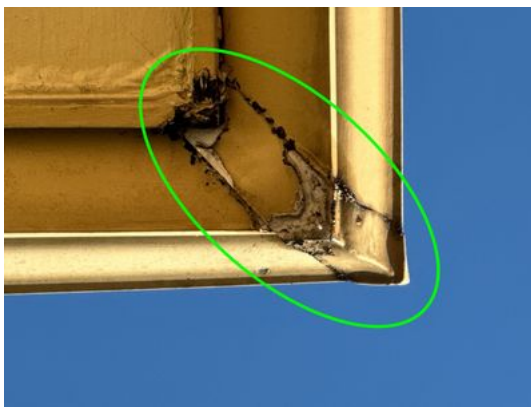
The following deficiencies were noted on the roof:

- A) There is an active leak in the “field” of the front slope, visible and wet to the touch, in the attic. There are other stained areas, but only one found to be actively leaking.
- B) There are a couple of damaged shingles.
- C) The flashing around the rooftop supports is raised in a couple of areas.
- D) The rooftop ductwork is holding water and the sealants have dried and cracked.
- E) The gutter joints are leaking, causing some minor damage to the soffit and gutters boards.

Have a qualified roofer repair all, as needed.

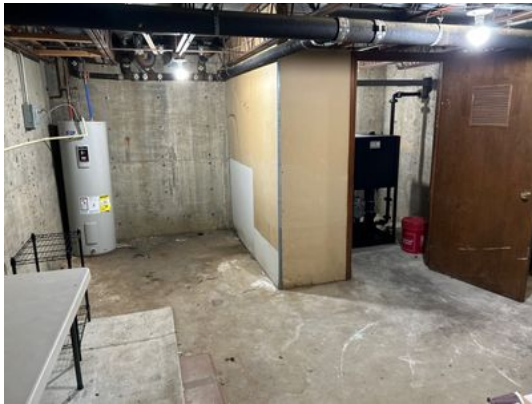
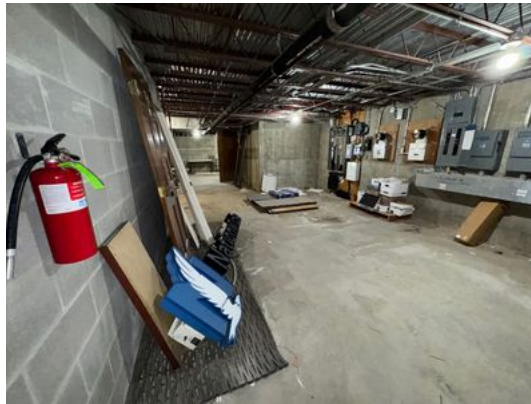
Overview of basement.

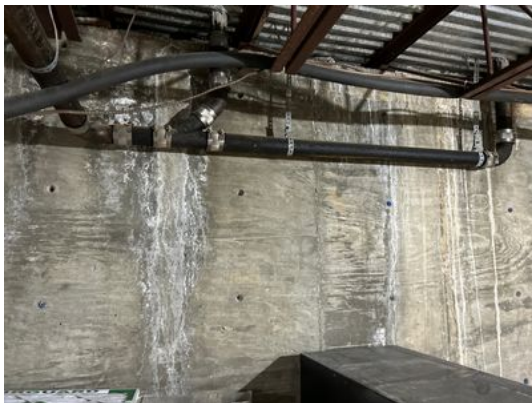
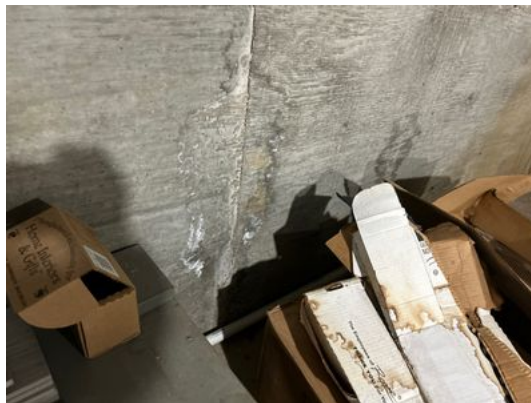
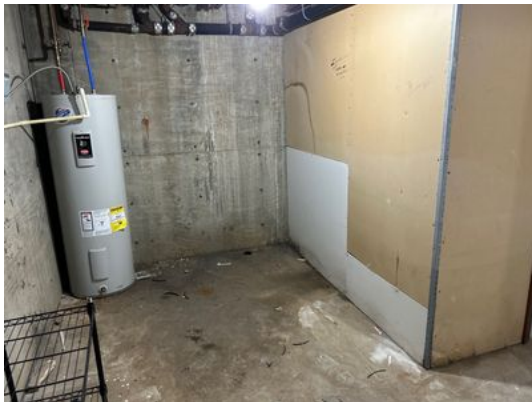
The white powdery substance noted on the basement walls and floors is, most likely, efflorescence. Efflorescence is harmless, but does indicate a high moisture content in or around the foundation wall and slab. The space and sump crock was found to be dry at the time of the inspection. Recommend that a qualified waterproofing specialist evaluate and repair, if a drier space is desired. NOTE: Other stains were noted on the structure, but appear to be from plumbing issues that have been previously resolved.

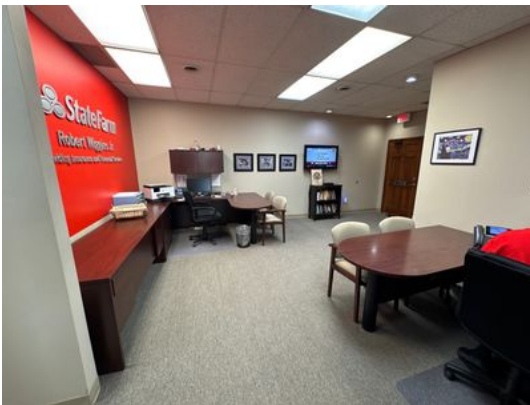
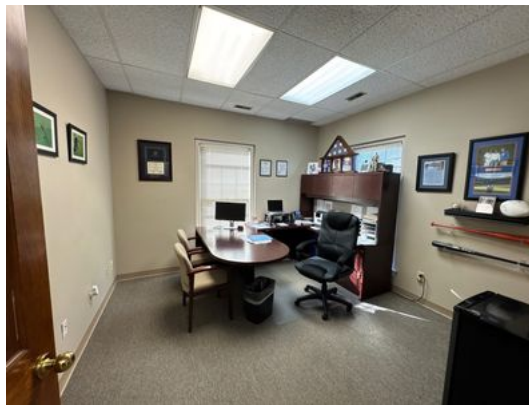
Overviews of the interior. Limited access, due to tenant restrictions and hours of operation.

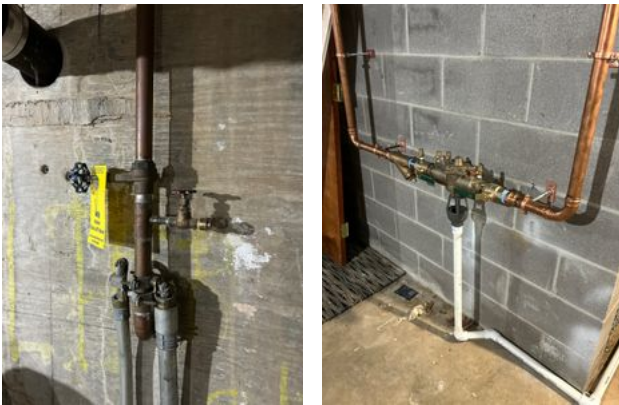
Main water shutoff and pressure regulator are located in the basement.

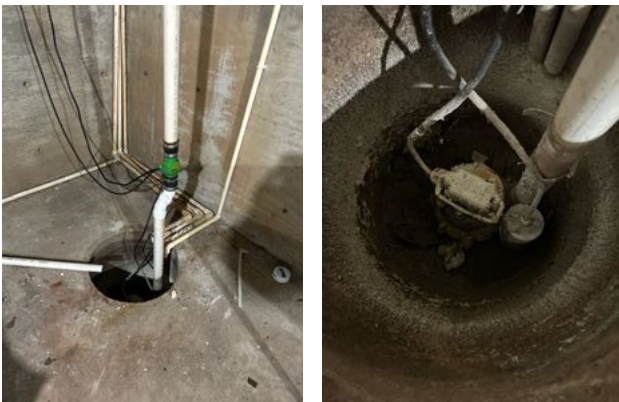
Sump pump operates as expected, but the crock was dry at the time of the inspection. Recommend monitoring during rains through the first months of occupancy to verify proper operation.

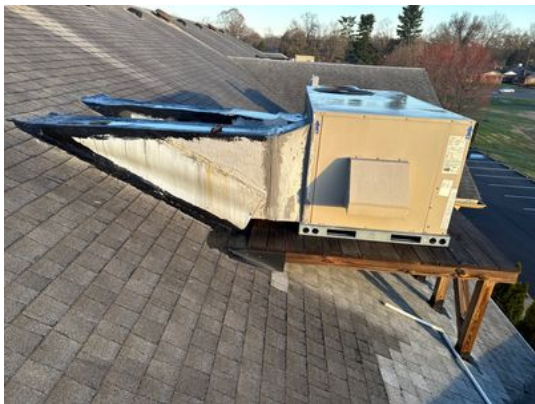
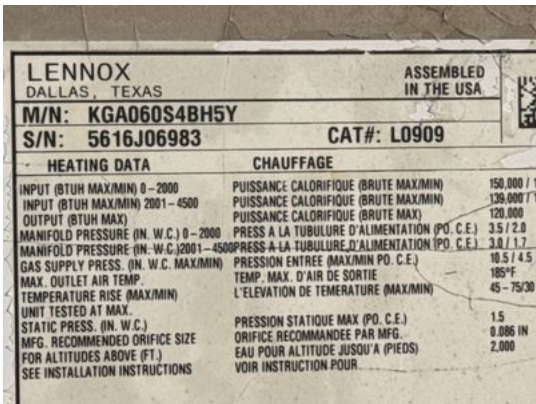
Unit A (right side): Heat and air conditioning is provided by combined, package unit on exterior. Operates as expected. Approximately 9 years old. Too cold to operate the AC portion. Outside temperature must be over 60 F for 24 hours or compressor could be damaged. Recommend an HVAC technician perform a service and start-up, when the warmer season arrives.

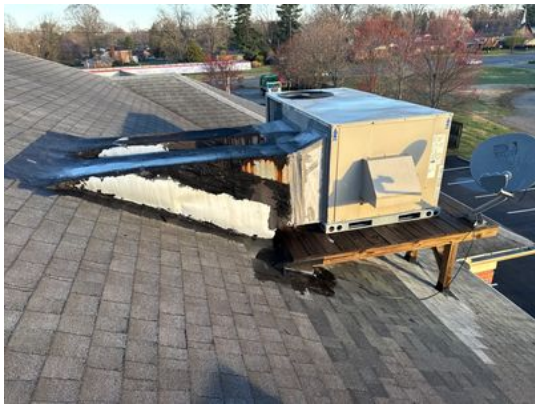
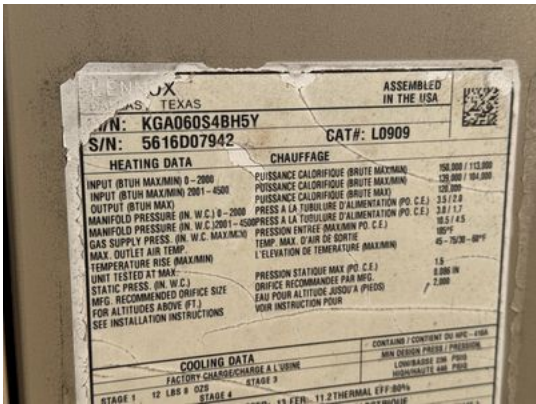
Unit B (left side): Heat and air conditioning is provided by combined, package unit on exterior. Operates as expected. Approximately 9 years old. Too cold to operate the AC portion. Outside temperature must be over 60 F for 24 hours or compressor could be damaged. Recommend an HVAC technician perform a service and start-up, when the warmer season arrives.

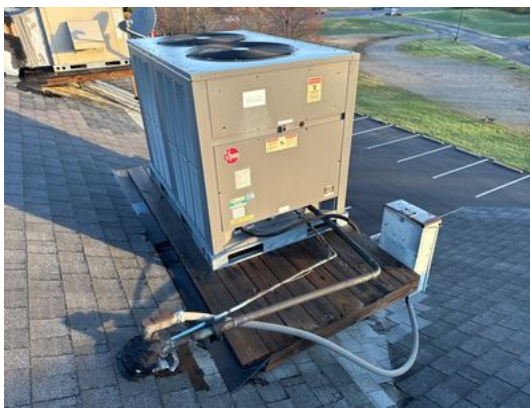
Left Side: AC unit and data plate. Approximately 9 years old. Too cold to operate. Outside temperature must be over 60 F for 24 hours or compressor could be damaged. Have a qualified HVAC contractor perform a service and start-up, when the warmer season arrives.

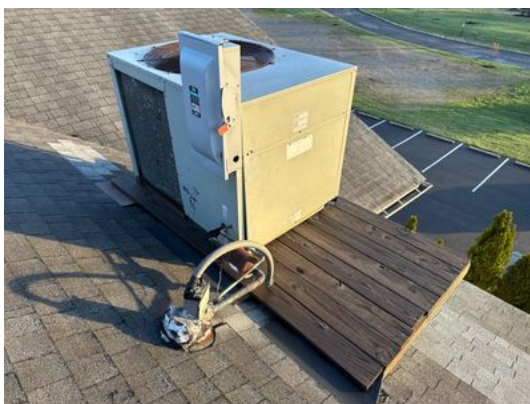
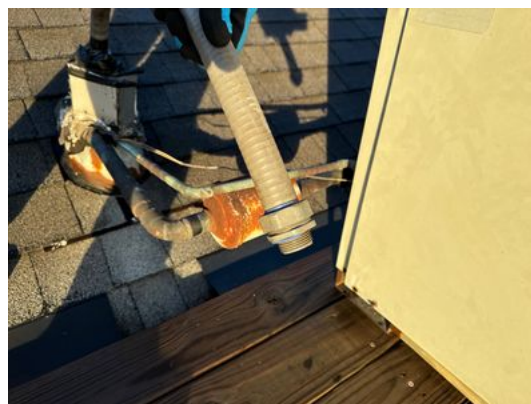
The center rooftop AC unit has been abandoned. Data plate was too faded to determine its age.

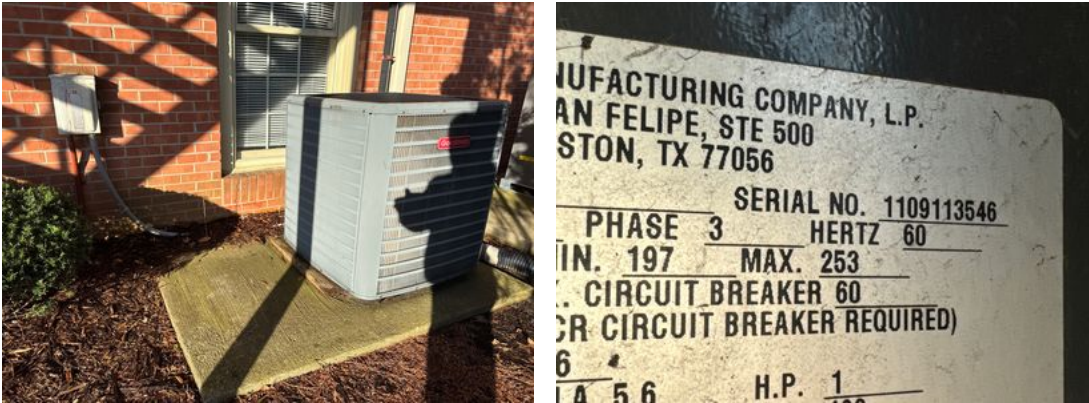
Ground A: AC unit and data plate. Approximately 14 years old. Too cold to operate. Outside temperature must be over 60 F for 24 hours or compressor could be damaged. Have a qualified HVAC contractor perform a service and start-up, when the warmer season arrives.

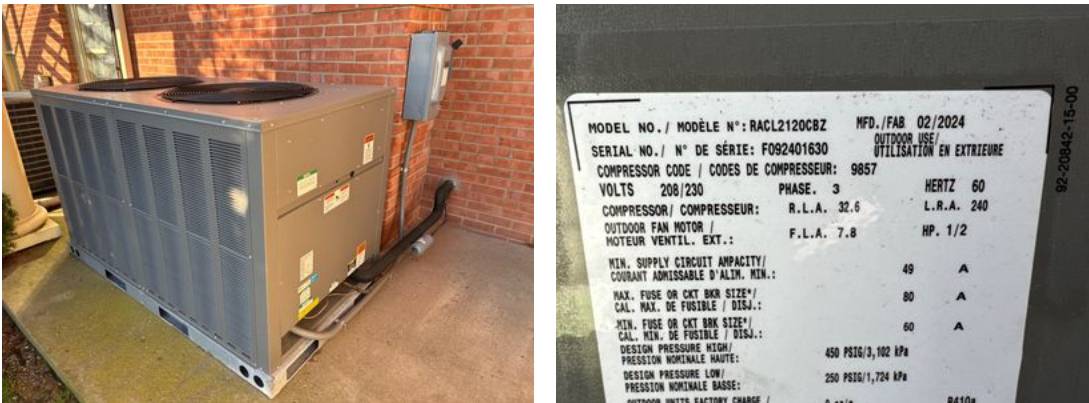
Ground B: AC unit and data plate. Approximately 1 year old. Too cold to operate. Outside temperature must be over 60 F for 24 hours or compressor could be damaged. Have a qualified HVAC contractor perform a service and start-up, when the warmer season arrives.

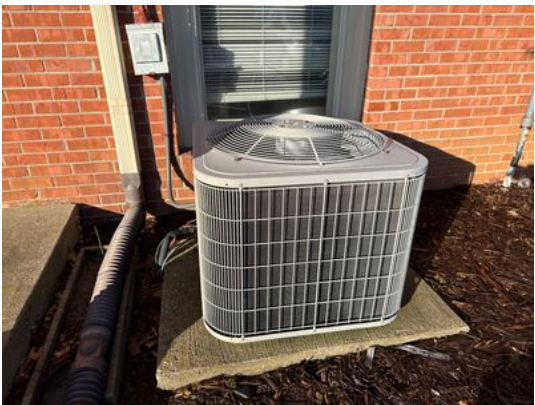
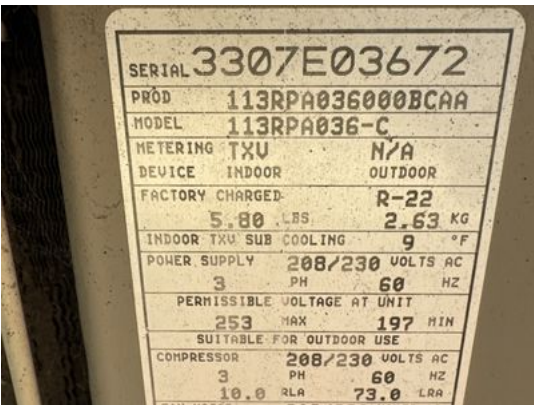
Ground C: AC unit and data plate. Unit has outlived its life expectancy of 15 years. Approximately 18 years old. Too cold to operate. Outside temperature must be over 60 F for 24 hours or compressor could be damaged. Have a qualified HVAC contractor perform a service and evaluation of the system, during the inspection period and prior to closing. Recommend budgeting for new.

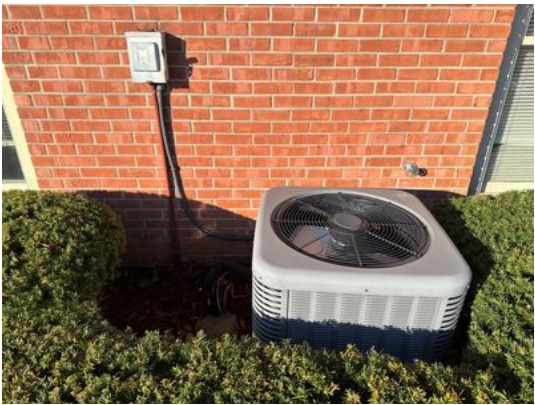
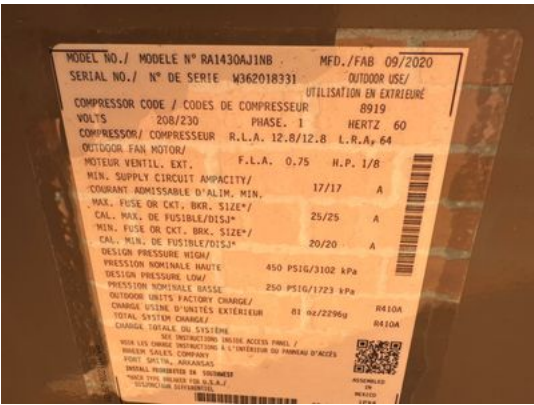
Ground D: AC unit and data plate. Approximately 5 years old. Too cold to operate. Outside temperature must be over 60 F for 24 hours or compressor could be damaged. Have a qualified HVAC contractor perform a service and start-up, when the warmer season arrives.

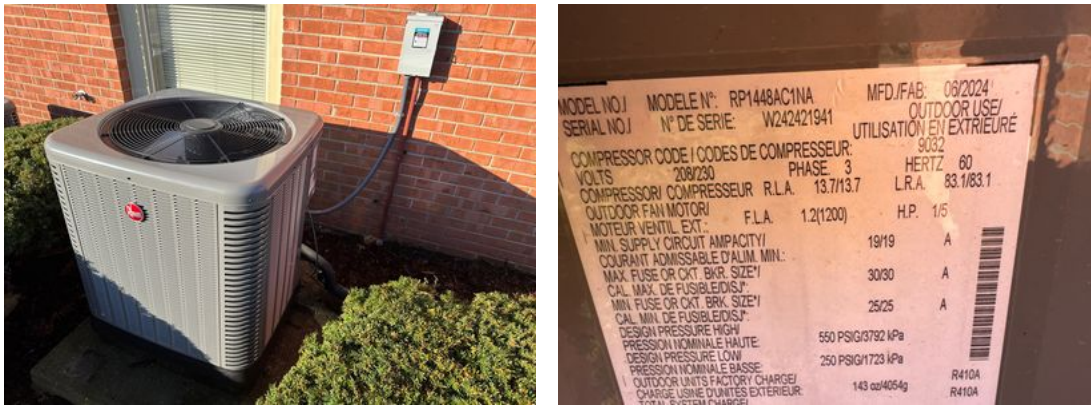
Ground E: Heat pump (exterior) was operating as expected. Approximately 1 year old.

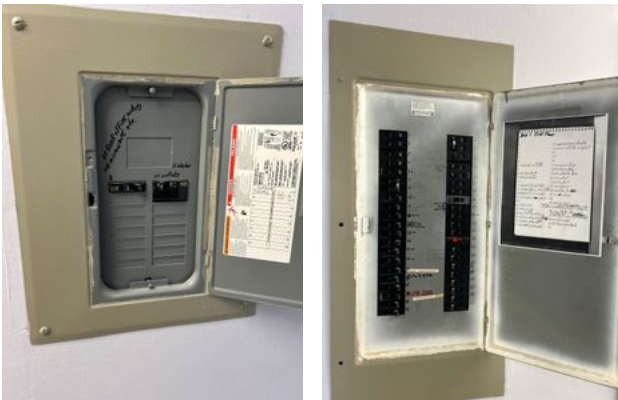
1st Floor Distribution Panels: Unable to remove covers. Painted to wall.

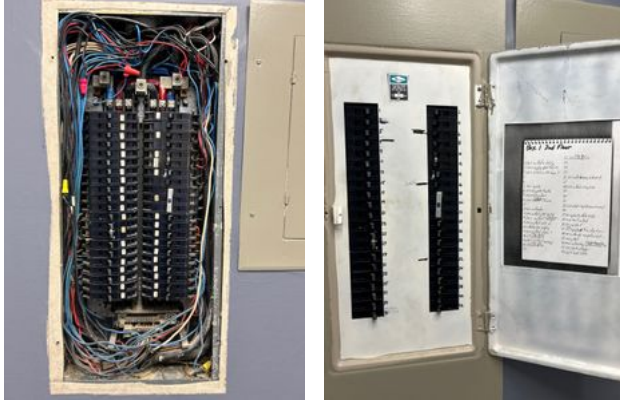
2nd Floor-Box 1: The Zinsco brand electrical panel and breakers are considered a safety hazard. Hazards associated with this manufacturer have been documented by industry experts. A high percentage of breakers have failed to open under

over-current conditions. Replacement breakers are difficult to find and those on the market are not UL listed. Recommend panel replacement for safety. At a minimum, the panel should be thoroughly inspected and deemed acceptable by a competent licensed electrician familiar with this type of panel and their opinion put in writing.

2nd Floor-Box 1: The Zinsco brand electrical panel and breakers are considered a safety hazard. Hazards associated with this manufacturer have been documented by industry experts. A high percentage of breakers have failed to open under over-current conditions. Replacement breakers are difficult to find and those on the market are not UL listed. Recommend panel replacement for safety. At a minimum, the panel should be thoroughly inspected and deemed acceptable by a competent licensed electrician familiar with this type of panel and their opinion put in writing.

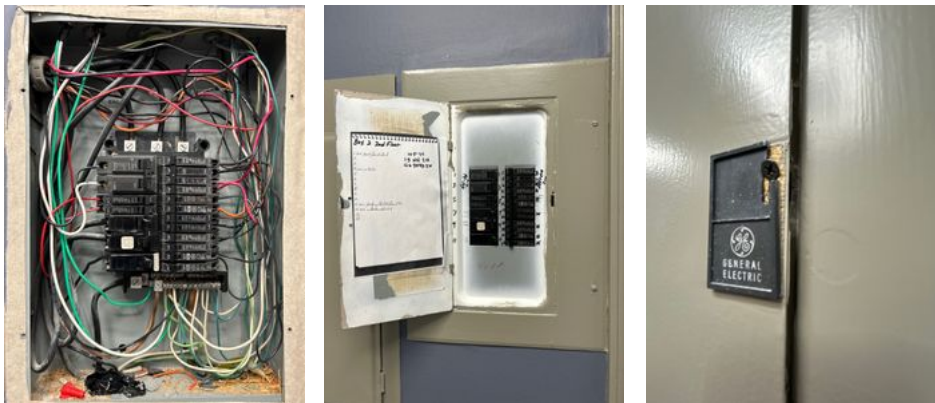
2nd Floor-Box 2: The latch is broken. Repair or replace.

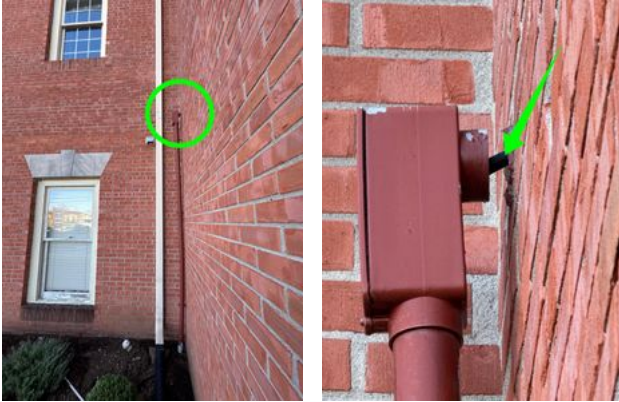
The electrical conduit at the front wall has pulled away, exposing the cable inside. Have a qualified professional repair, as needed, for safety.

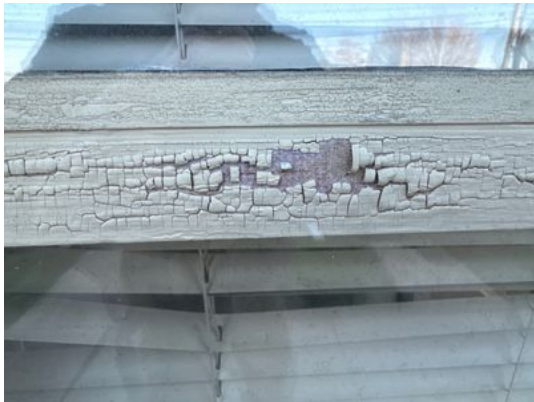
A few of the window sashes need prep, paint and glazing. The peeling paint is, most likely, lead-based. Have a qualified painter or other professional, experienced with lead paint removal and old window repairs, evaluate and repair, as needed, if the windows are not budgeted to be replaced.
