502 Inspections, Inc.  
(502) 230-7233  
[www.502inspections.com](http://www.502inspections.com)

## Commercial Inspection

6432 Two Notch Rd  
"Arcadia Lakes"  
Columbia, SC 29223

Prepared For: [REDACTED]  
Inspected On Tue, Aug 26, 2025 at 9:00 AM

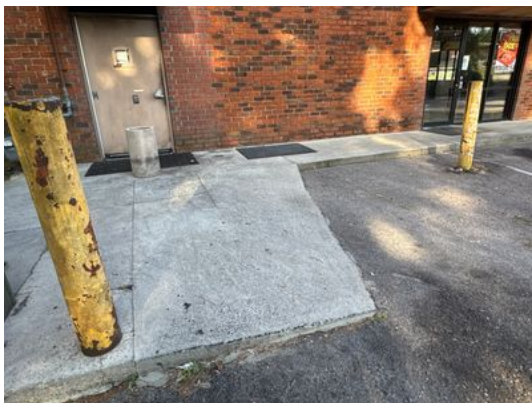
Front sidewalks were in an acceptable condition.

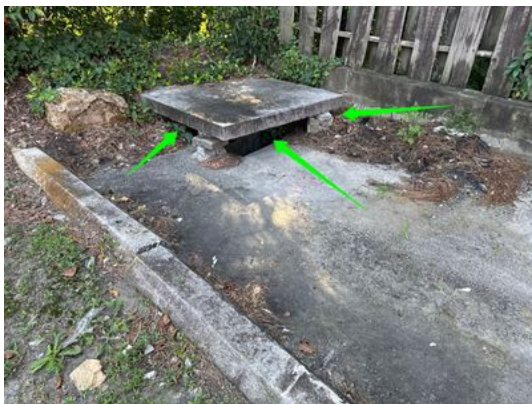
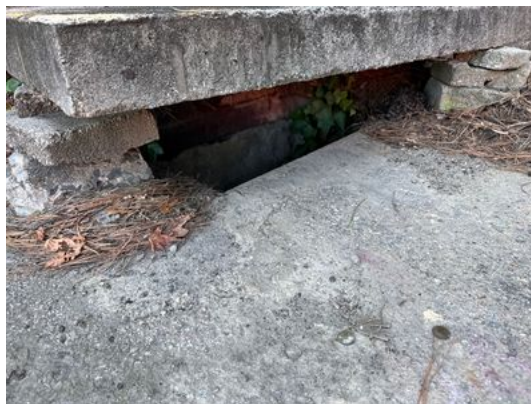
The apparent catch basin, in the east corner of the parking lot, is not protected by a proper grate. Have a qualified professional install a frame and grate or enclose the existing openings for safety.

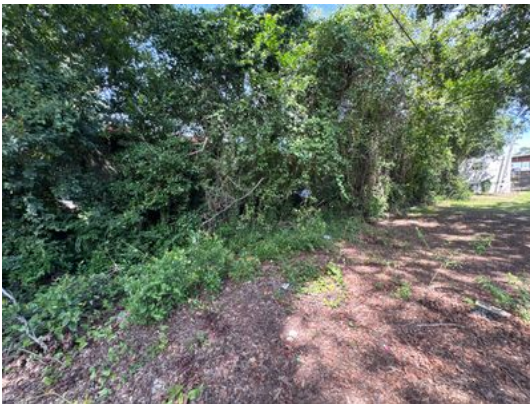
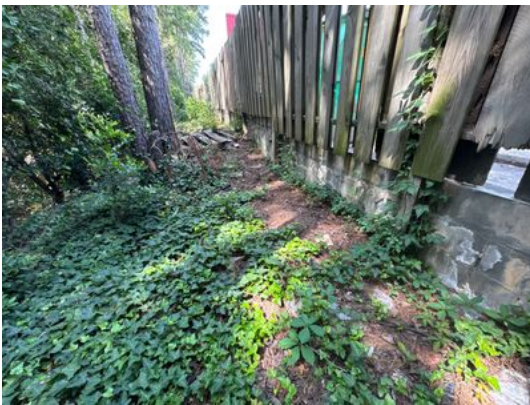
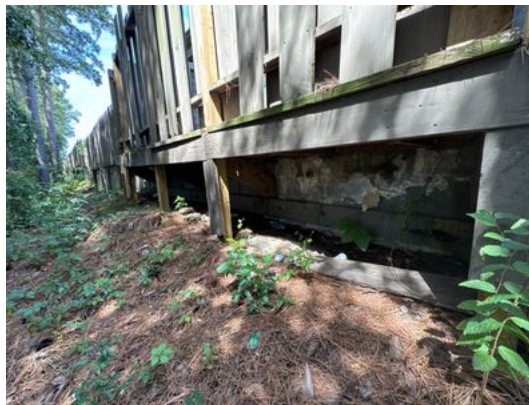
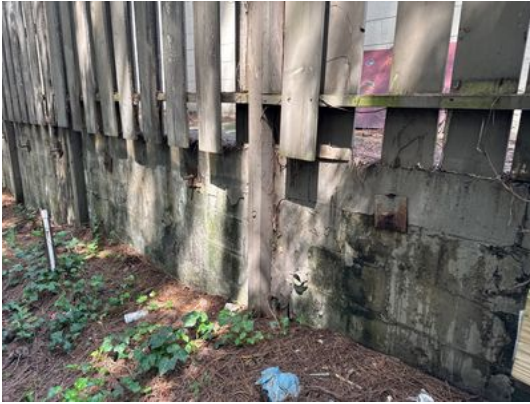
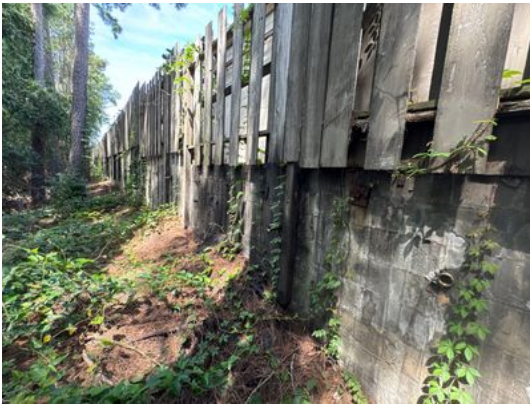
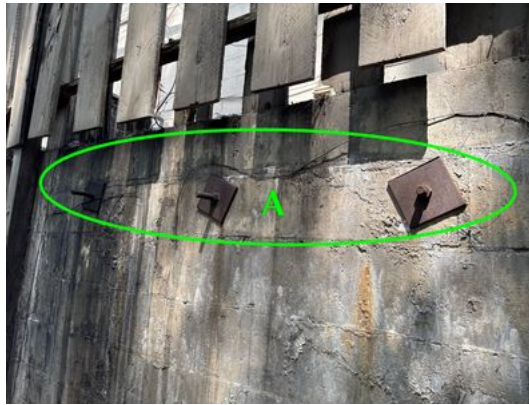
The retaining wall, along the east and south boundary's appeared to be in an acceptable condition, with the following exceptions/comments:

A) Some stabilization work is present. Recommend consulting with the seller to determine if the plates and rods were installed, during construction, as part of the design, or as a result of failure. This has or may be contributing to the building foundation settlement, noted in the Structure section. Some hairline and cracking was noted in the grout joints, as was some minor bowing in the wall, which is, generally, typical for a structure of this age.

B) Some apparent wall footing work was found, roughly, mid-length. The form work is still present and does not need to be removed. Consult with the seller to determine the history of the repair.

C) The catch basins are blocked by debris, and water was present, along the top of the wall, most, a result of condensation from the rear and interior heat pumps. This is having a negative effect on some of the grout joints and may affect the integrity of the steel plates and rods, supporting the wall.

Have a qualified professional repair item “C” and monitor the wall for further movement. NOTE: The east wall and other portions of the wall were covered by vegetation and not visible to inspect.

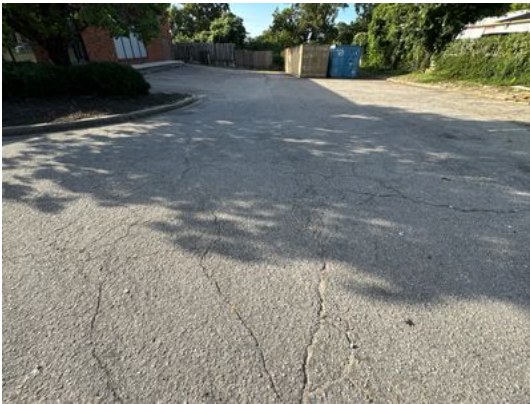
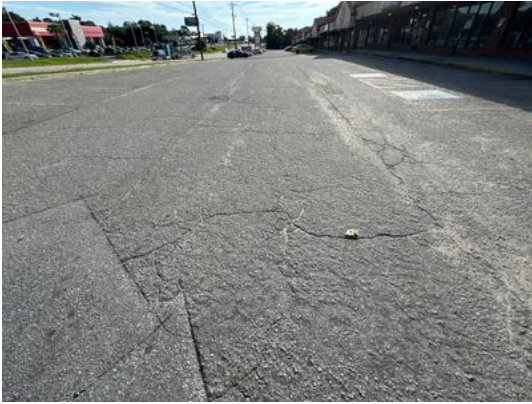
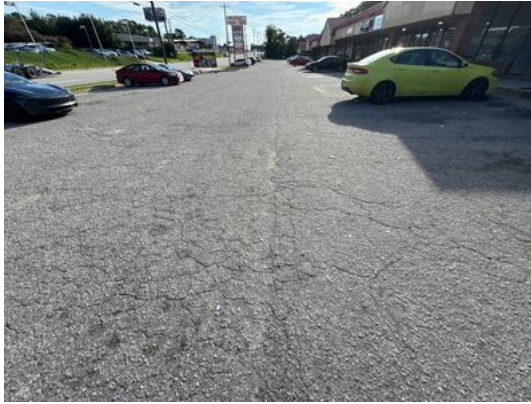
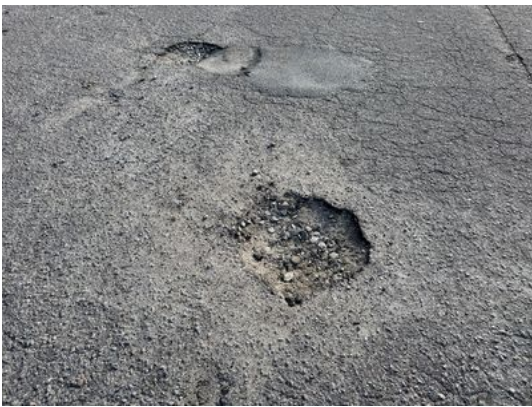
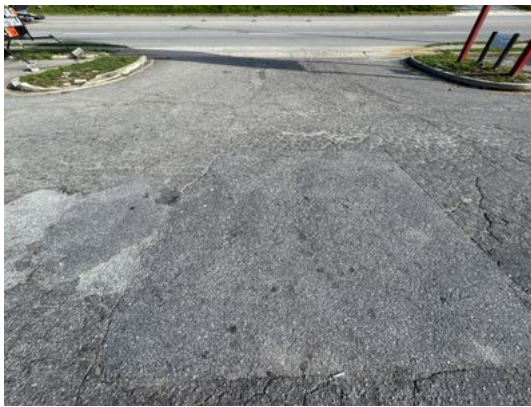
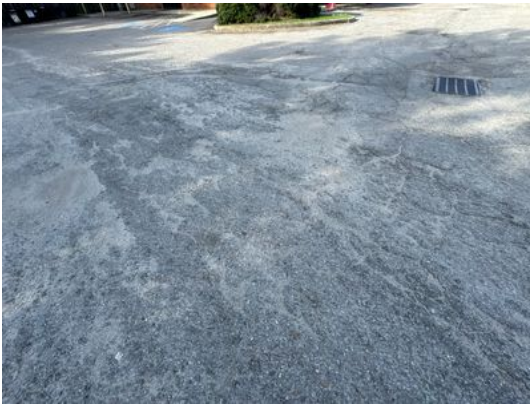
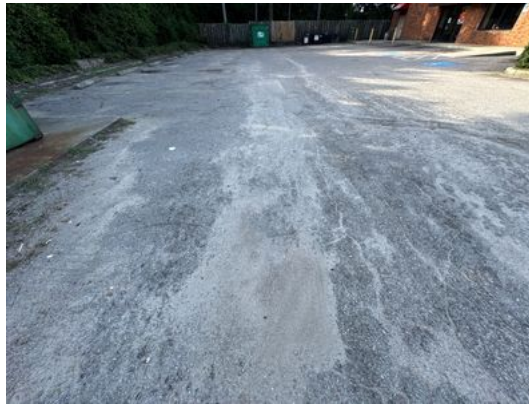
Asphalt paving is aging, but in a generally acceptable condition. Recommend budgeting for minor patching, a sealer application and re-stripping in the near future.

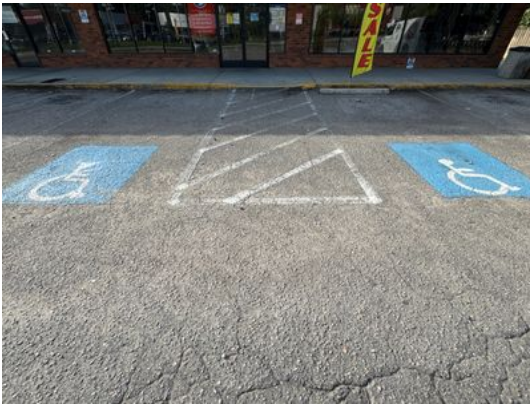
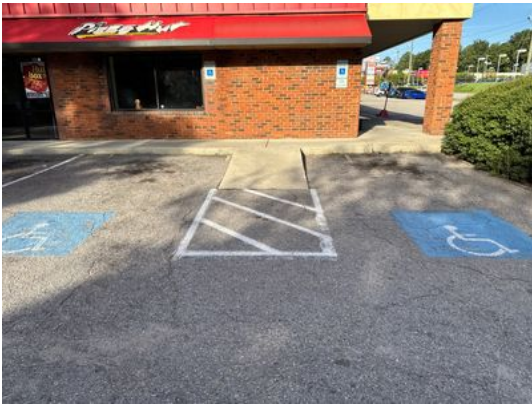
Handicap accessible parking spaces were in an acceptable condition, but some posted signage was missing. Consult with local code officials regarding compliance and install signage, as needed.

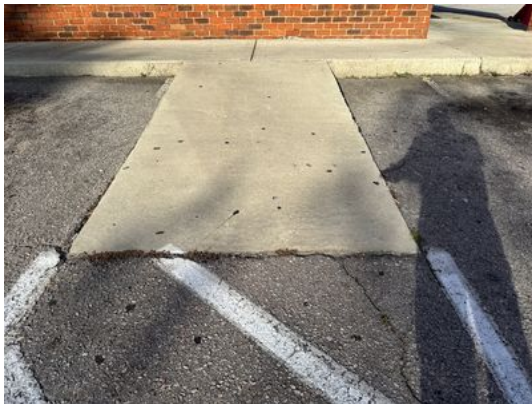
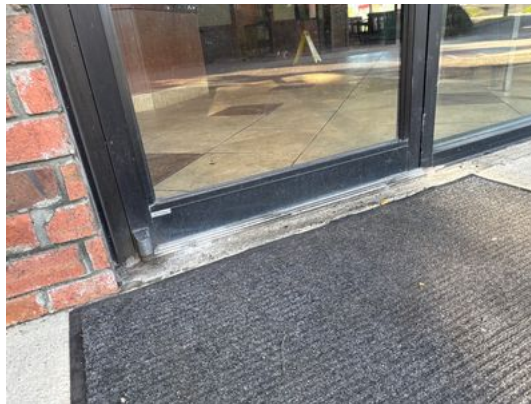
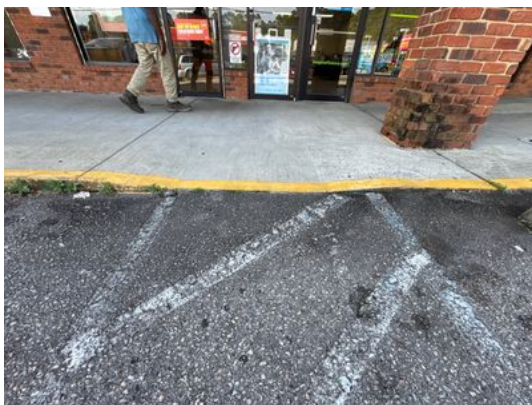
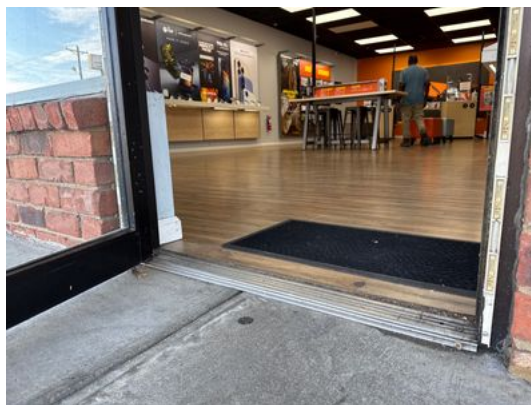
Handicap accessible sidewalk ramps present at each entrance and there is no curb or obstruction at the thresholds.

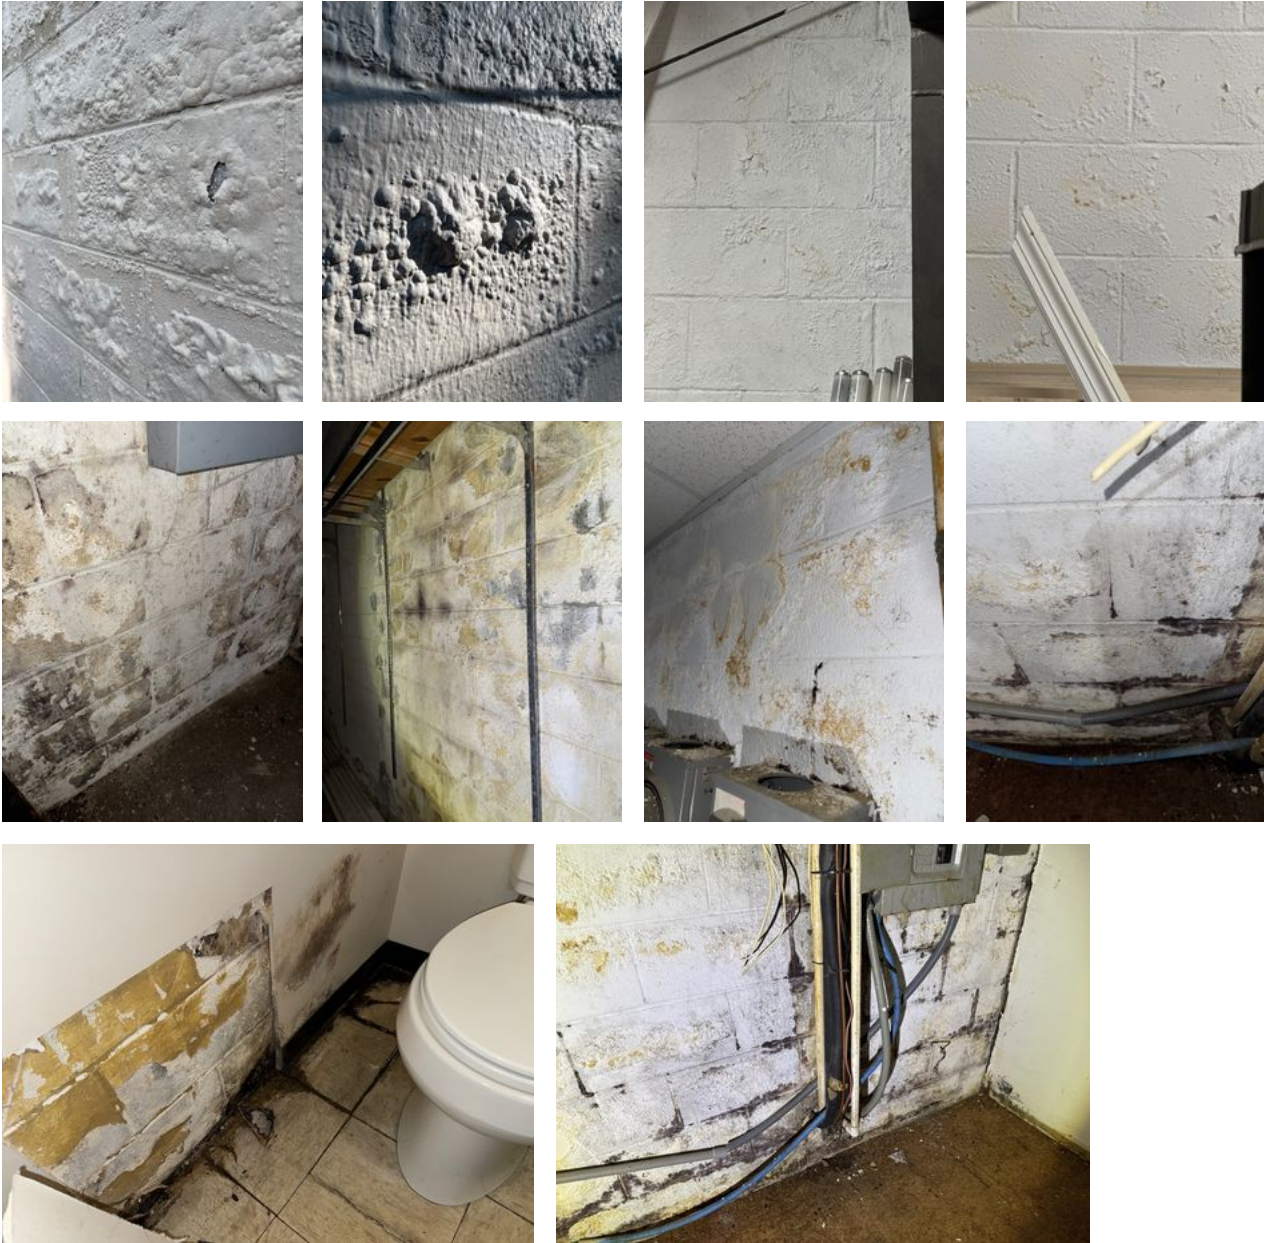
The paint along the rear or south wall is peeling. This is also visible from inside the spaces, to some degree. It is, most likely, a result of leaking gutters and roof system, over time. As a result, some of the interior spaces have developed, what appears to be, an environmental growth. After the gutters and roof repairs have been made, have a qualified painter clean, prep and paint/seal, as needed. This should include the remediation of any hazards or growths on the interior.

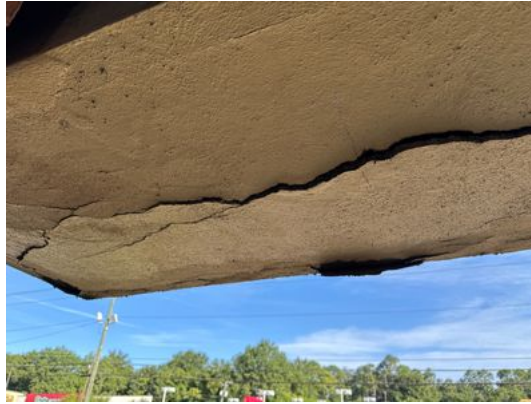
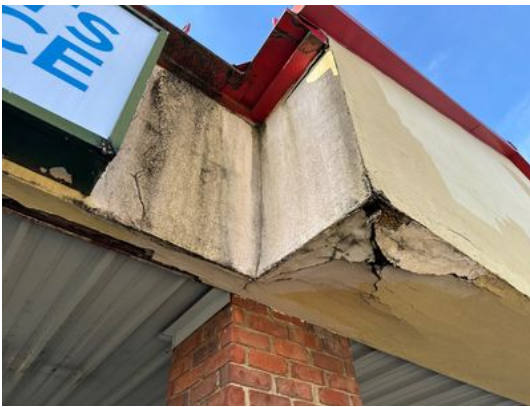
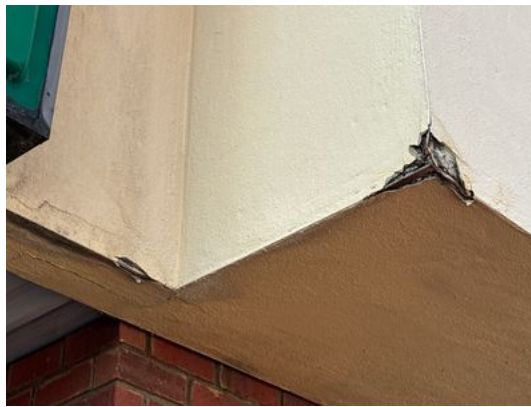
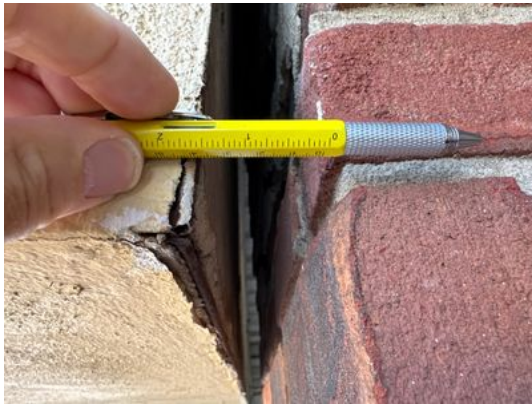
EIFS (exterior insulation finishing system) is heavily damaged in a number of areas. In one area, near “The Queen of Soul,” the framing has pulled away from the structure. Have a qualified EIFS contractor evaluate and make any necessary repairs to prevent water intrusion and to improve the integrity of the system. This should include repairs to the structure and framing, as needed.

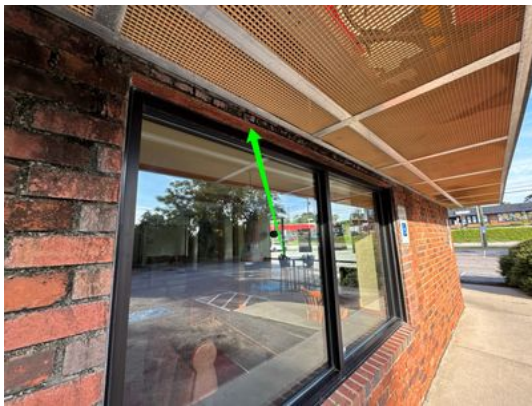
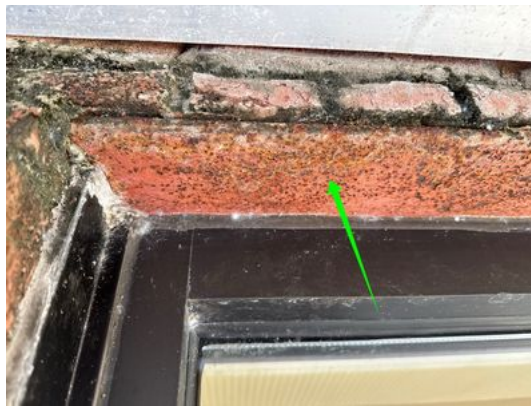
The steel lintels, above the windows and doors, have only been shop primed and are heavily rusted. In at least one location, the steel has flexed and pushed the grout out of position. Have a qualified professional repair, as needed, to prevent staining and to maintain the integrity of the veneer above.

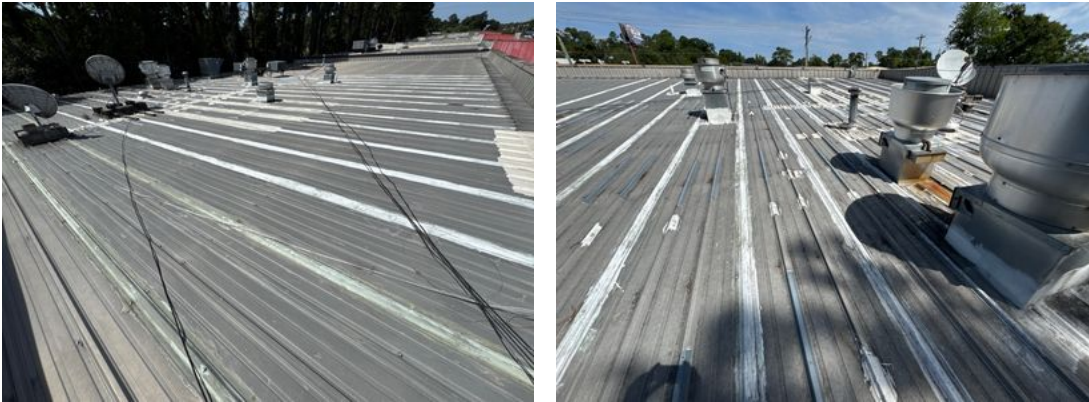
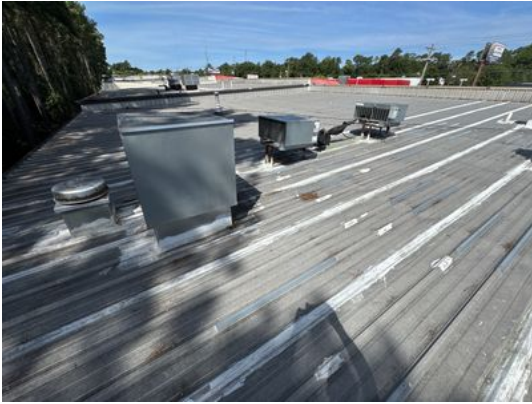
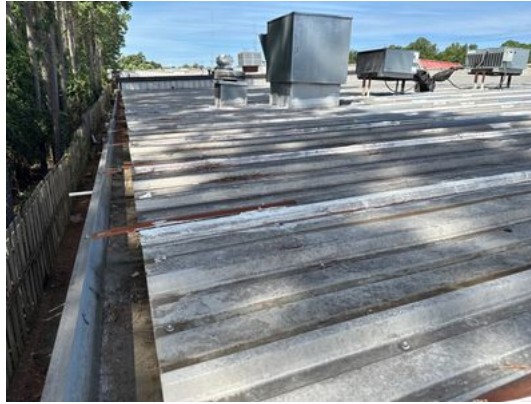
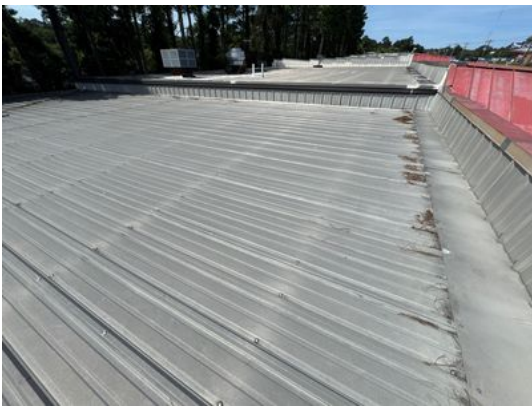
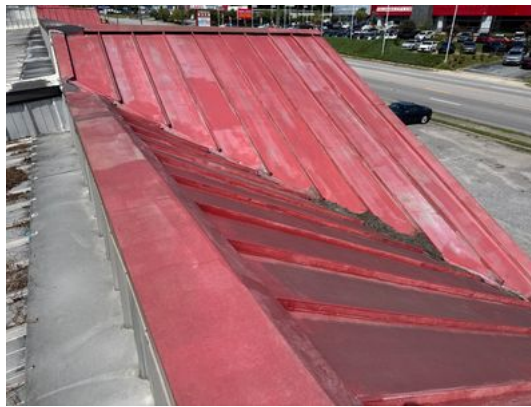
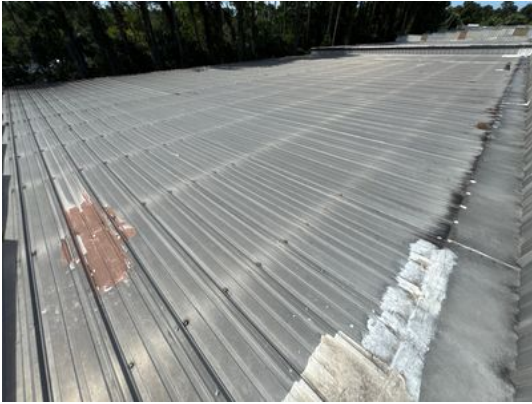
Visible roofing and gutters were in an acceptable condition, except as noted.

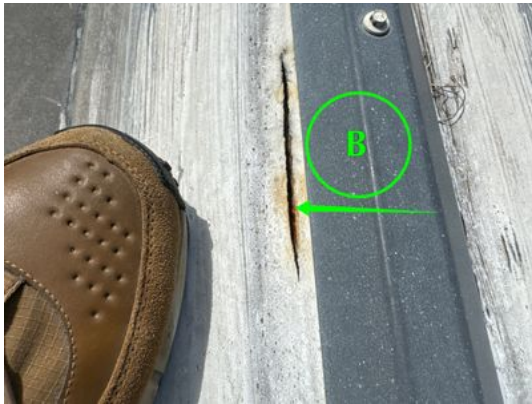
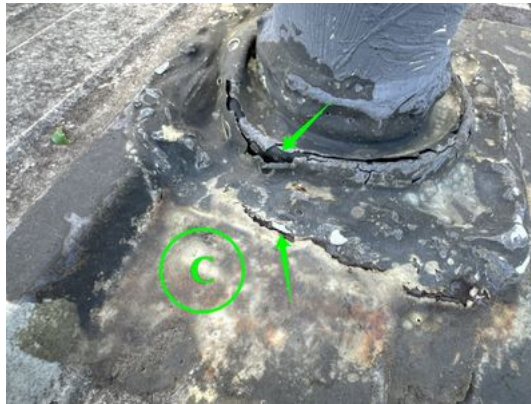
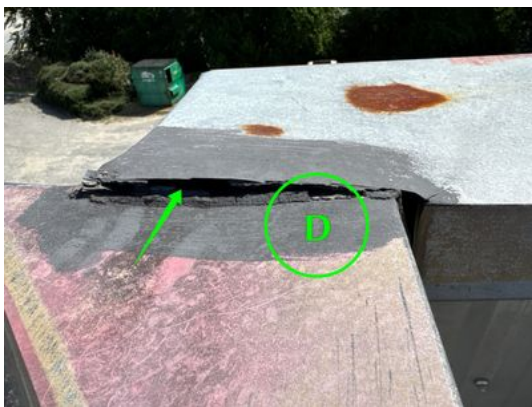
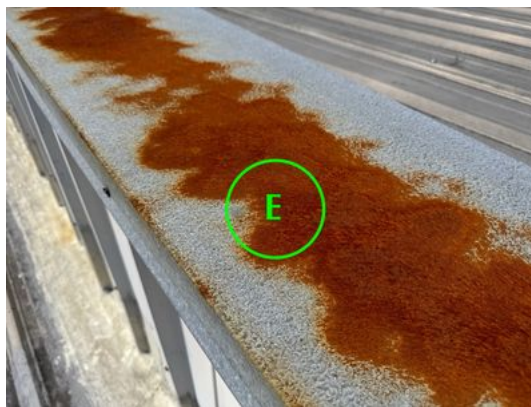
The following deficiencies were noted on the roof:

- A) A number of the gutter joints are leaking, contributing to the paint damage, along the rear wall.
- B) The roof has been repaired in a number of areas, and some of those repairs are peeling or deteriorated.
- C) Some of the roof penetration sealants are dried and cracked.
- D) Some of the cap flashing has separated or been repaired and the repairs have separated.
- E) Several areas of the metal cap flashing and some minor areas of the roof panels, themselves, are rusted.
- F) The majority of the roof fasteners have been replaced, but not all. This is a typical maintenance item for metal roofs and should be included, as such.

Have a qualified roofer, familiar with metal panel repairs, repair items A-E, as needed.

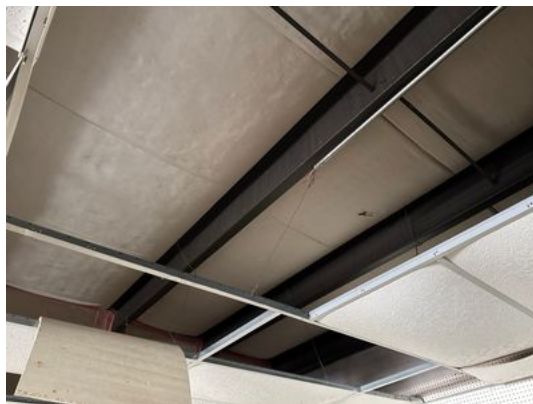
The building is a pre-engineered structure with fiberglass batt insulation in the roof and concrete block walls. Visible steel connections, anchor bolts, purlins, etc. appeared to be in an acceptable condition, but most were concealed by drywall or the tenants stored items.

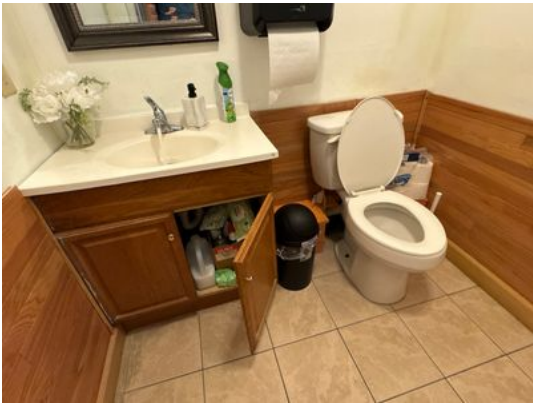
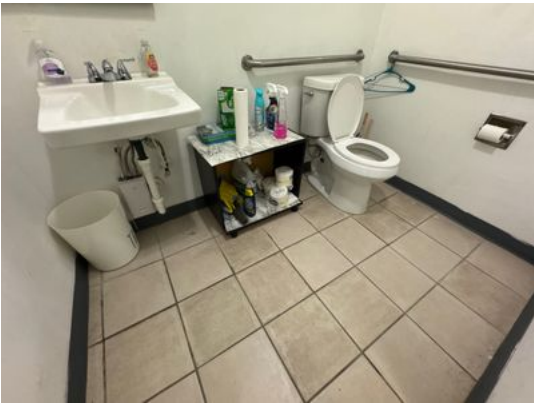
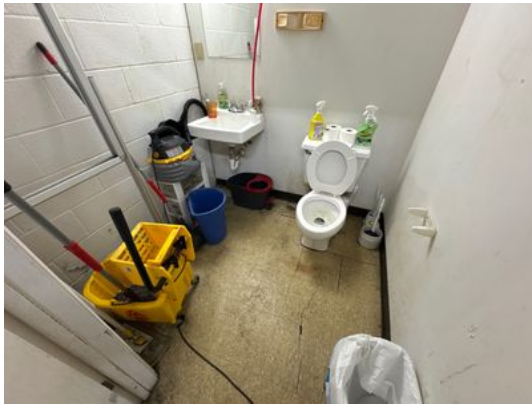
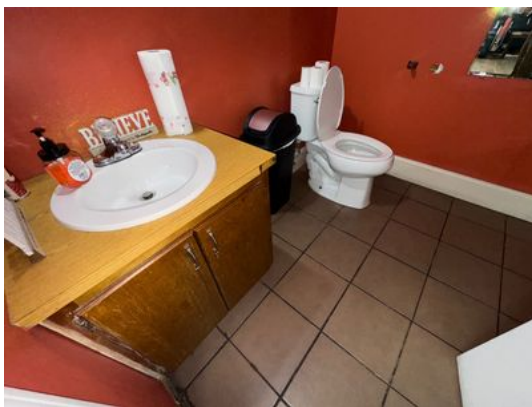
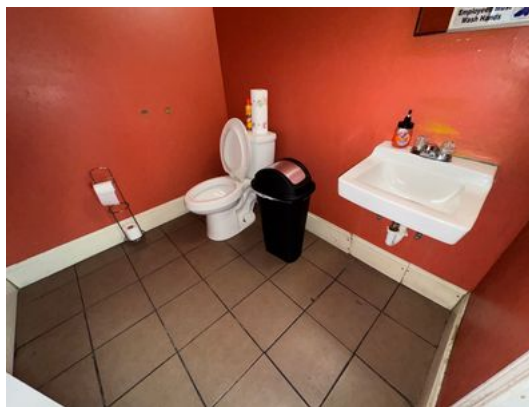
Overview of the tenant restrooms. There was a compliant of sewer gas odors, when the toilet was flushed, in Boost Mobile, but none noted at the time of the inspection. A couple of the toilets ran continuously, but overall, the plumbing fixtures were operating as expected. Listing agent claims that water heaters and all other major equipment, is the responsibility of the tenant for maintenance and replacement. These appliances were not tested.

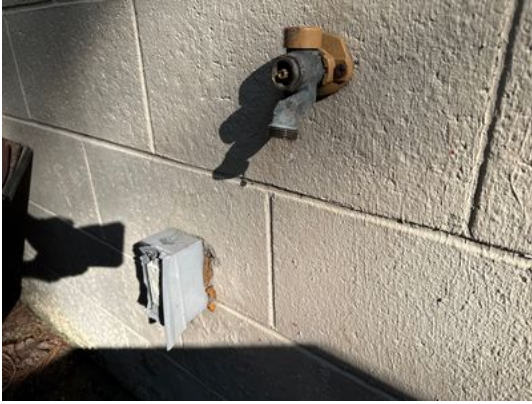
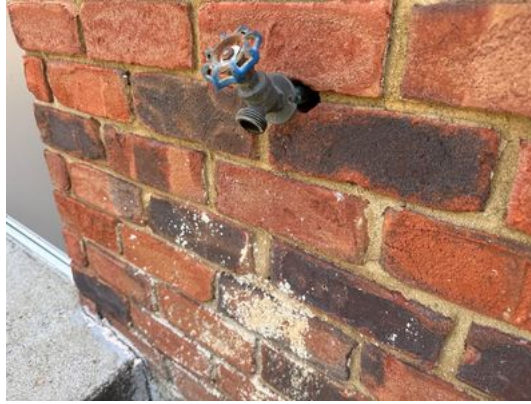
The outside hose bibs dripped continuously. Have a licensed plumber repair or replace, as needed.

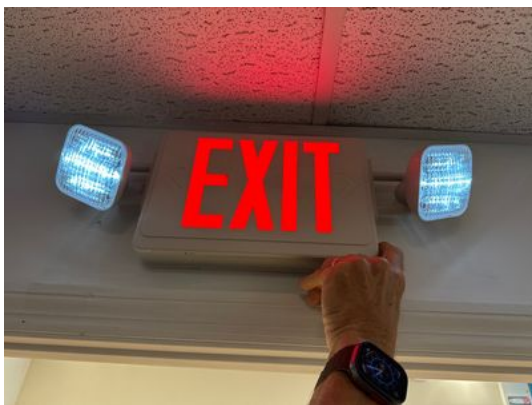
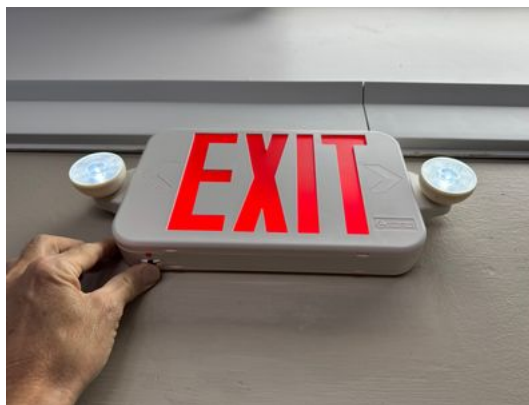
Most of the emergency lighting and exits sign were operating in test mode, but not all, particularly in the vacant spaces. Have a licensed electrician repair or replace for safety.

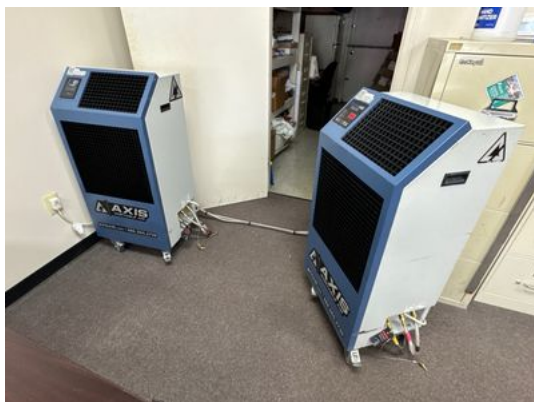
The listing agent stated that the HVAC systems are the tenants responsibility to maintain and replace (generally, installed by the seller, upon occupancy or build-out.) These systems were not inspected further.
