## Home Inspection Report

108 Kenton Dr  
Bardstown, KY 40004

Inspected By: Mike Meurer, KY License #102913;  
IN License #HI01900074; CCPIA-000572

Prepared For: [REDACTED]  
Inspected On Tue, Oct 6, 2026 at 9:00 AM

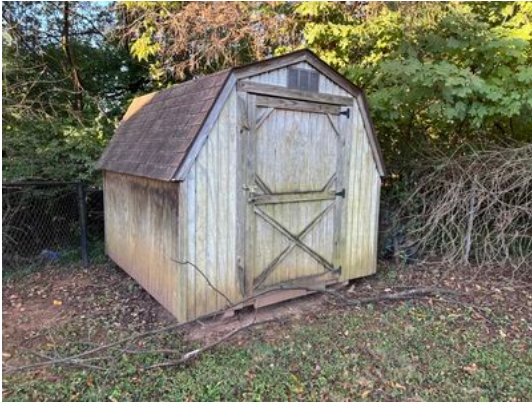
**Comment 1  
Information**

Storage shed is present, but was not inspected. It is beyond the scope of a home inspection.

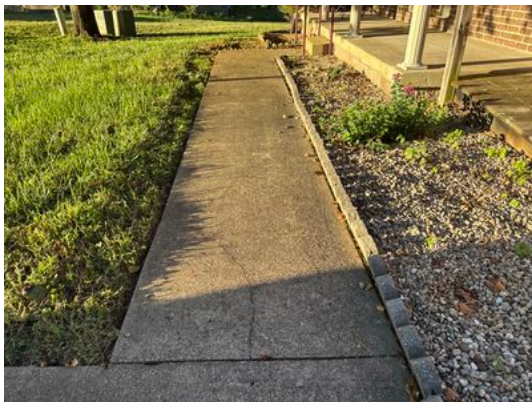
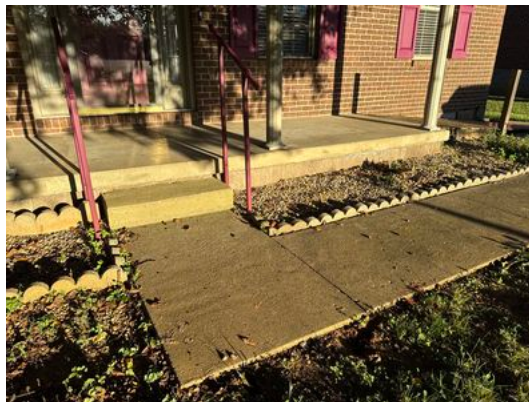
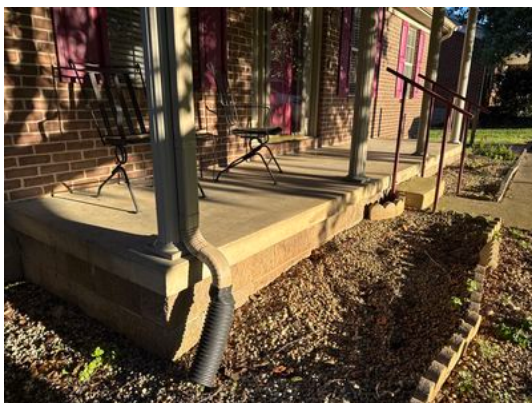
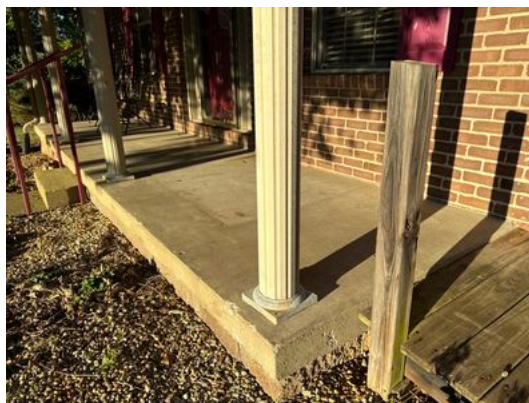
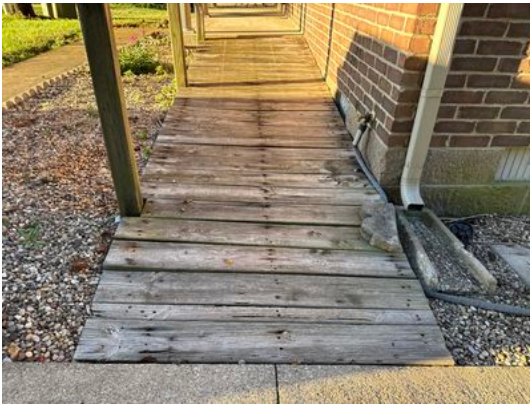
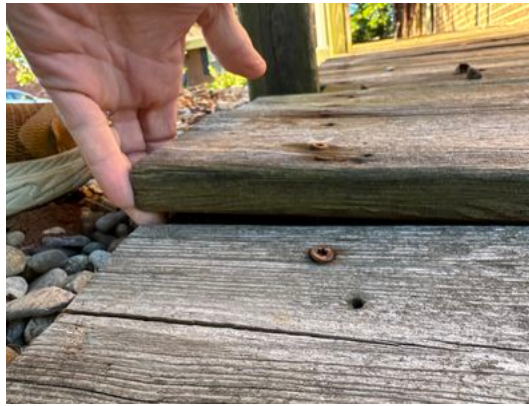
#### Comment 2

The front porch, steps and sidewalk were in an acceptable condition, but some of the ramp planking is rotted and loose. Have a qualified professional repair, as needed, for safety.

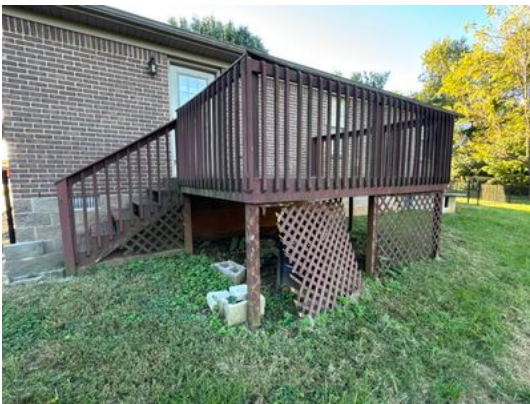
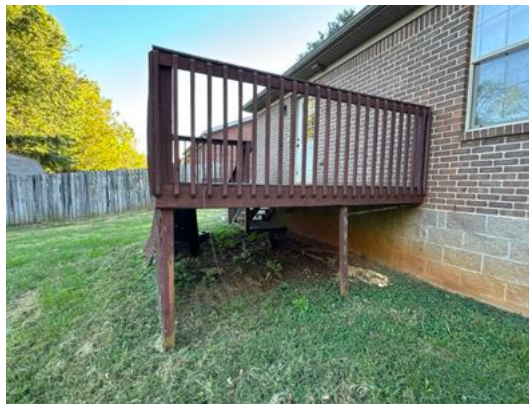
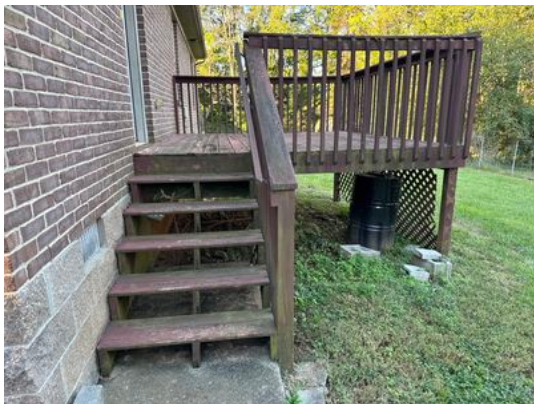
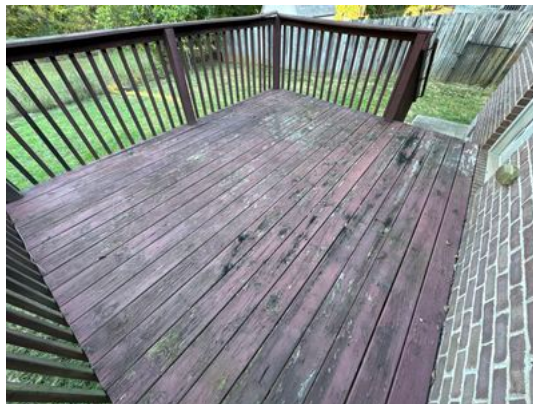
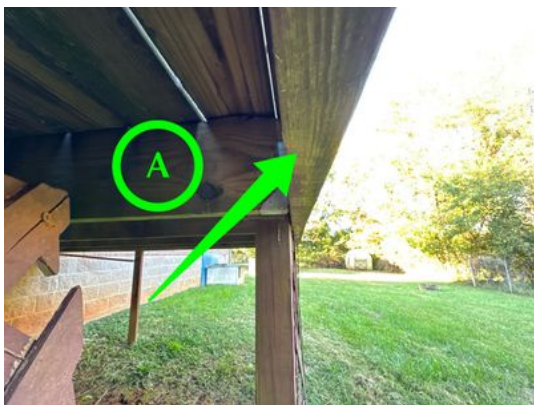
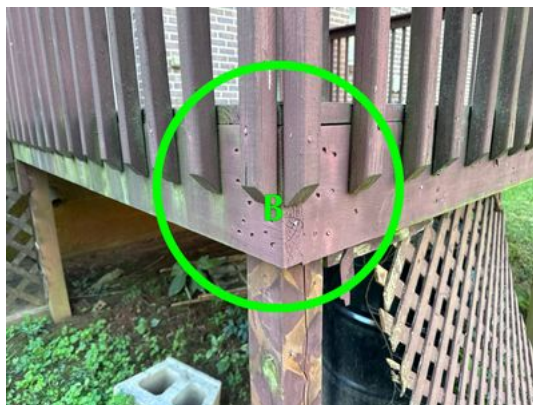
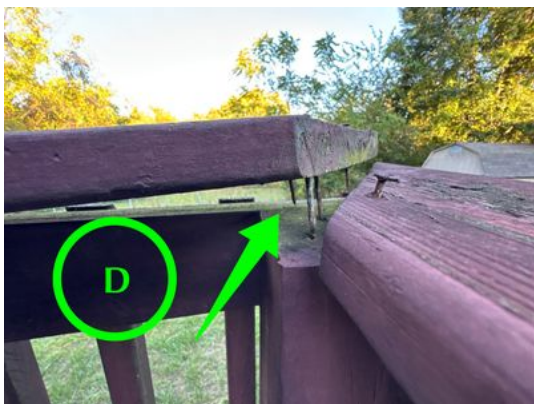
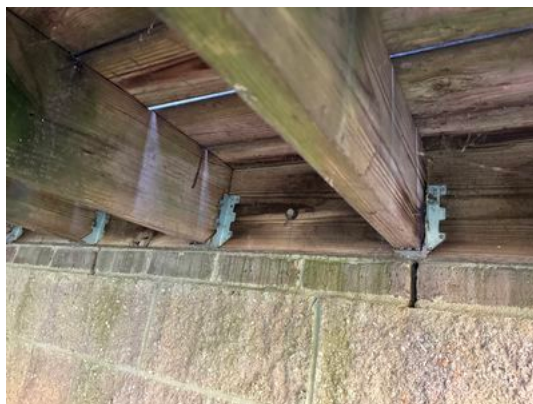
**Comment 3**  
**Deficiency**

The following deficiencies were noted on the rear deck:

- A) The outside beam is only a single member and should be doubled, at a minimum.
- B) The post-to-beam connections are only nailed and should be screwed or bolted.
- C) The stair risers are open.
- D) There is some minor damage and raised areas on the top rails.
- E) All of the surfaces are due to be cleaned and painted or sealed (not a deficiency.)

Have a qualified professional make all repairs, as needed, for safety and to improve the integrity of the structure.

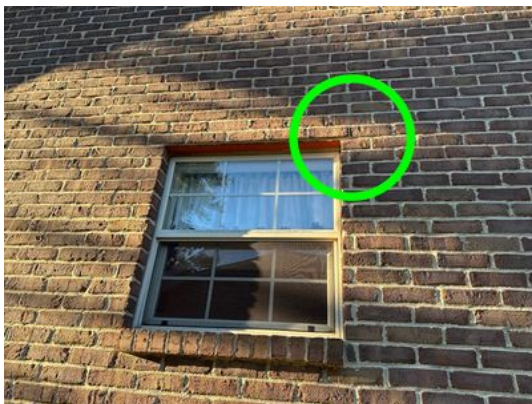
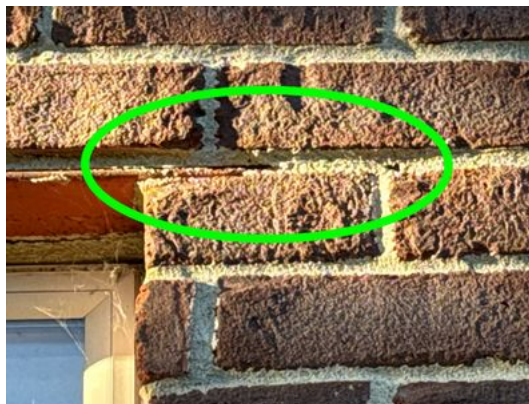
**Comment 4**

The steel brick lintels above the front door and windows have not been finish painted or covered, only shop primed, and are beginning to corrode. A portion of the lintel, on the right side, was not properly bedded in grout and is exposed. Have a qualified professional prep and paint and seal the bearing ends, to prevent rust from affecting the integrity of the steel and staining doors and windows below.

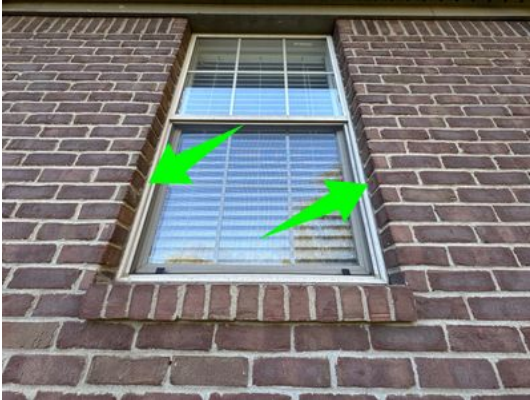
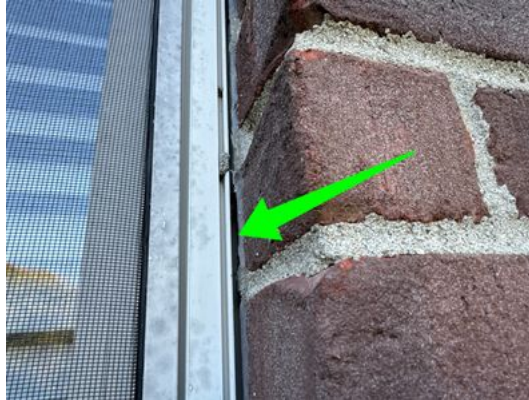
**Comment 5**

The perimeter sealant of some of the exterior windows has begun to fail. Have a qualified professional caulk or seal all for maximum energy efficiency and to prevent water and pest intrusion.

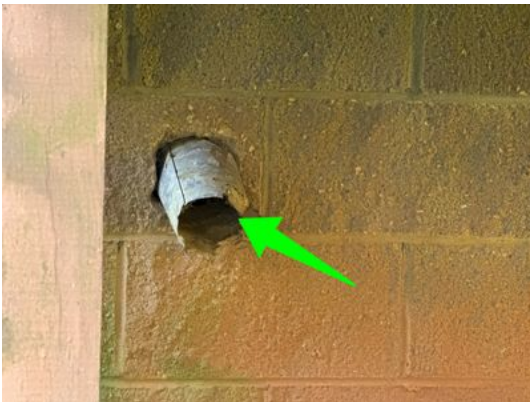
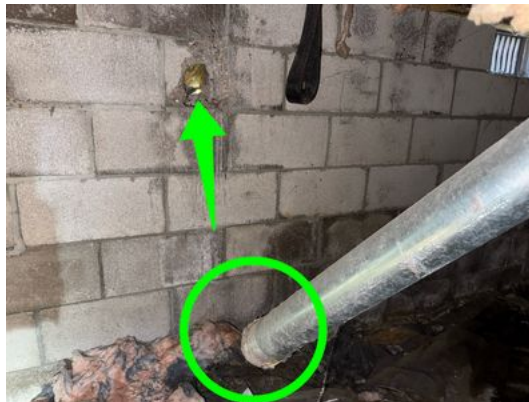
**Comment 6**

Dryer vent is missing its louver and disconnected from the duct, in the crawl space. Have a qualified professional repair/replace, as needed.

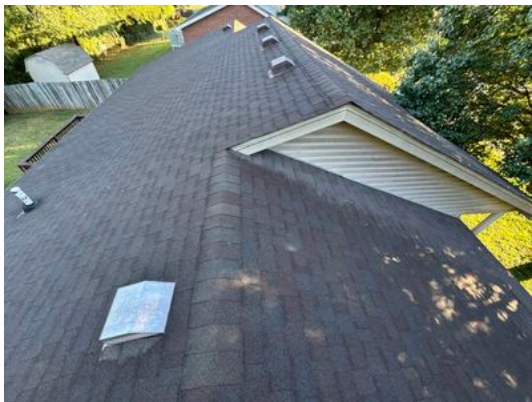
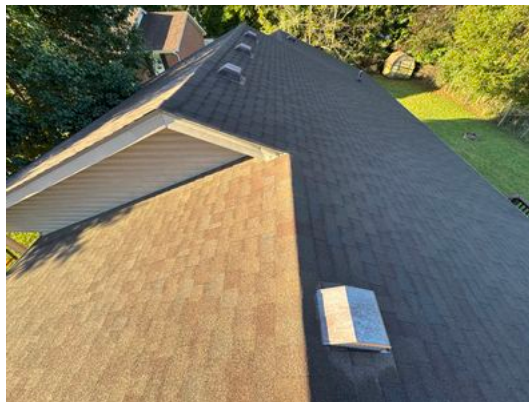
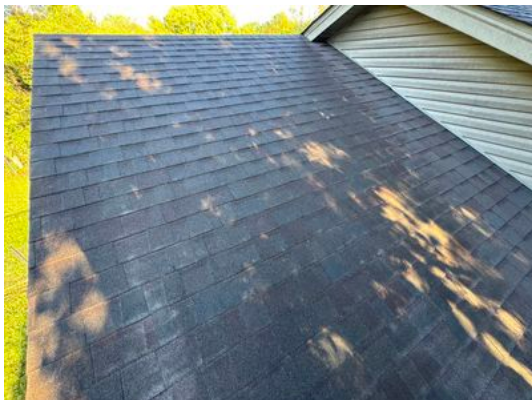
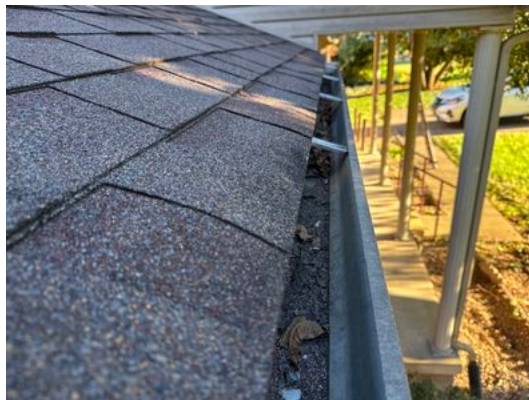
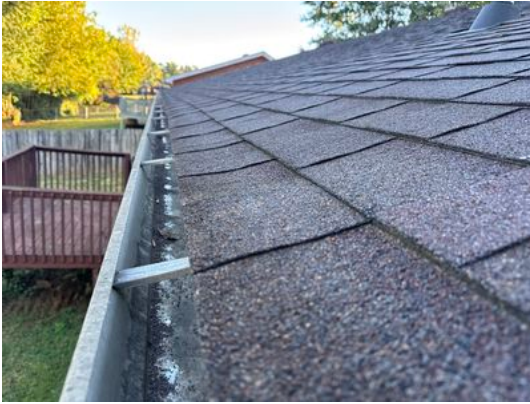
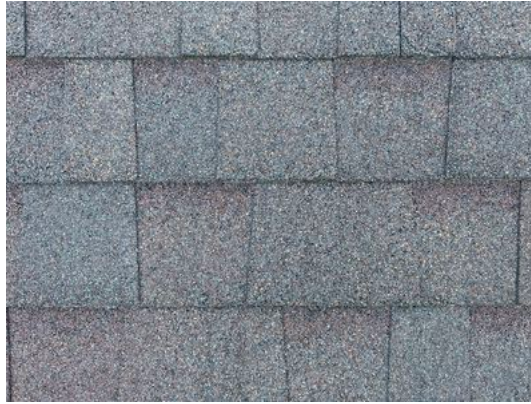
#### Comment 7 Information

Visible roofing and gutters were in an acceptable condition.

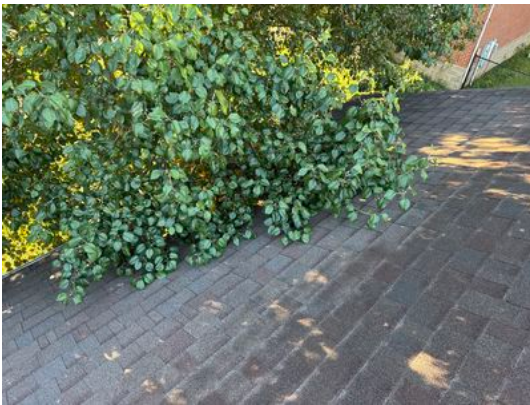
**Comment 8**  
**Information**

Keep tree limbs trimmed clear of the roof surface to help extend the life of the roof and help in keeping the gutters clear.

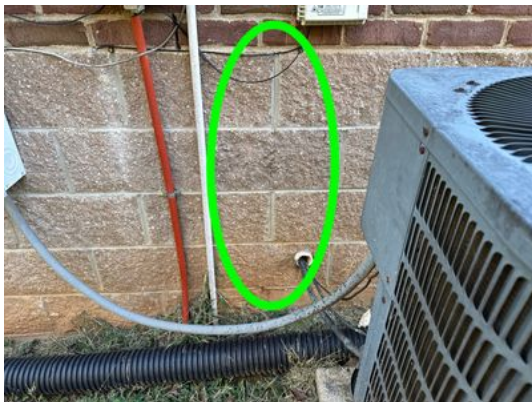
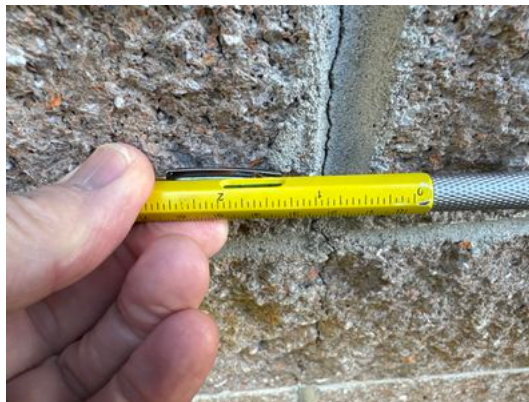
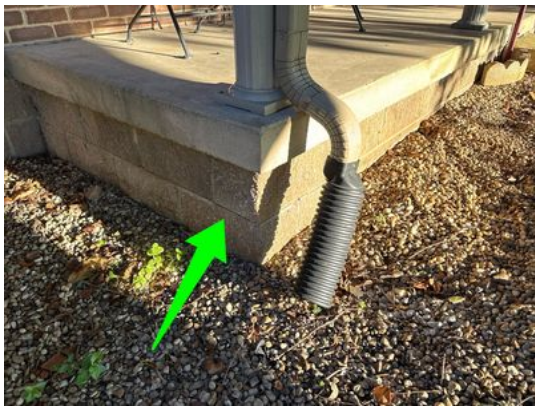
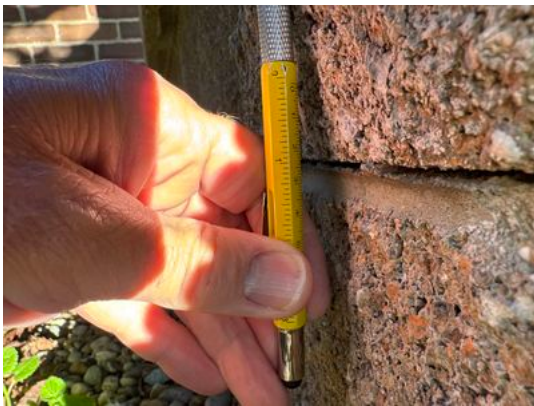
#### Comment 9 Information

Typical hairline concrete cracks in some areas of the foundation wall. These are, generally, not a structural concern and are typical for concrete block foundations and homes of this age. Monitor for further movement.

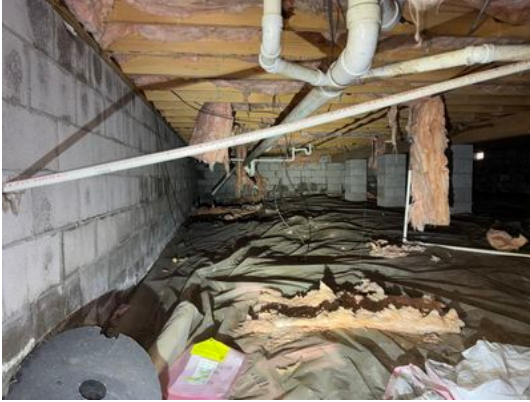
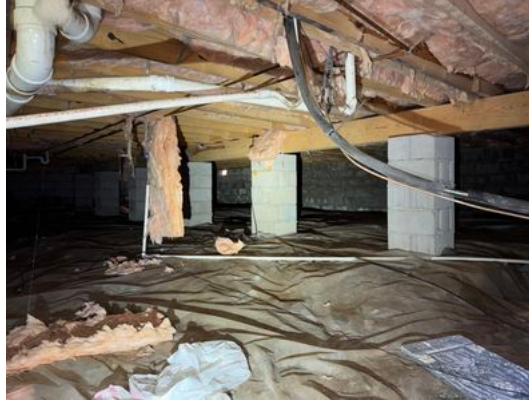
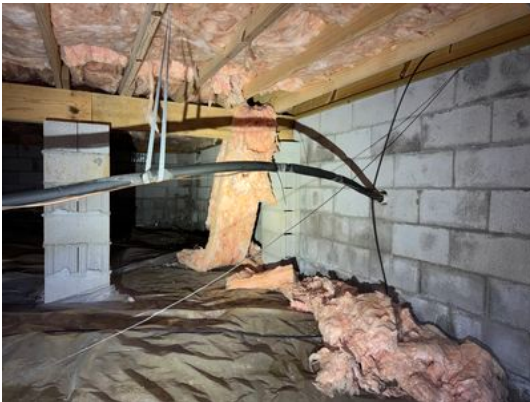
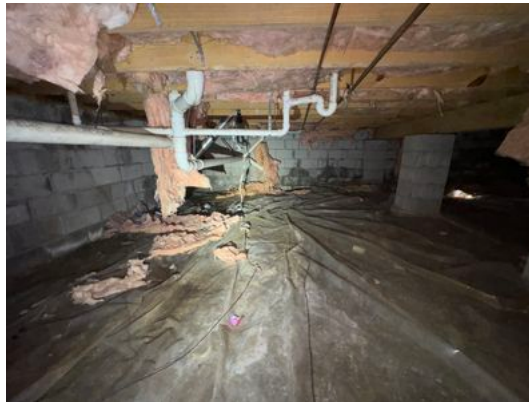
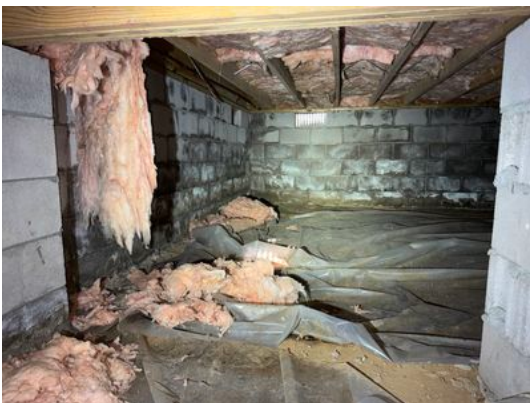
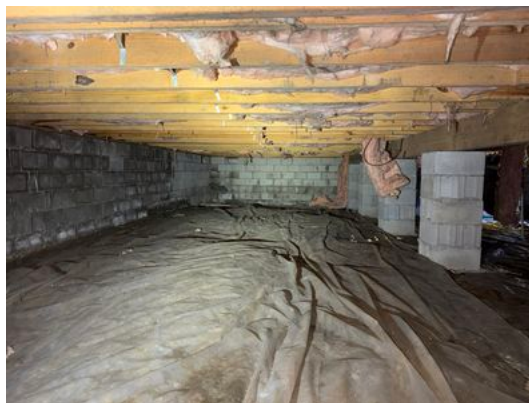
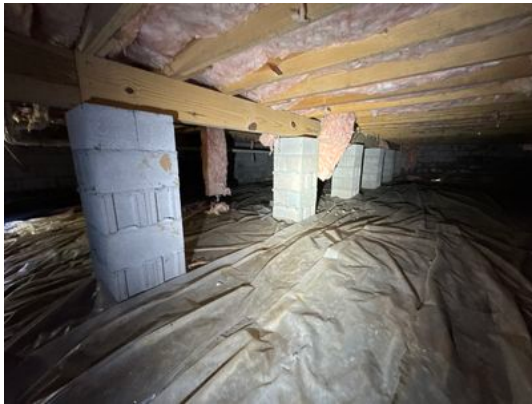
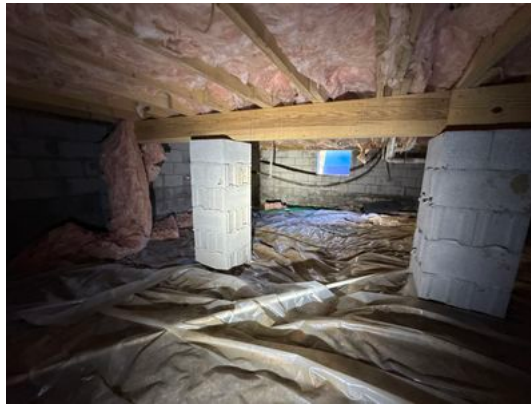
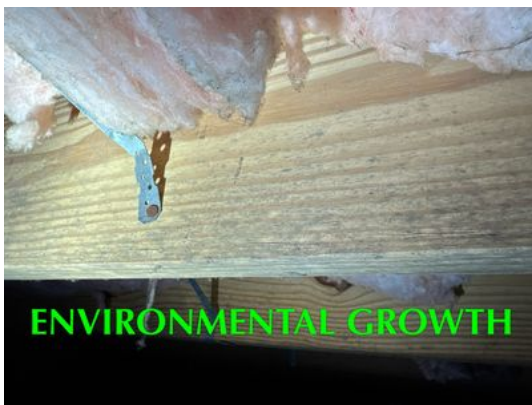
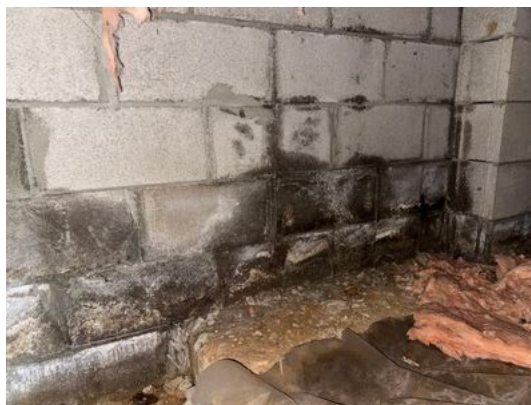
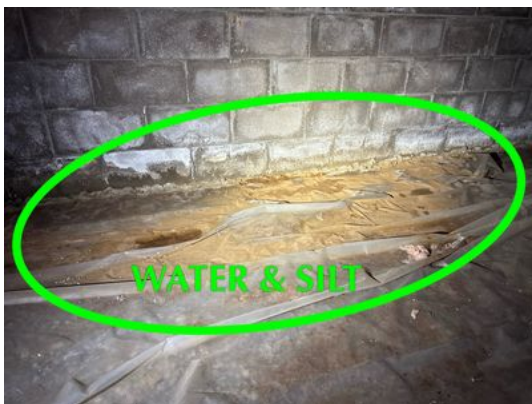
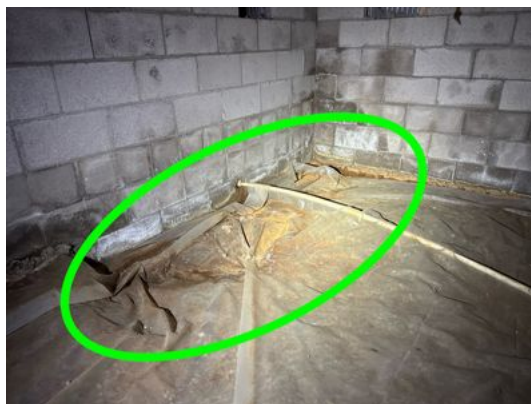
Comment 10

View inside the crawl space. There is, what appears to be, some environmental growth on the floor structure and other surfaces, throughout the space. Additionally, there are signs of moisture penetration through the foundation, signs of silting

and standing water. Have a qualified waterproofing/environmental specialist repair and remediate any hazards/issues, as needed. NOTE: The entire space, systems and components were not visible or accessible for a full inspection, due to batt insulation.

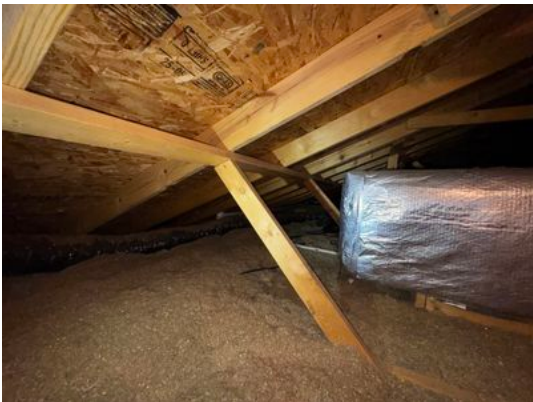
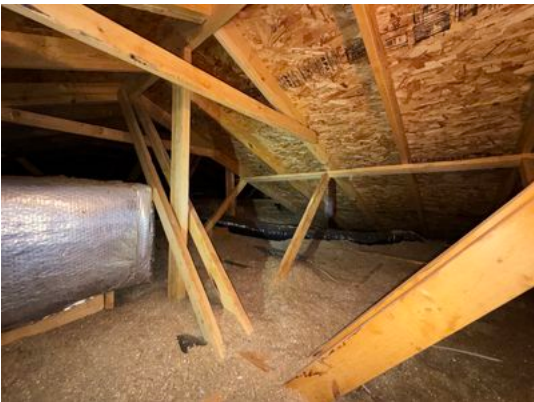
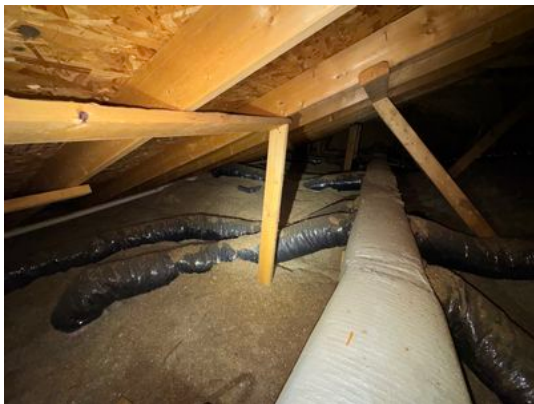
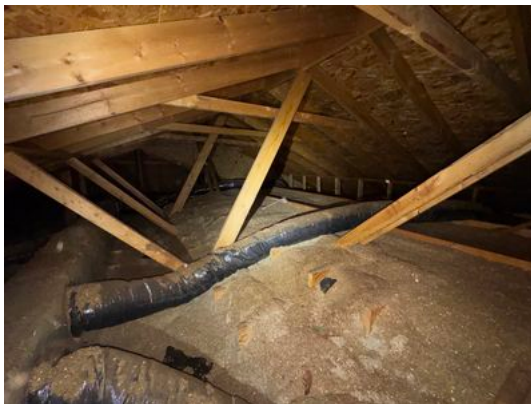
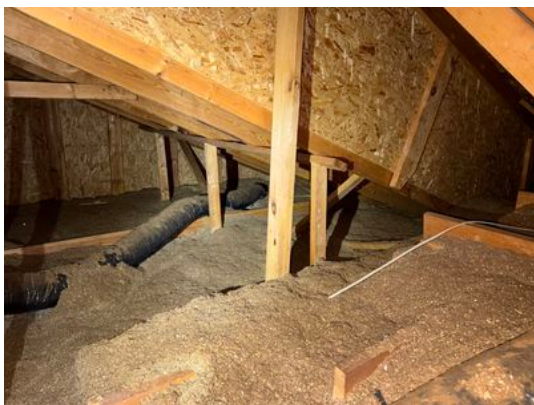
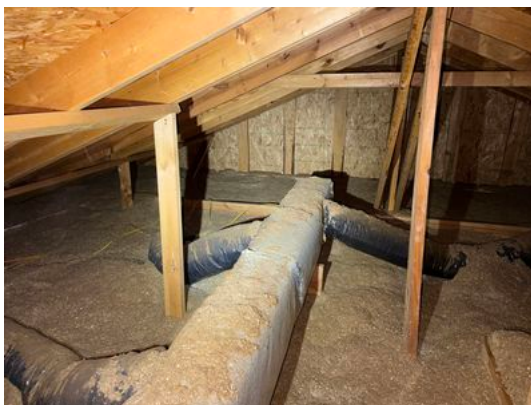
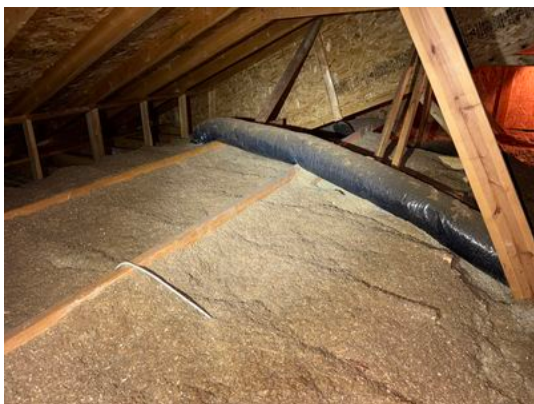
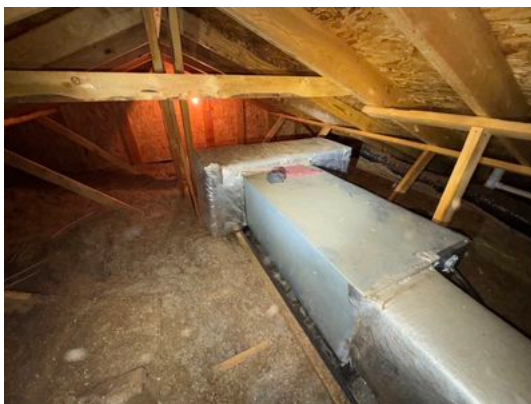
Comment 12  
Information

View inside the attic. The entire space, systems and components were not visible or accessible for a full inspection. Some stains are present on the structure and sheathing, but were dry and firm, at the time of the inspection. This is typical for most older homes.

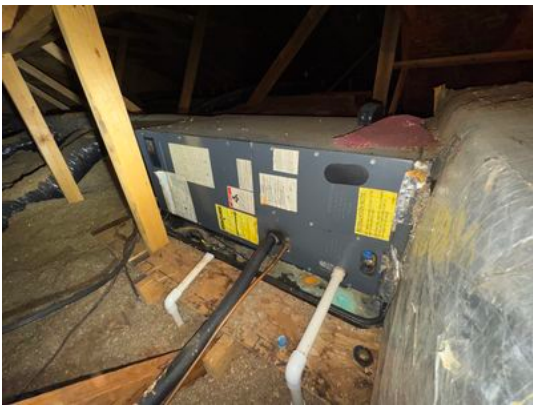
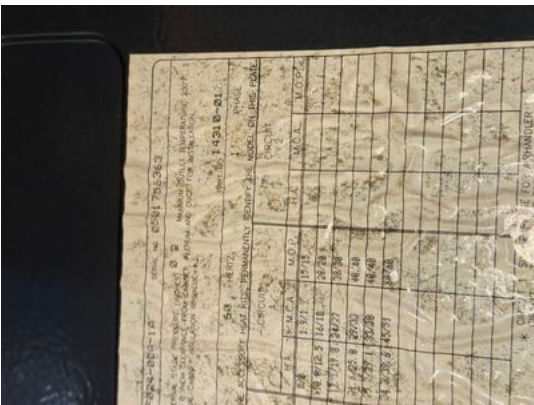
**Comment 13**  
**Deficiency**  
Heat pump (interior) unit and data plate. The unit was operating as expected, but is beyond its life expectancy of 15 years old (approximately 21 years old.) Have cleaned, serviced and checked, during the inspection period and prior to closing, by a licensed HVAC contractor. Recommend budgeting for new.

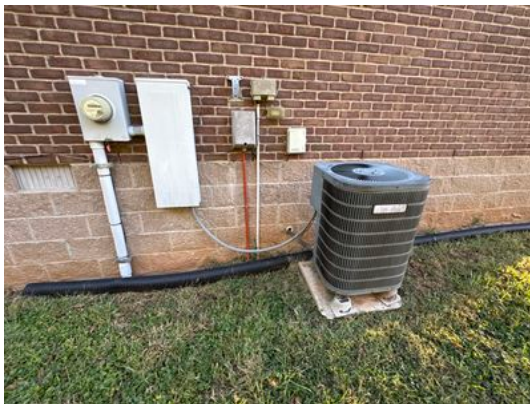
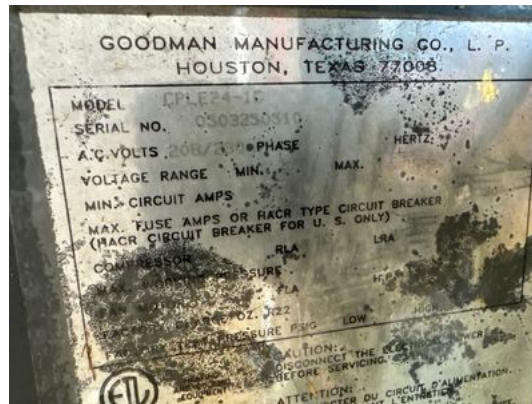
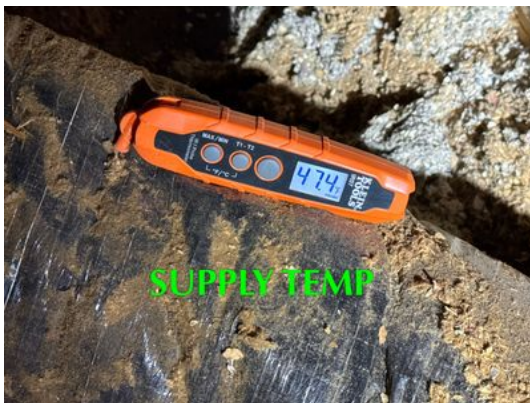
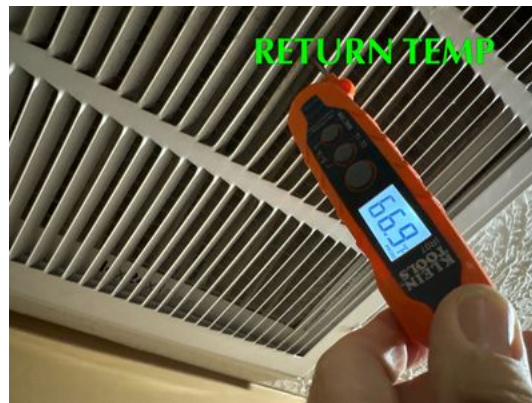
#### Comment 14

Heat pump (exterior) unit and data plate. The unit was operating as expected, but is beyond its life expectancy of 15 years old (approximately 21 years old.) Have cleaned, serviced and checked, during the inspection period and prior to closing, by a licensed HVAC contractor. Recommend budgeting for new.

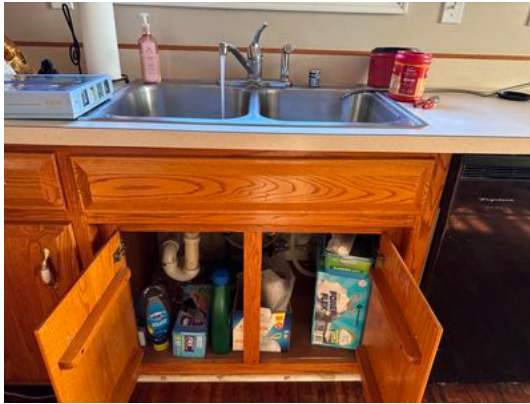
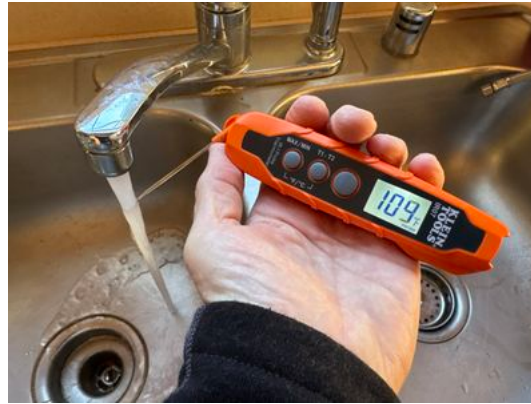
Kitchen plumbing fixtures were operating as expected.

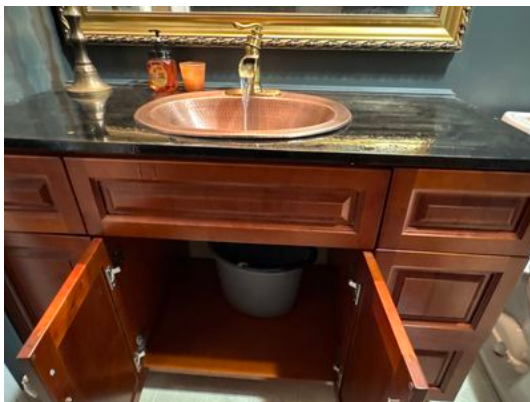
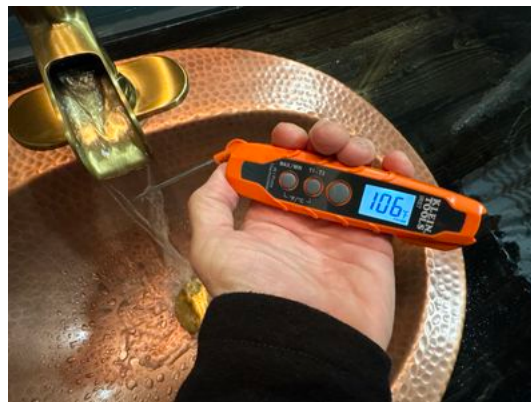
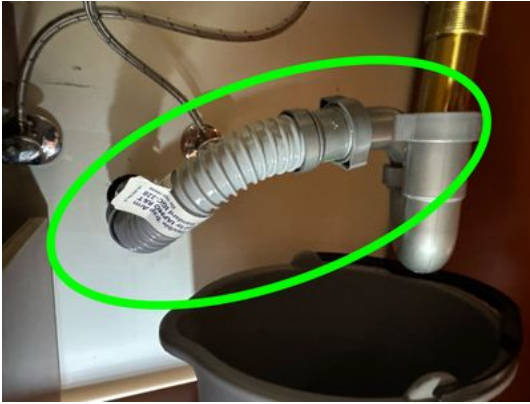
Hallway bath plumbing fixtures were operating as expected, but the toilet assembly had to be manually operated to flush. Additionally, the ribbed/corrugated drain piping traps hair, debris, grease, and bacteria, leading to frequent clogs and poor drainage. Recommend that a qualified professional replace that section with a proper p-trap in smooth-walled piping. Have a qualified professional repair/replace the toilet assembly, as needed.

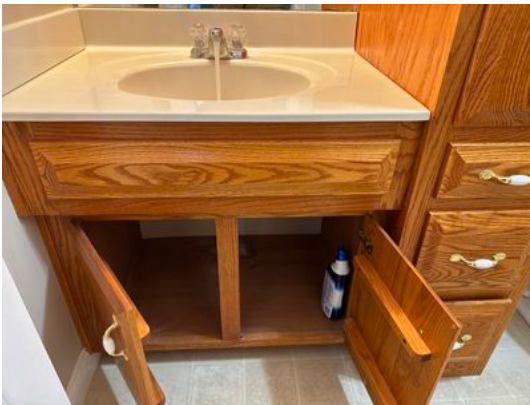
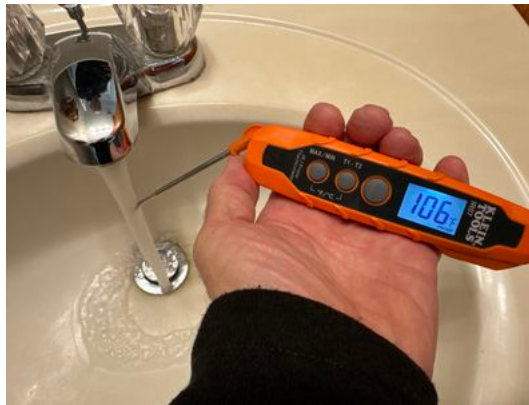
**Comment 20**  
**Information**

Bedroom bath plumbing fixtures were operating as expected.

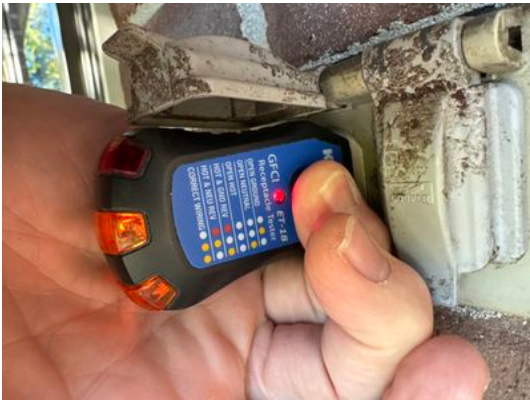
Front and rear exterior outlets are not GFCI protected. Have a licensed electrician replace for safety.
