502 Inspections, Inc.  
(502) 230-7233  
[www.502inspections.com](http://www.502inspections.com)

## Commercial Inspection

1313 Lyndon Ln  
Louisville, KY 40222

Prepared For: [REDACTED]  
Inspected On Mon, Mar 24, 2025 at 9:00 AM

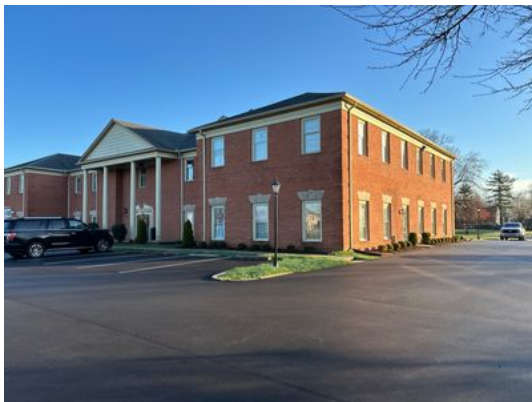
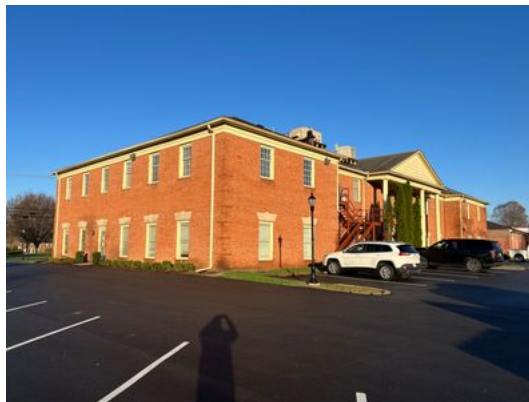
#### Comment 1 Information

Overview of the exterior.

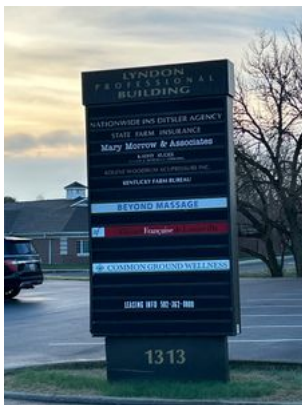
### Comment 2 Information

Marquee signage is present and in an acceptable condition.

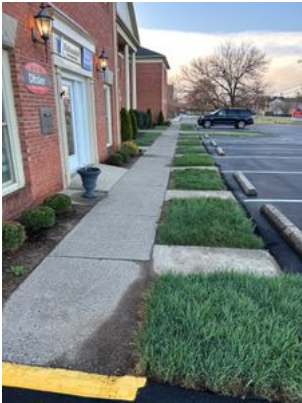
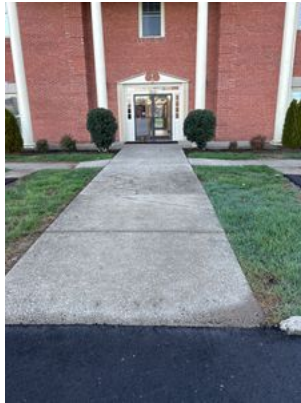
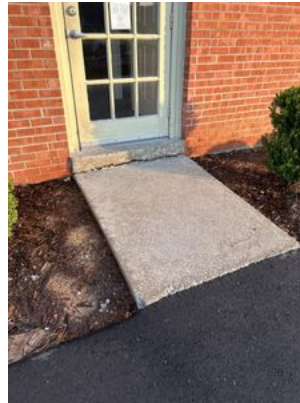
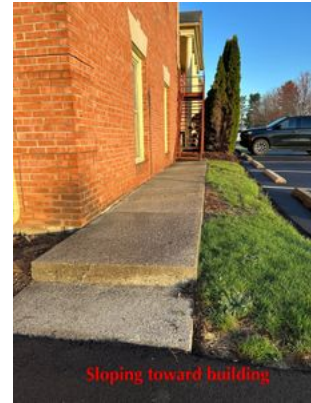
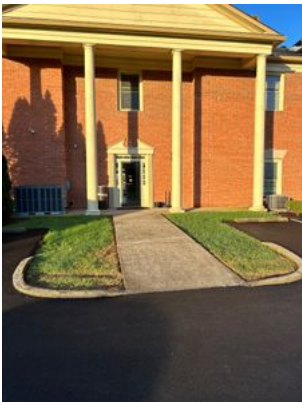
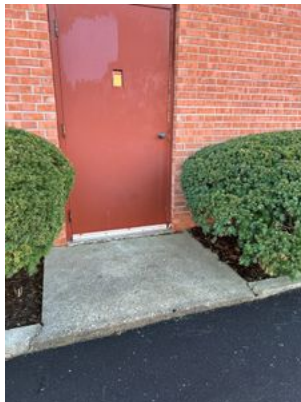
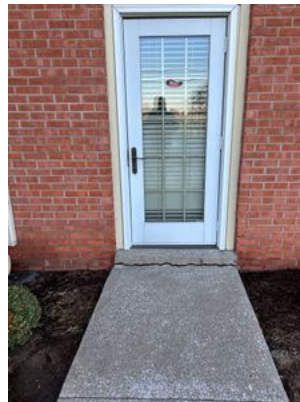
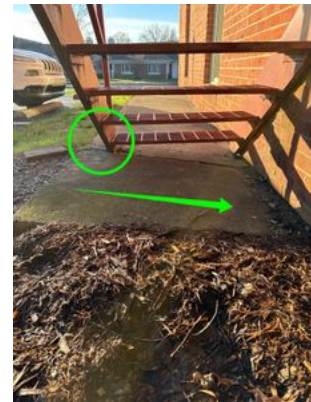
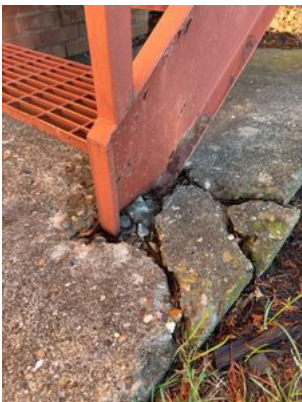
The sidewalks were in a mostly acceptable condition, but the walk beneath the fire escape structure is broken and slopes towards the foundation. Have a qualified professional repair (slab-jacking specialist) or remove and replace, as needed, to move water away from the structure and stabilize the base of the steps.

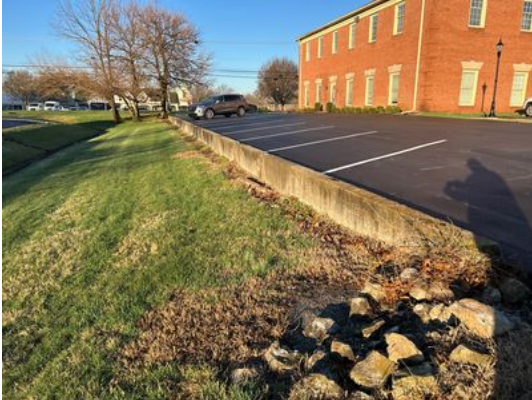
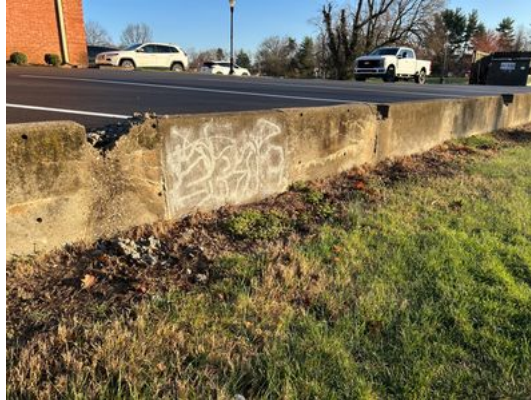
**Comment 5**

The retaining wall/parking bumper, along the right side, has been heavily damaged in some areas. Have a qualified concrete or restoration specialist repair, as needed, to maintain the integrity of the structure.

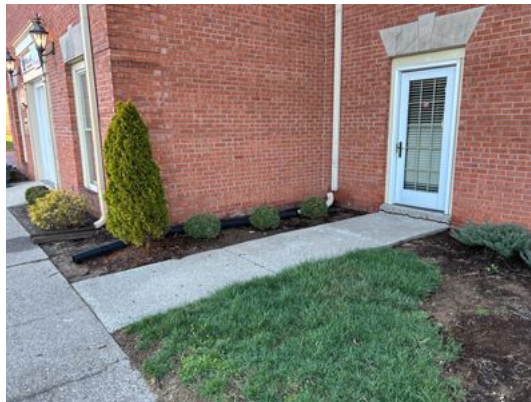
**Comment 6**

The landscape areas on both sides of the main entry appear to drain poorly. Have a qualified waterproofing specialist evaluate and repair, as needed, in an effort to move water away from the structure. Reconnect all downspouts to extensions and extend any that are not.

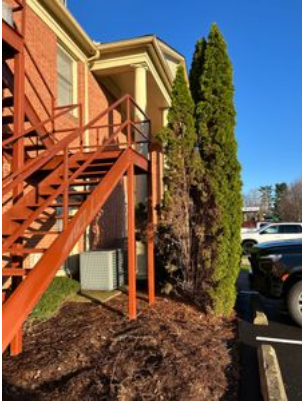
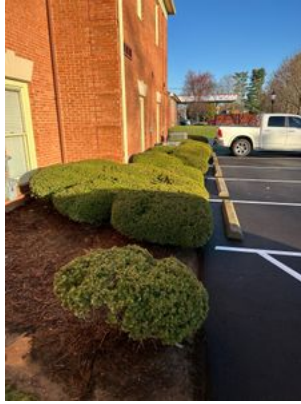
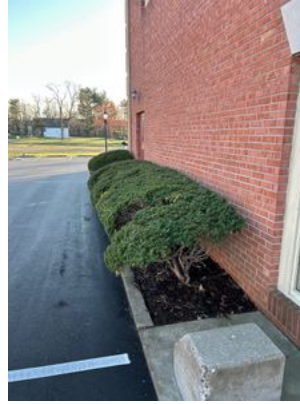
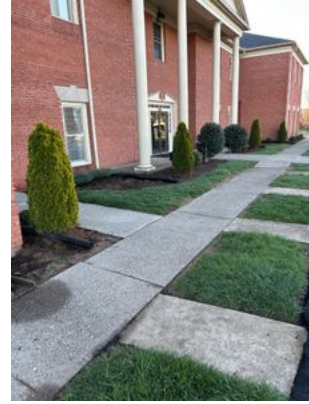
**Comment 7  
Information**

Landscaping has been generally well maintained.

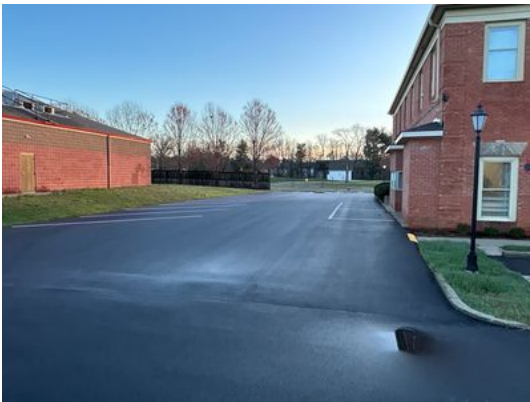
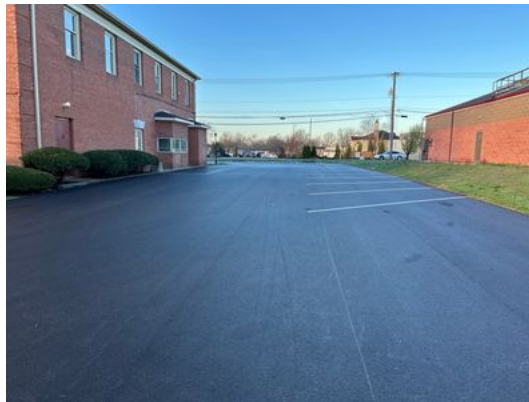
### Comment 8 Information

Asphalt parking, driveways and paint striping were in an acceptable condition.

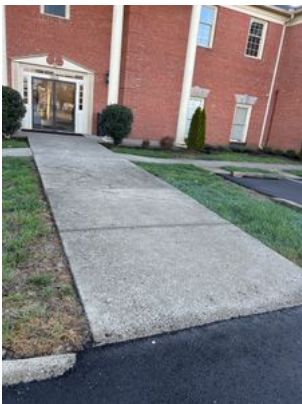
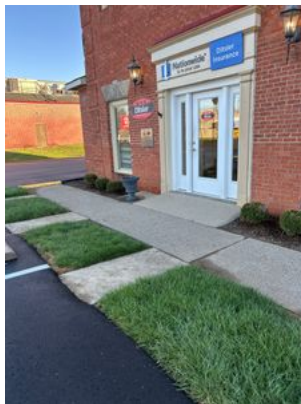
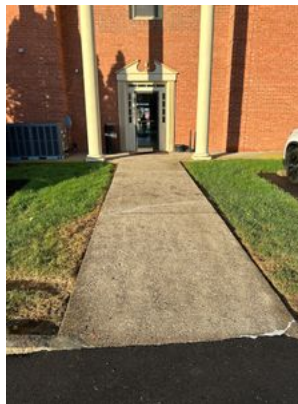
#### Comment 9 Information

Handicap accessible sidewalk ramps present at each entrance and there is no curb or obstruction at the thresholds.

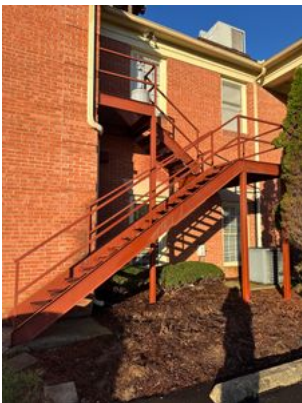
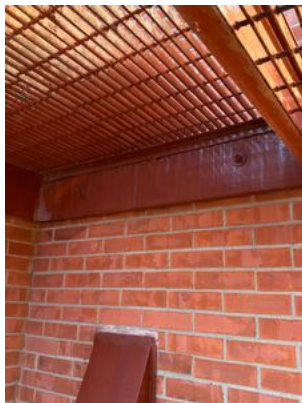
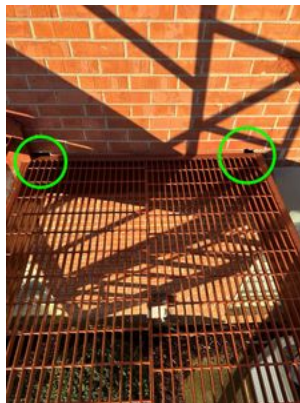
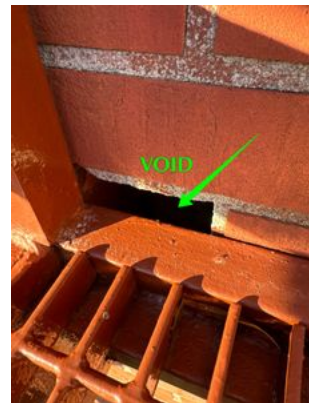
The metal fire escape was in a mostly acceptable condition, with the following exceptions:

- A) Some sections are rusting.
- B) There are openings in the brick at the landing bearing points.
- C) Recommend adding balusters around the guardrail for safety.

Have a qualified professional evaluate and repair all, as needed.

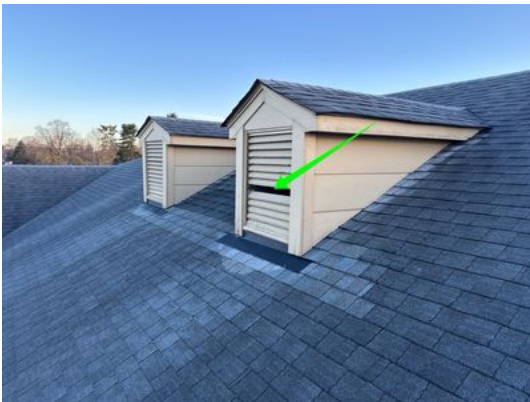
There is a missing wood louver on the front dormer. Have a qualified professional replace.

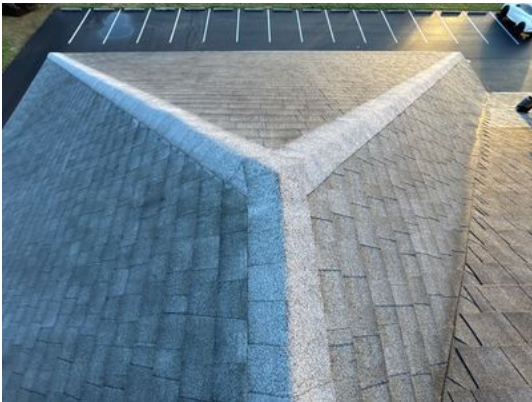
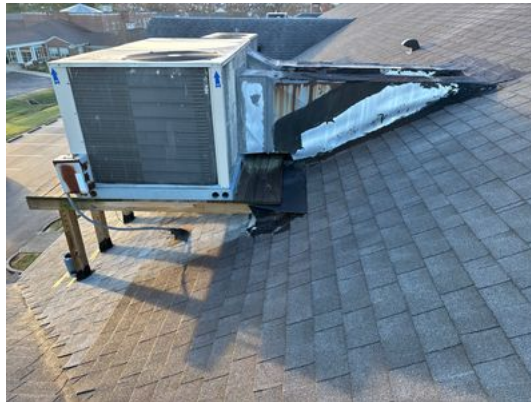
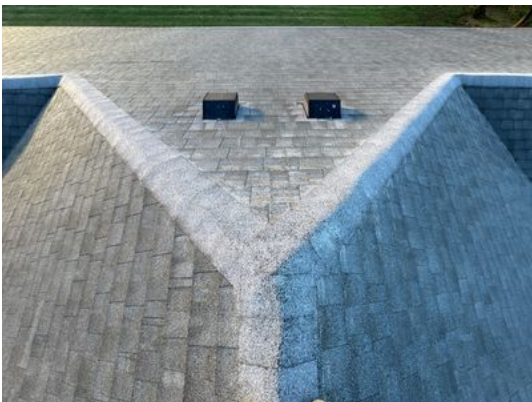
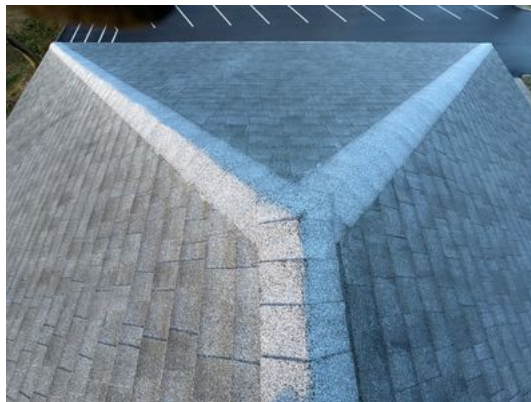
Visible roofing and gutters are nearing the end of their life expectancy. Granules are loosening, the matrix is exposed on some edges (primarily on the windward side) and tabs are very brittle. The areas around the rooftop equipment is more heavily worn from maintenance of the equipment. Recommend budgeting for replacement in the next few years.

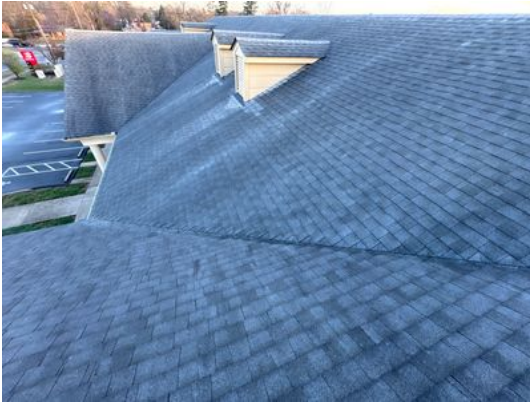
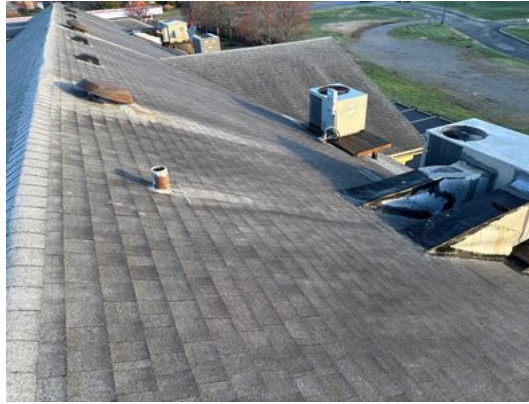
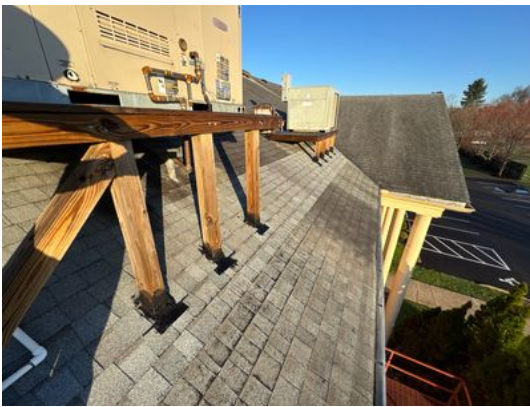
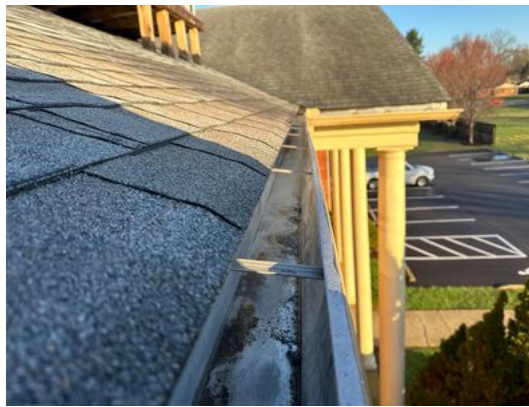
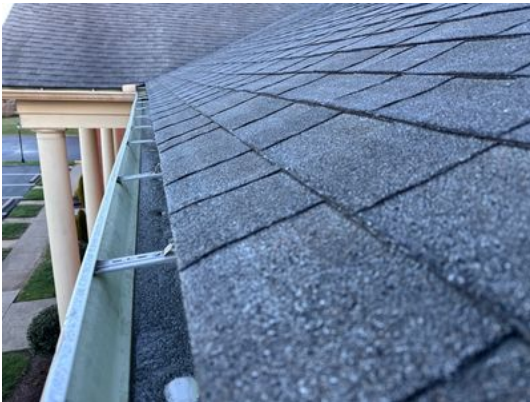
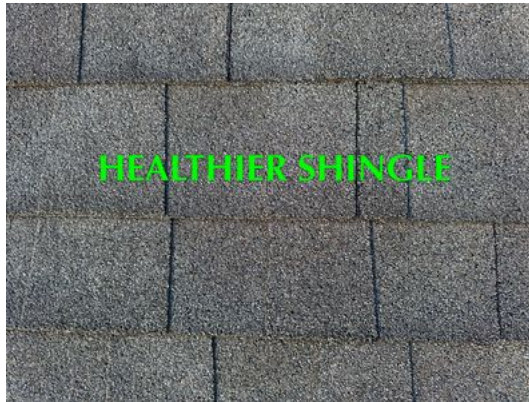
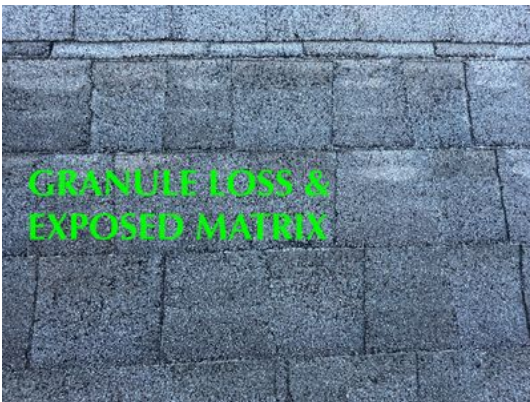
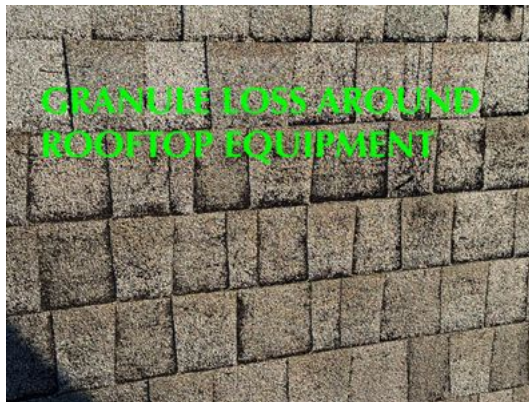
### Comment 17

The following deficiencies were noted on the roof:

- A) There is an active leak in the “field” of the front slope, visible and wet to the touch, in the attic. There are other stained areas, but only one found to be actively leaking.
- B) There are a couple of damaged shingles.
- C) The flashing around the rooftop supports is raised in a couple of areas.
- D) The rooftop ductwork is holding water and the sealants have dried and cracked.
- E) The gutter joints are leaking, causing some minor damage to the soffit and gutters boards.

Have a qualified roofer repair all, as needed.

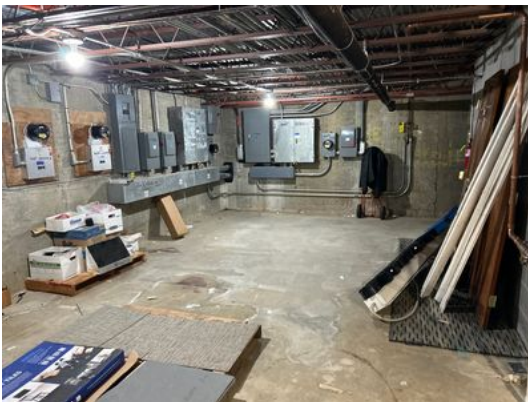
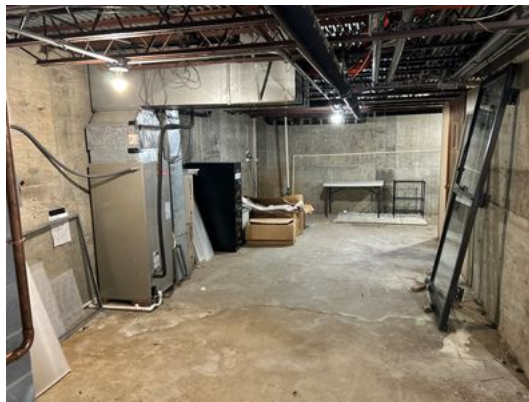
Overview of basement.

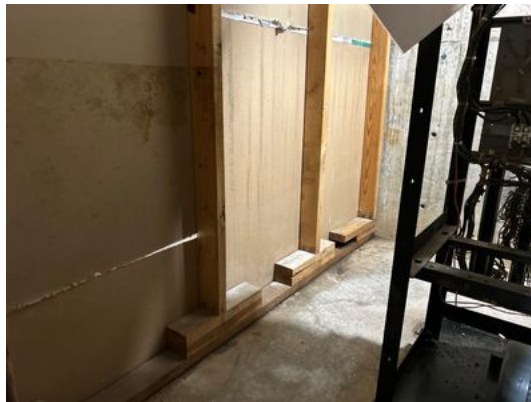
**Comment 19**  
**Information**

The white powdery substance noted on the basement walls and floors is, most likely, efflorescence. Efflorescence is harmless, but does indicate a high moisture content in or around the foundation wall and slab. The space and sump crock was found to be dry at the time of the inspection. Recommend that a qualified waterproofing specialist evaluate and repair, if a drier space is desired. NOTE: Other stains were noted on the structure, but appear to be from plumbing issues that have been previously resolved.

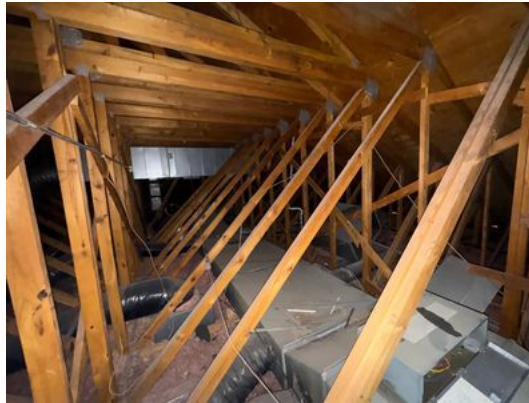
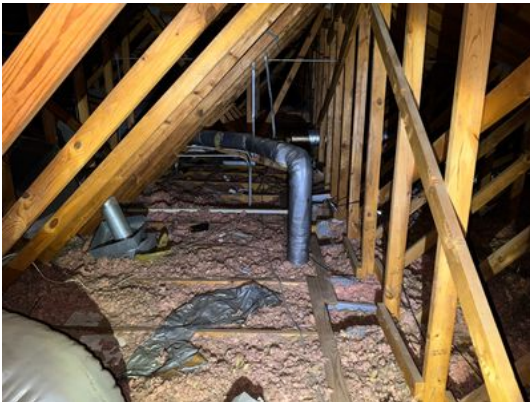
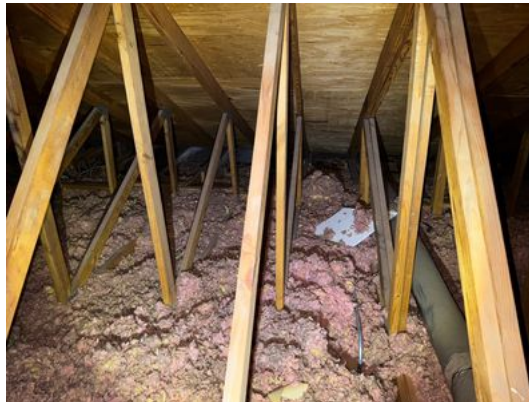
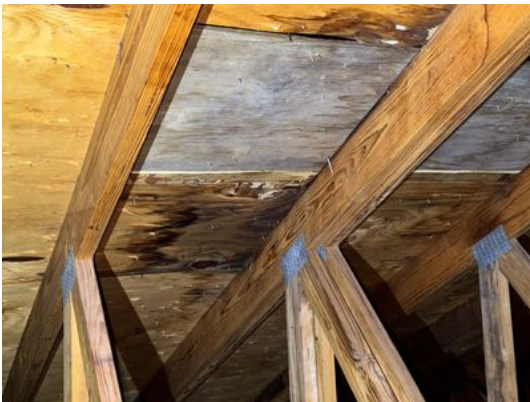
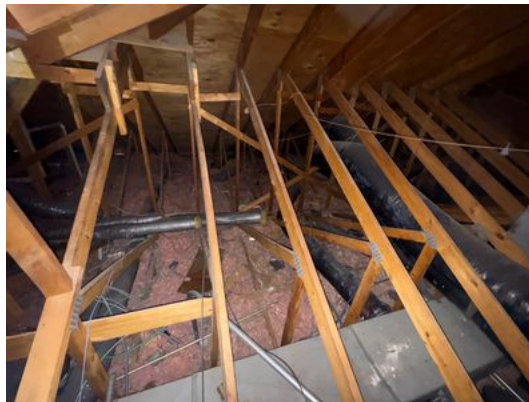
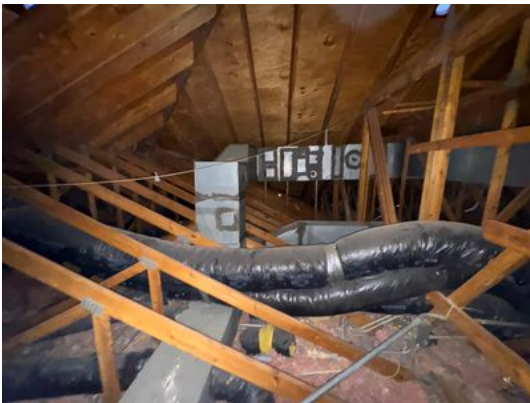
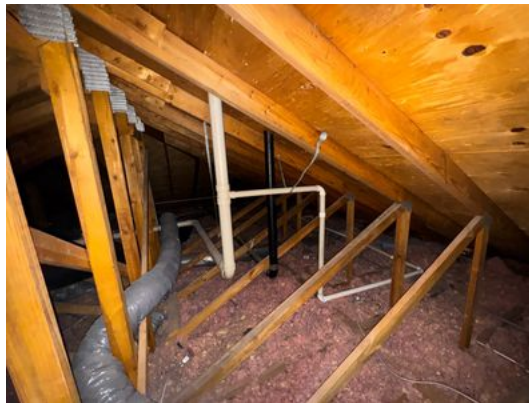
**Comment 21**  
**Deficiency**

View inside attic. The entire space, systems and components were not visible or accessible for a full inspection. Some stains are present on the structure and sheathing, but all were dry and firm, at the time of the inspection, with the exception of one area, noted in the Roofing section. The following deficiencies were noted:

A) There are a few areas where the insulation is missing or been pushed aside. Recommend replacing for maximum energy efficiency. Very little insulation was present, but this is typical for a structure of this age.

B) Some of the plywood sheathing is damaged on the rear slope. Have a qualified professional add support, as needed.

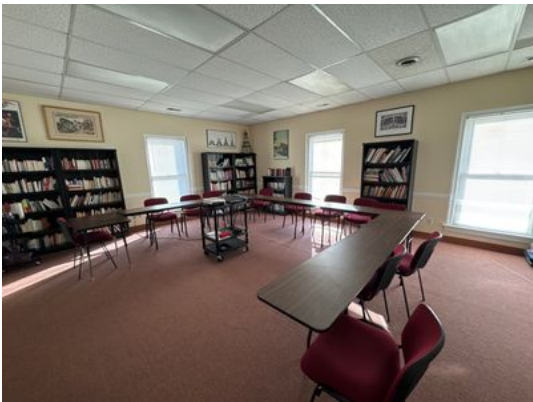
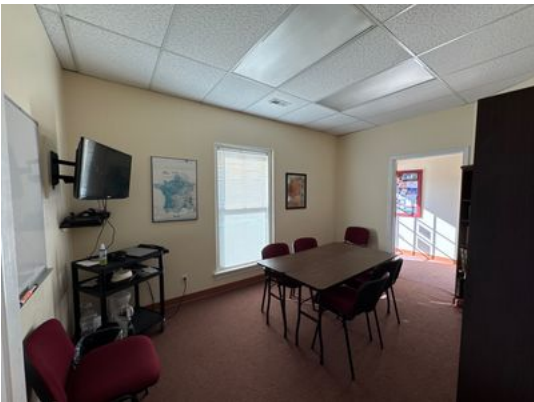
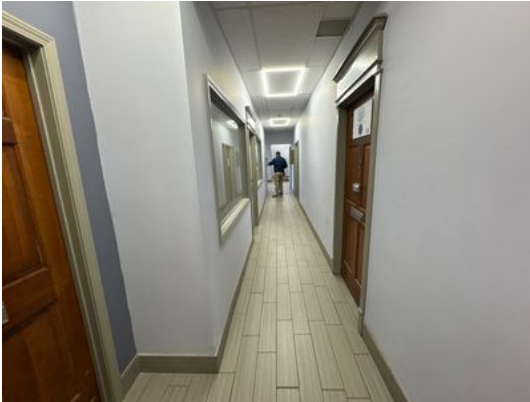
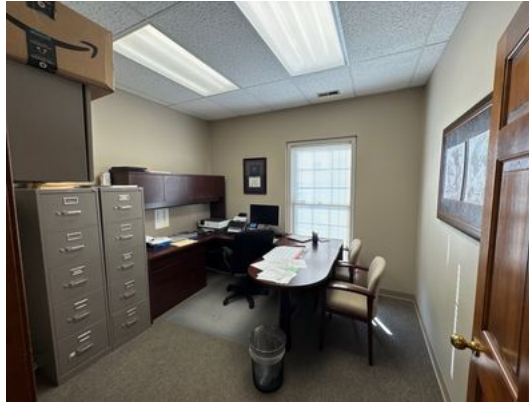
Comment 22  
Information

Overviews of the interior. Limited access, due to tenant restrictions and hours of operation.

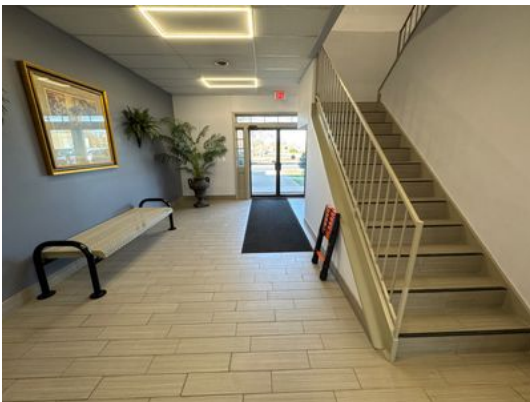
**Comment 23**

The stairwell to the basement is missing a graspable handrail. Recommend installing a rail for safety.

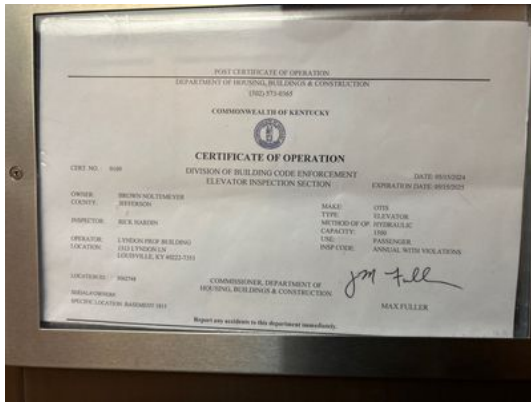
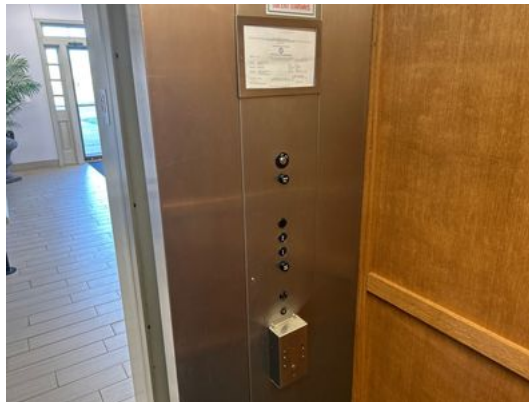
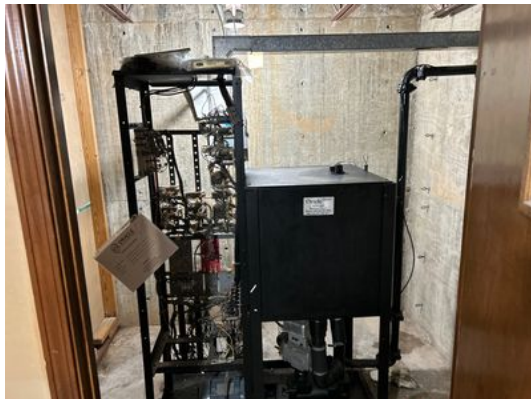
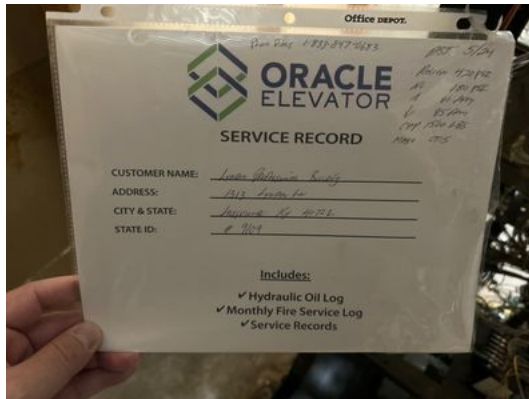
### Comment 24 Information

Elevator operated as expected. State Certificate of Operation is in place and valid through May, 2025. An annual inspection is required, as long as the elevator is in service.

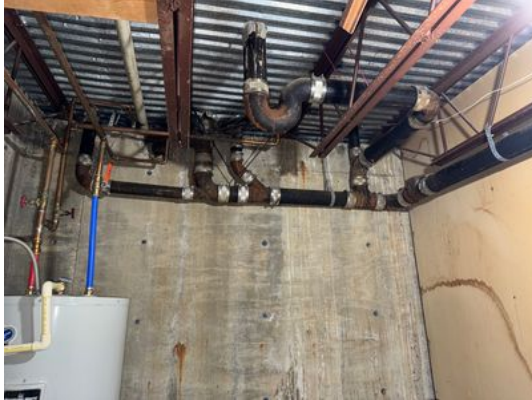
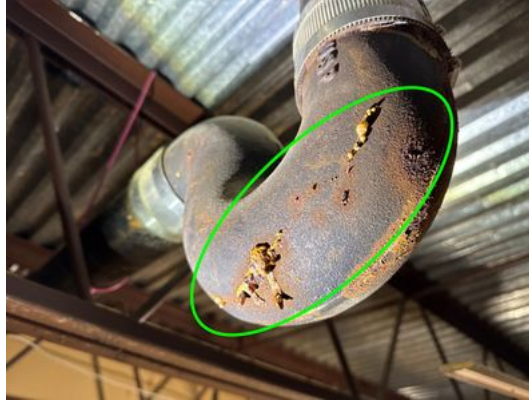
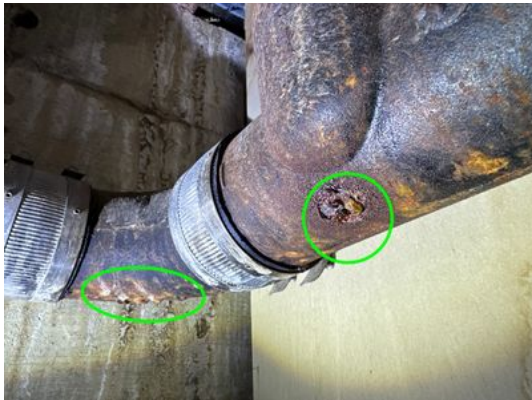
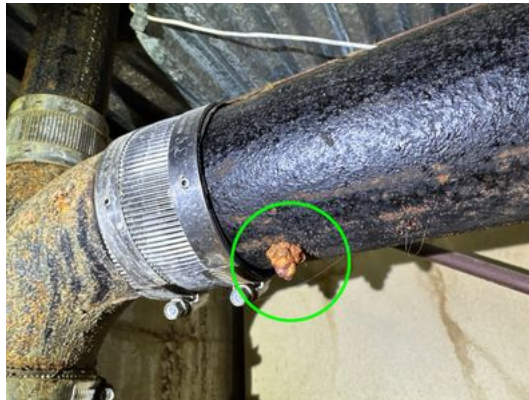
For a property of this age, it is recommended to have a sewer scope performed to learn the condition of the primary drain system, prior to closing. There are some rust “barnacles” or “buttons” on the visible sections of cast iron drain pipe in the

basement. Typically, what occurs on the outside of the pipe is way behind what may be corroding on the inside of the pipe or a weak spot occurs in this location, which may lead to leaks. Pending the findings of the scope, have a licensed plumber make repairs, as needed.

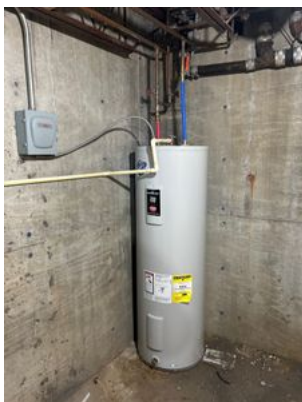
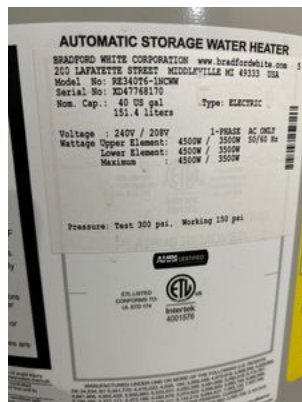
### Comment 26 Information

Water heater was operating as expected. Approximately 4 years old.

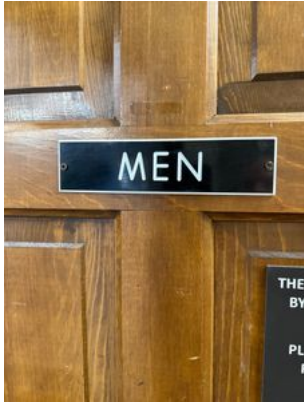
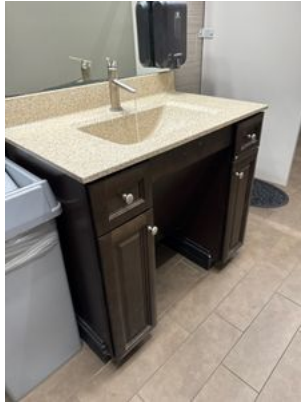
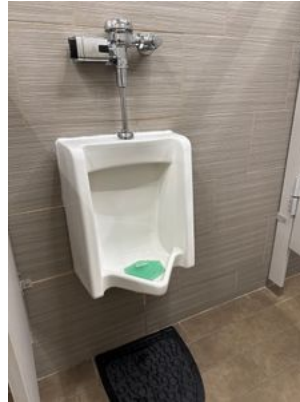
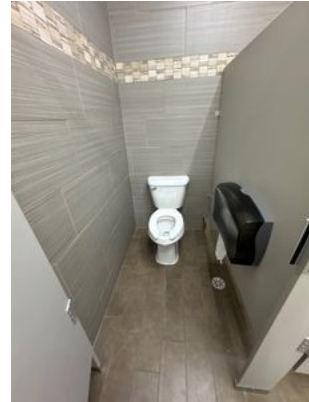
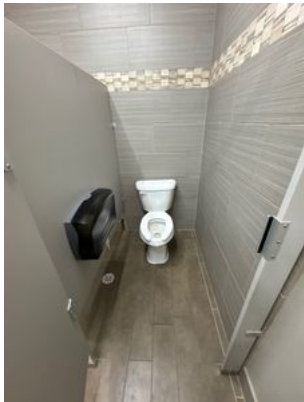
### **Comment 30** **Deficiency**

The 1st floor Men's restroom plumbing fixtures operating as expected. The restroom layouts are not within ADA Title III compliance, but the building was constructed prior to the act being made law in 1990. The ADA applies to all new construction and also requires that barriers to access be removed from existing buildings, where readily achievable. Most building codes

and laws are not applied retroactively, but the need to comply will be determined by local and/or state code officials. Recommend consulting with the local jurisdictions (permitting offices, etc.,) prior to budgeting for renovations, if any, and/or closing on the property.

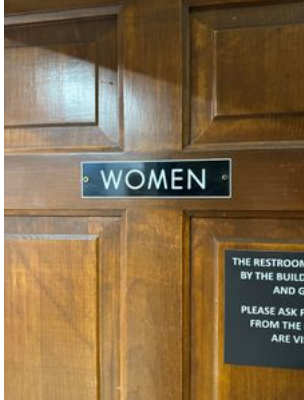
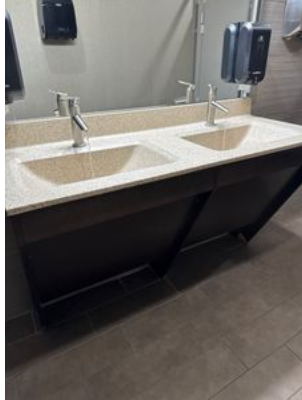
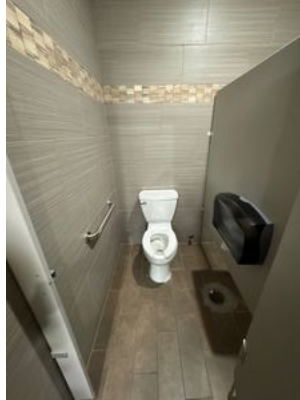
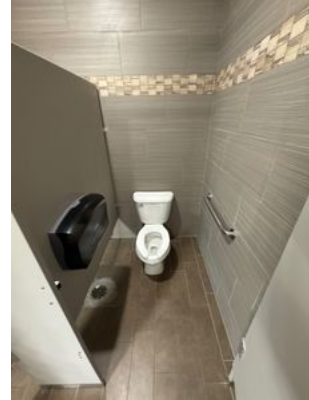
### **Comment 31** **Deficiency**

The 2nd floor Women's restroom plumbing fixtures operating as expected. The restroom layouts are not within ADA Title III compliance, but the building was constructed prior to the act being made law in 1990. The ADA applies to all new construction and also requires that barriers to access be removed from existing buildings, where readily achievable. Most building codes

and laws are not applied retroactively, but the need to comply will be determined by local and/or state code officials. Recommend consulting with the local jurisdictions (permitting offices, etc.,) prior to budgeting for renovations, if any, and/or closing on the property.

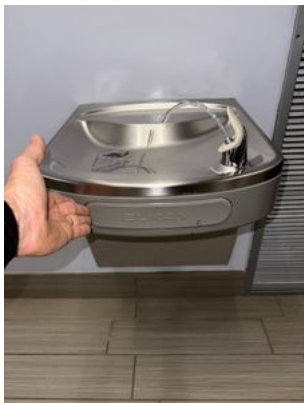
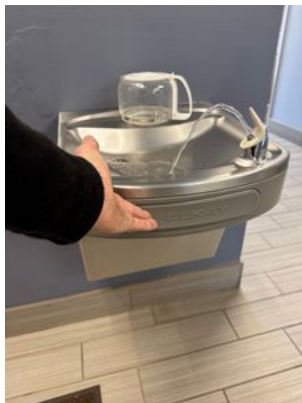
### Comment 32 Information

Water coolers were operating as expected.

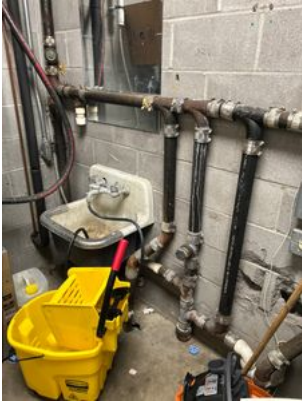
**Comment 33**  
**Information**

Mop sink in janitors closet was operating as expected.

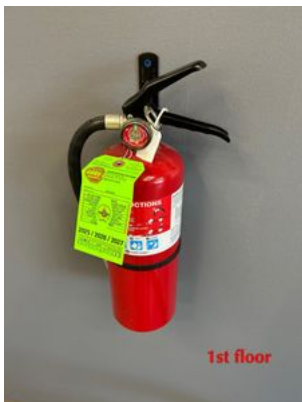
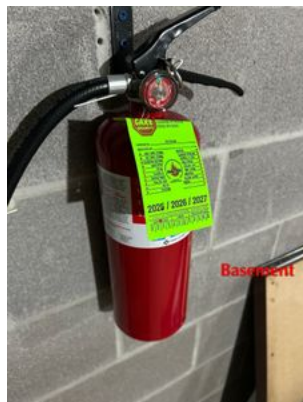
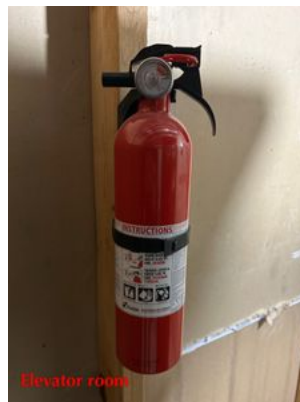
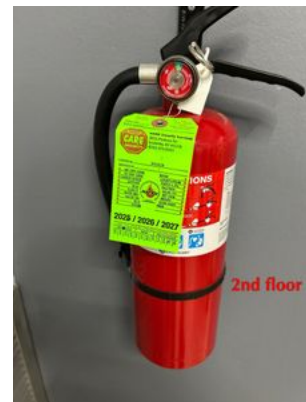
### Comment 34 Information

Fire extinguishers are in place throughout and inspections by the supplier/vendor are current.

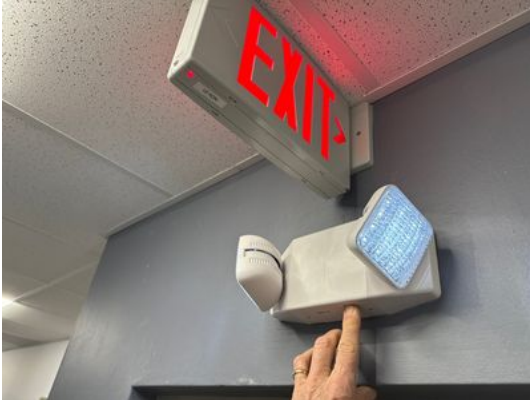
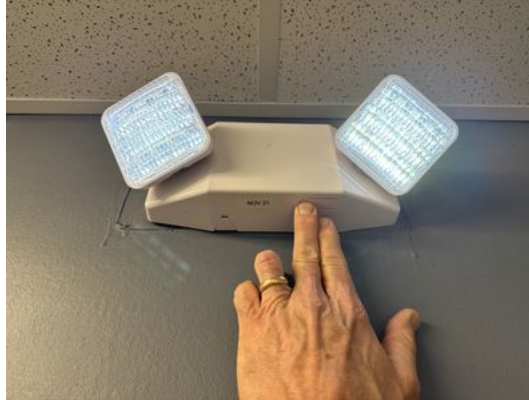
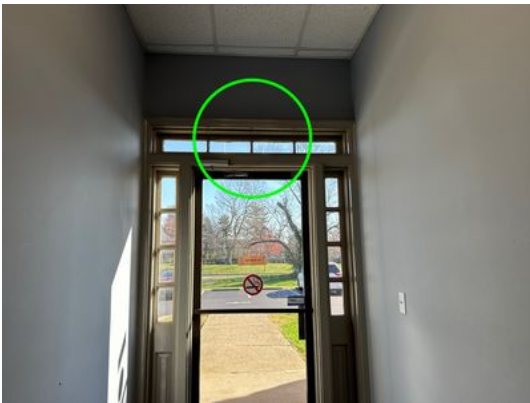
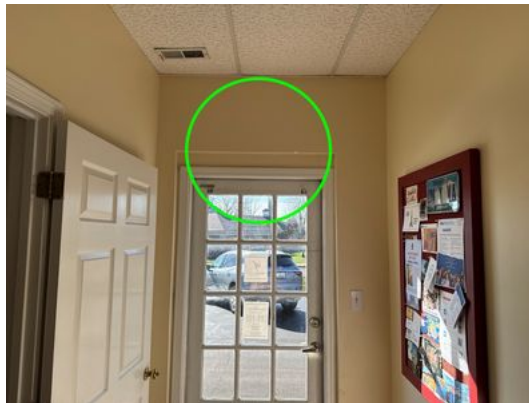
**Comment 35**

Existing emergency lighting and exit signs were operating and present at most exits and stairwells, but a couple of exit signs were missing and no emergency lighting was present in the restrooms. Have a licensed electrician install for safety.

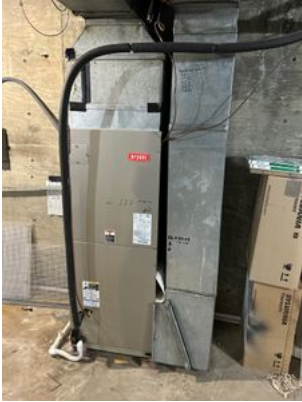
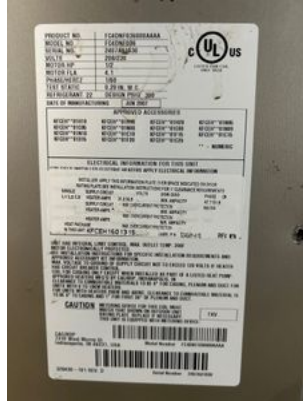
### Comment 39 Information

Air handler in the basement was operating as expected. Approximately 18 years old.

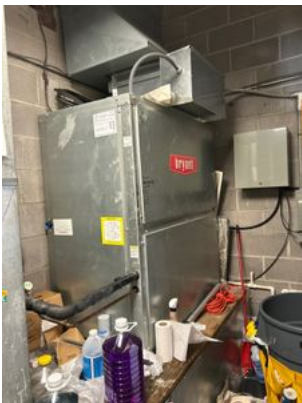
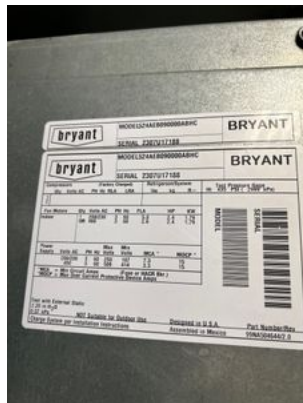
### Comment 40 Information

Air handler in the 1st floor janitor closet was operating as expected. Approximately 18 years old.

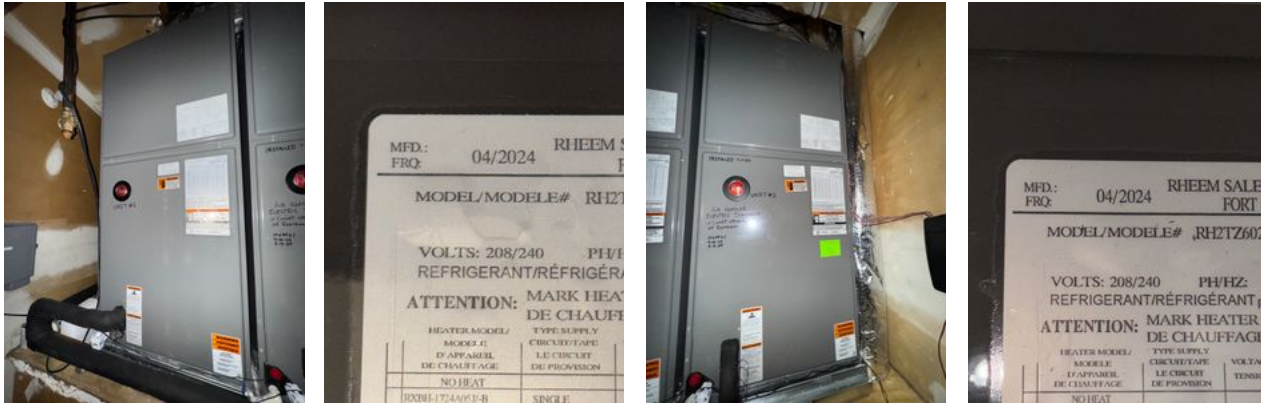
## Comment 41 Information

Air handlers in the second floor women's restroom closet were operating as expected. Approximately 1 year old.

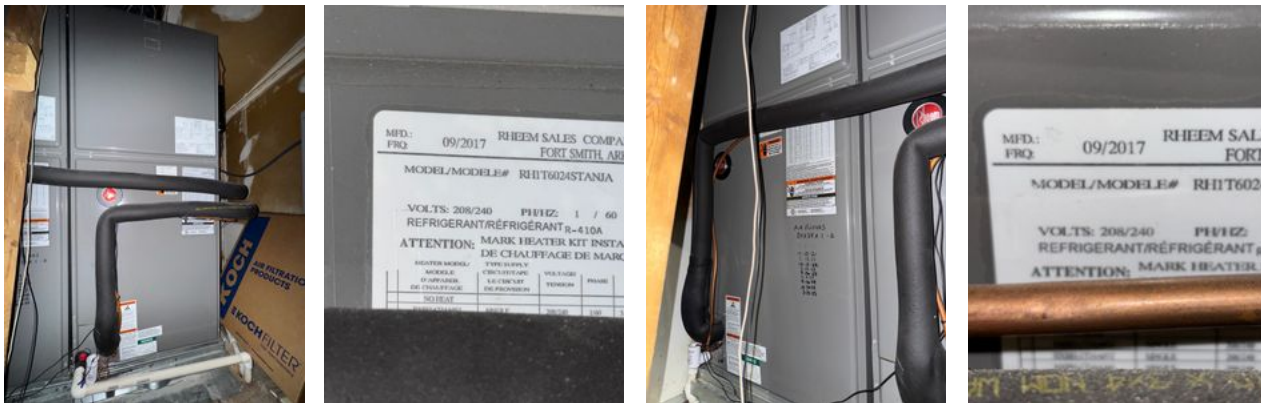
## Comment 42 Information

Air handlers in the other second floor women's restroom closet were operating as expected. Approximately 1 year old.

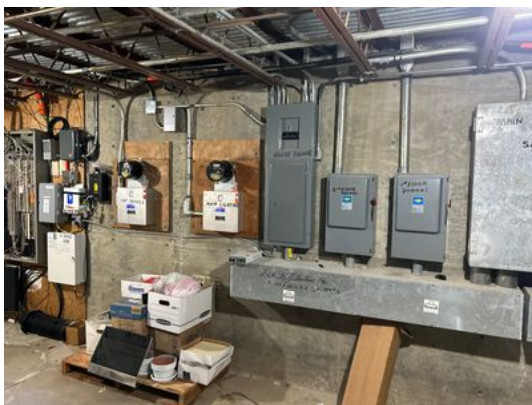
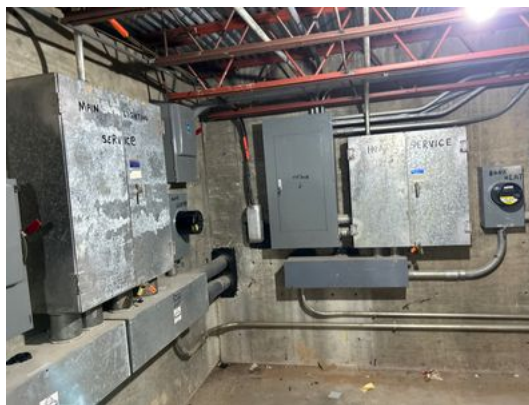
Electrical meters are located in the basement.

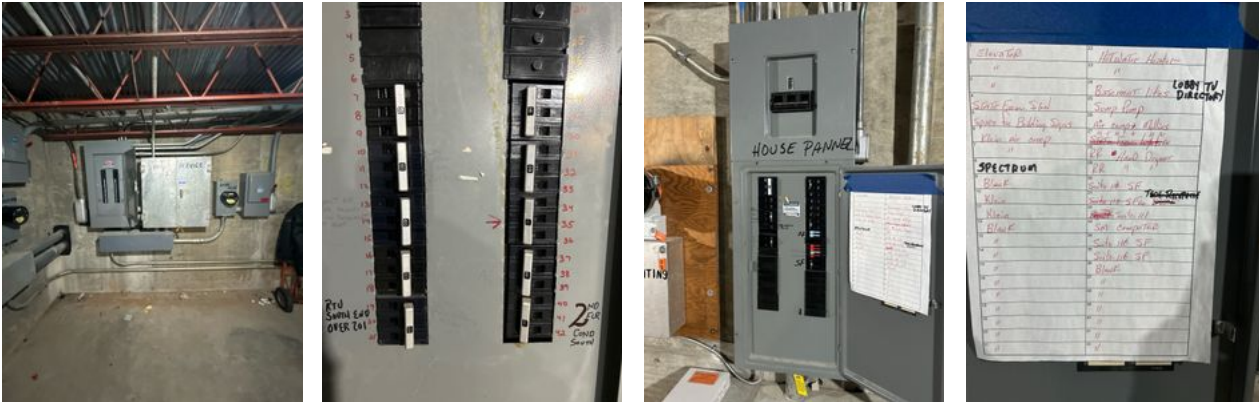
**Comment 51**  
**Information**

Main distribution and house panel located in the basement. NOTE: Most of the panel covers were not removed, because of size, safety and avoidance of service interruption.

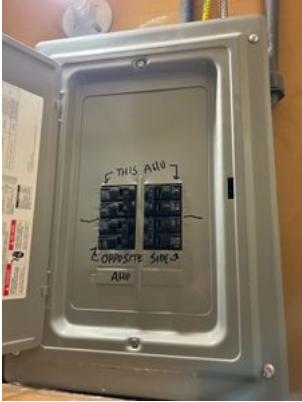
### Comment 55 Information

Women's room utility closet panel. The cover was not removed, due to stored belongings and mechanical equipment.

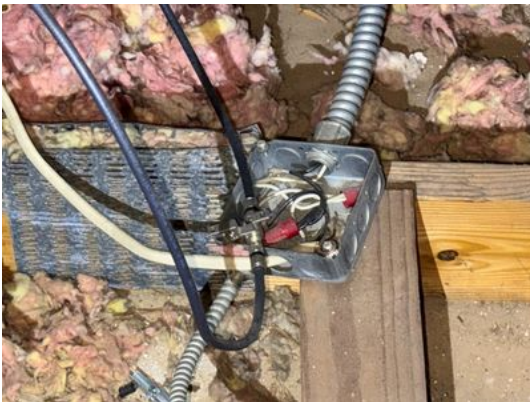
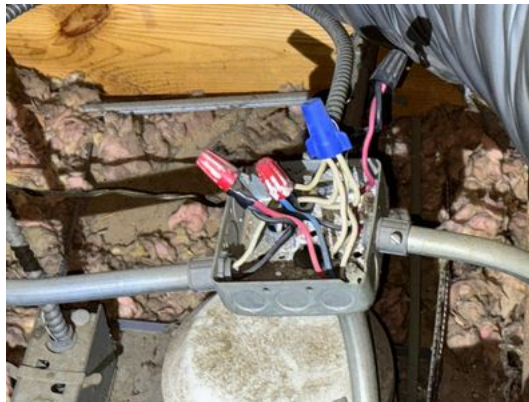
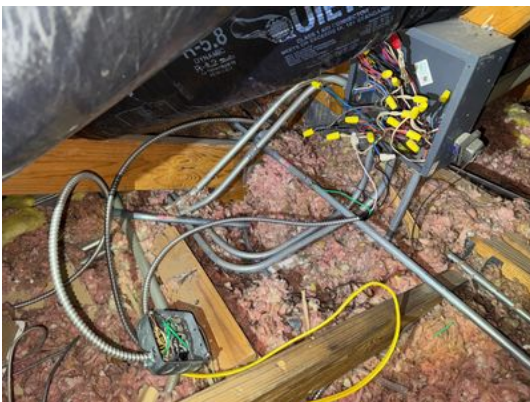
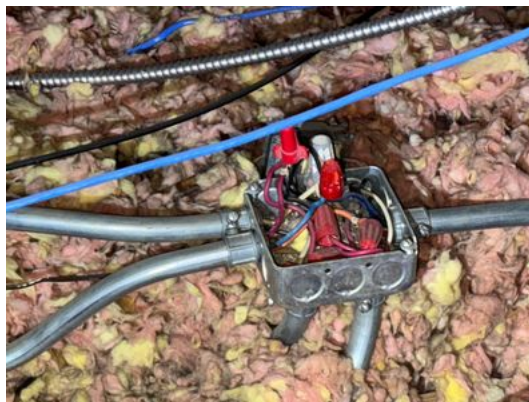
### Comment 56 Deficiency

Several wire junction boxes are open in the attic and some cable is not properly connected or terminated. Have repaired by a licensed electrician for safety.
