502 Inspections, Inc.  
(502) 230-7233  
[www.502inspections.com](http://www.502inspections.com)

## Commercial Inspection

6432 Two Notch Rd  
"Arcadia Lakes"  
Columbia, SC 29223

Prepared For: [REDACTED]  
Inspected On Tue, Aug 26, 2025 at 9:00 AM

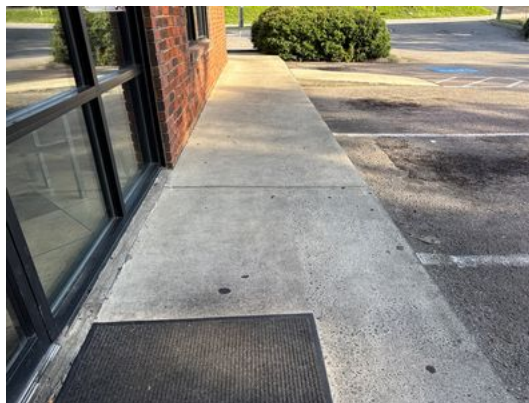
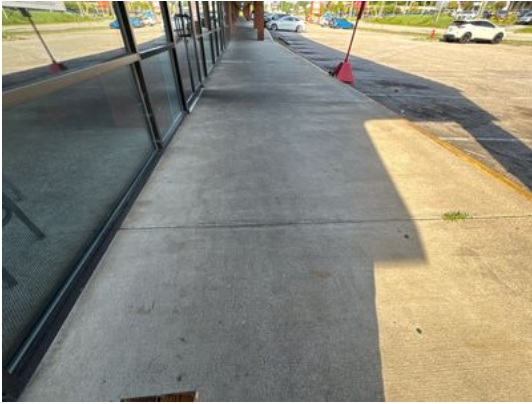
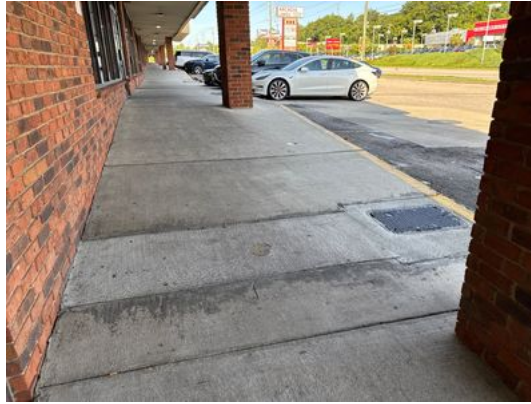
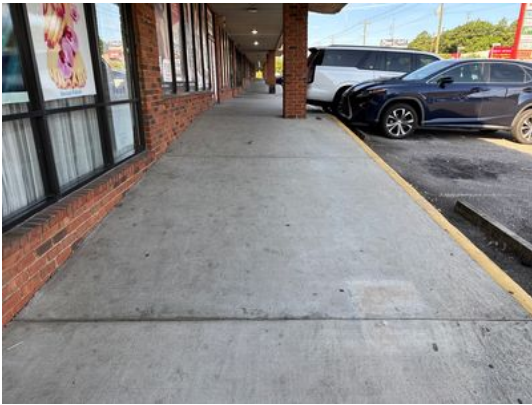
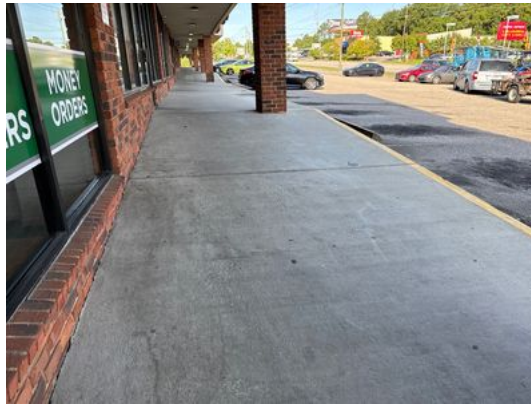
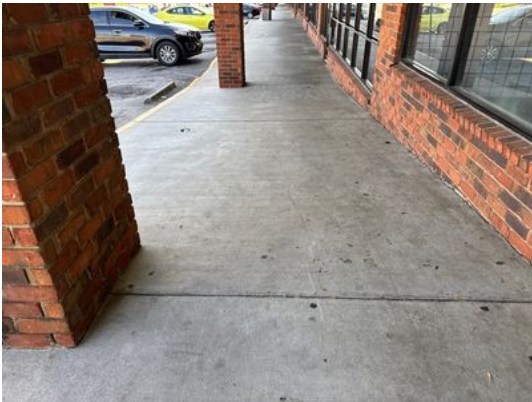
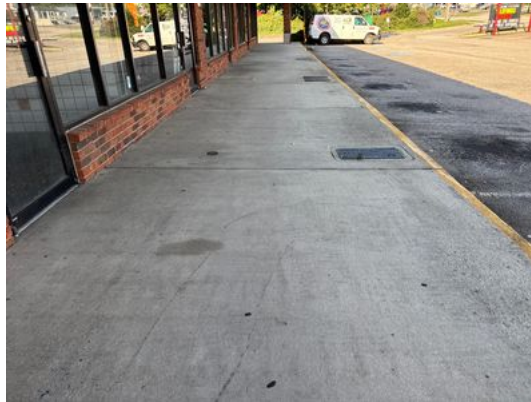
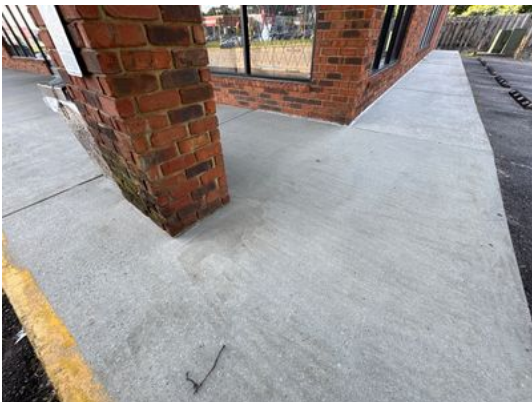
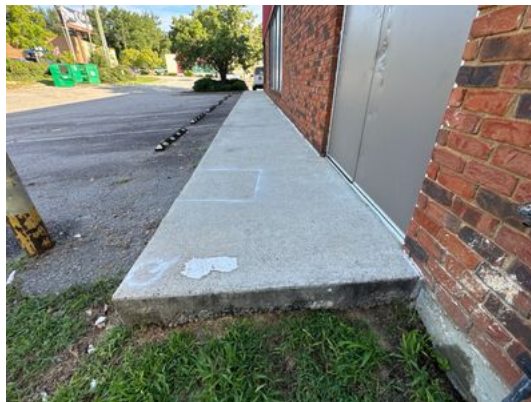
Front sidewalks were in an acceptable condition.

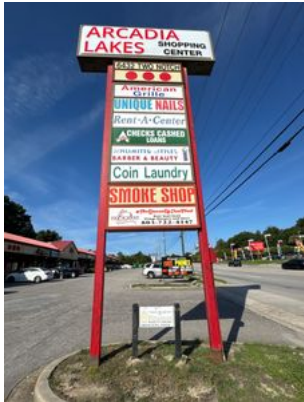
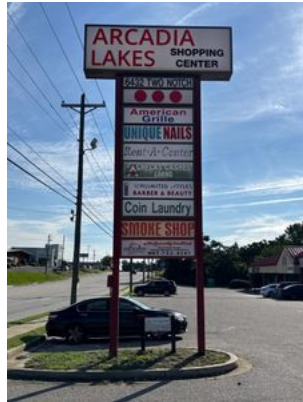
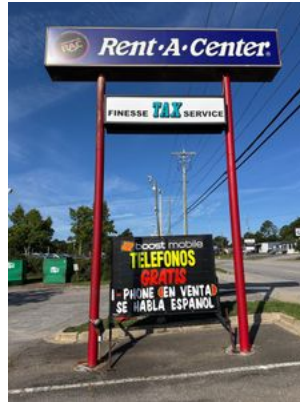
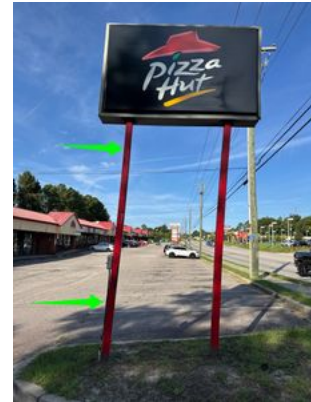
Marquee signage is present and in an acceptable condition, with the exception of the Pizza Hut sign, which appears to have settled. Have a qualified foundation specialist repair, as needed.

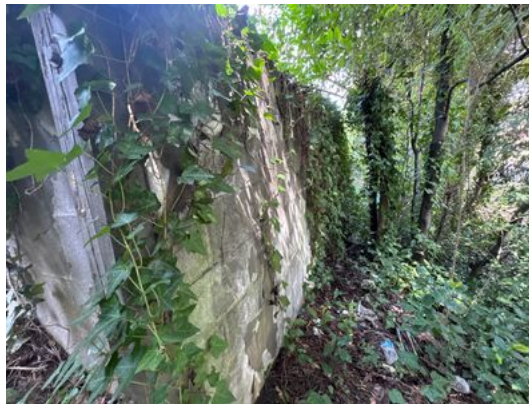
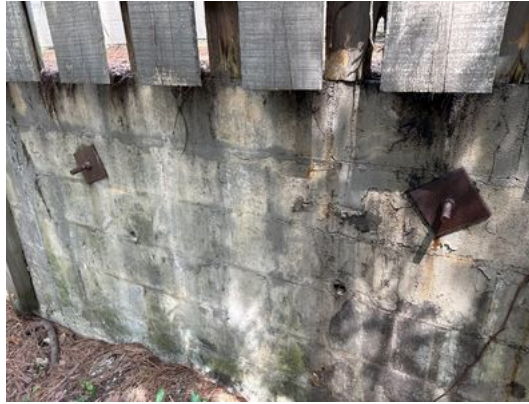
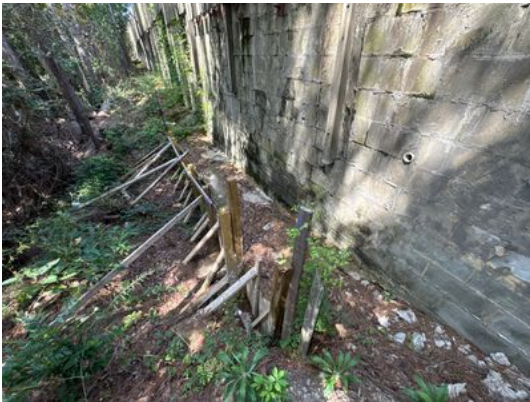
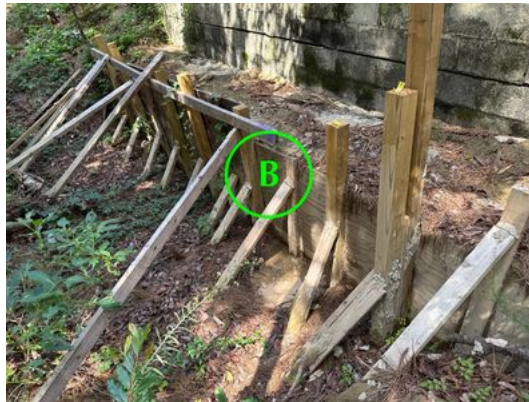
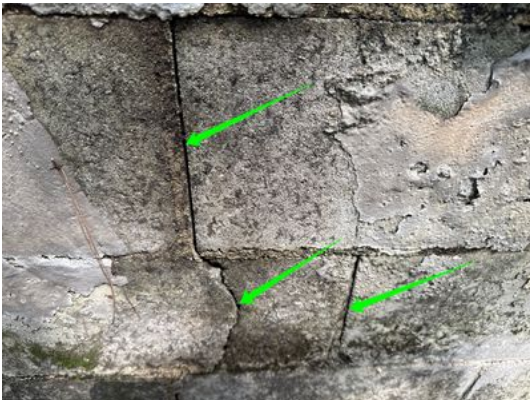
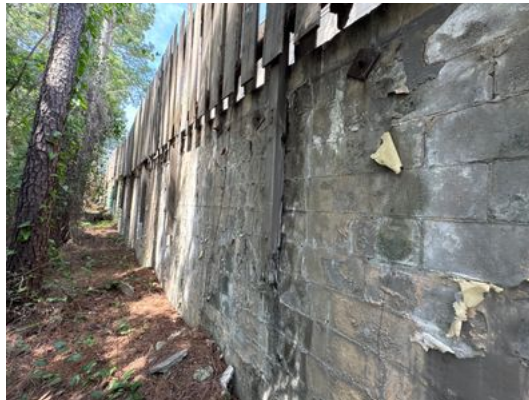
The retaining wall, along the east and south boundary's appeared to be in an acceptable condition, with the following exceptions/comments:

A) Some stabilization work is present. Recommend consulting with the seller to determine if the plates and rods were installed, during construction, as part of the design, or as a result of failure. This has or may be contributing to the building foundation settlement, noted in the Structure section. Some hairline and cracking was noted in the grout joints, as was some minor bowing in the wall, which is, generally, typical for a structure of this age.

B) Some apparent wall footing work was found, roughly, mid-length. The form work is still present and does not need to be removed. Consult with the seller to determine the history of the repair.

C) The catch basins are blocked by debris, and water was present, along the top of the wall, most, a result of condensation from the rear and interior heat pumps. This is having a negative effect on some of the grout joints and may affect the integrity of the steel plates and rods, supporting the wall.

Have a qualified professional repair item “C” and monitor the wall for further movement. NOTE: The east wall and other portions of the wall were covered by vegetation and not visible to inspect.

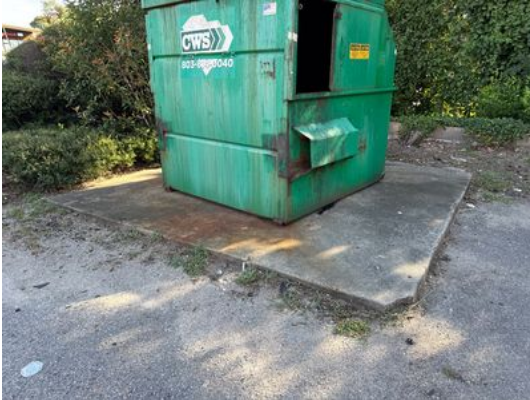
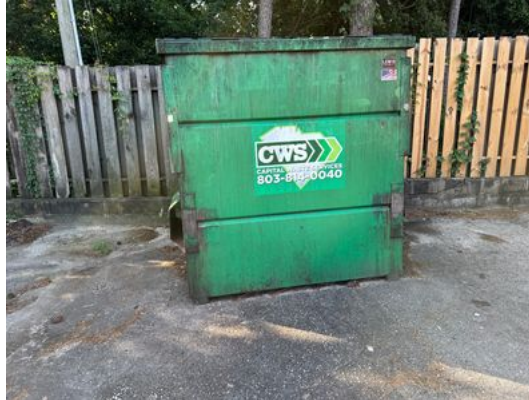
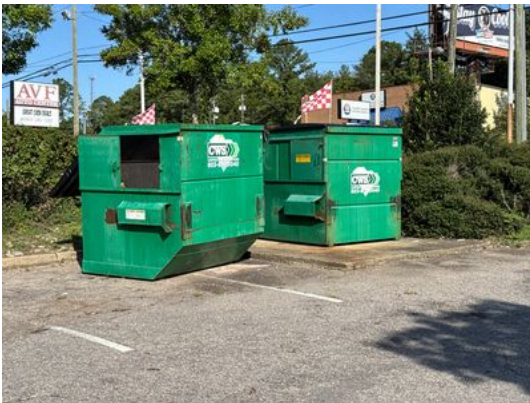
**Comment 6**  
**Information**

There is no concrete pad beneath some of the dumpsters. Recommend removing the asphalt and creating or extending the existing a concrete pads, to prevent deterioration of the surface.

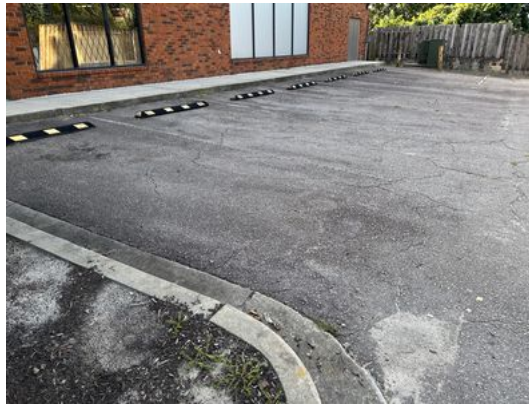
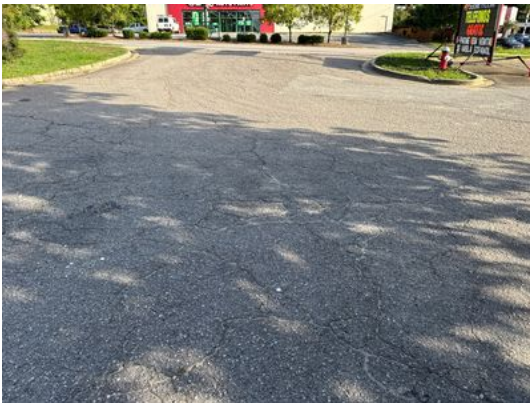
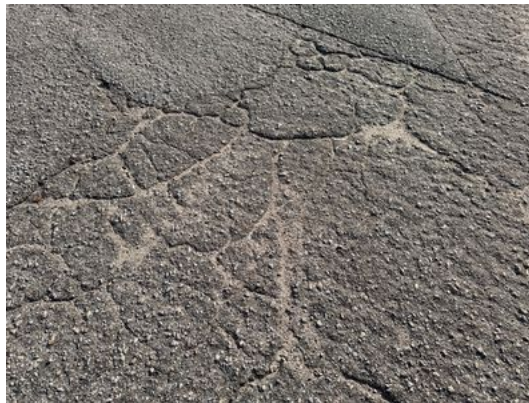
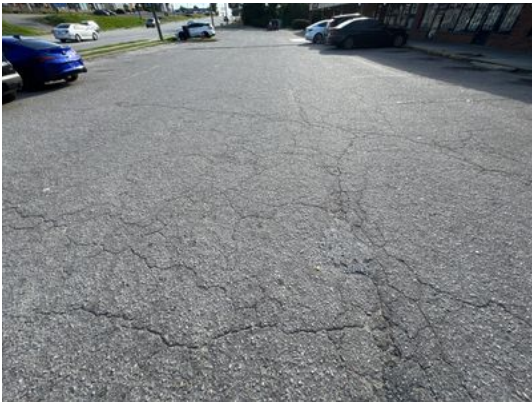
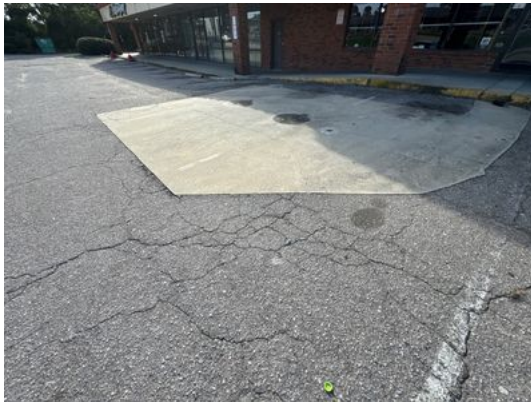
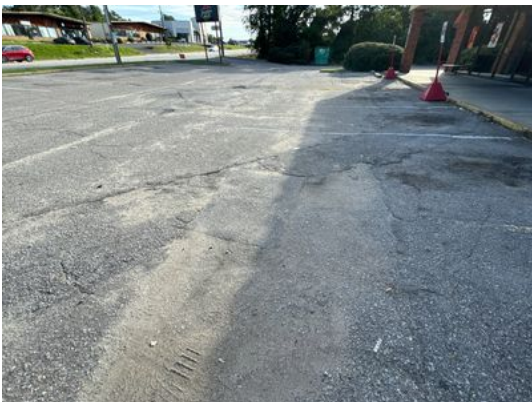
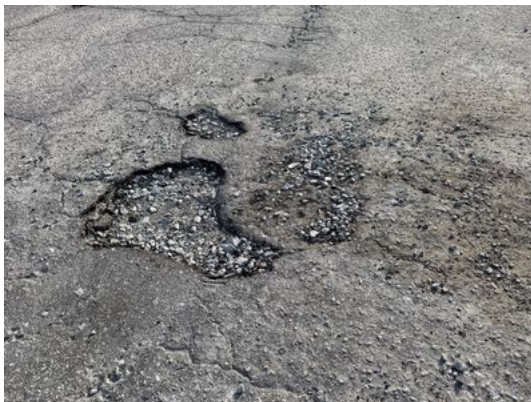
Asphalt paving is aging, but in a generally acceptable condition. Recommend budgeting for minor patching, a sealer application and re-stripping in the near future.

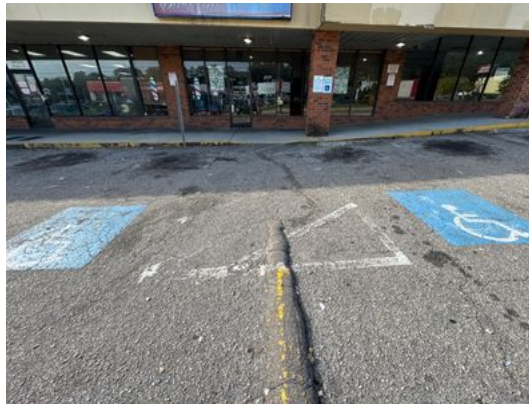
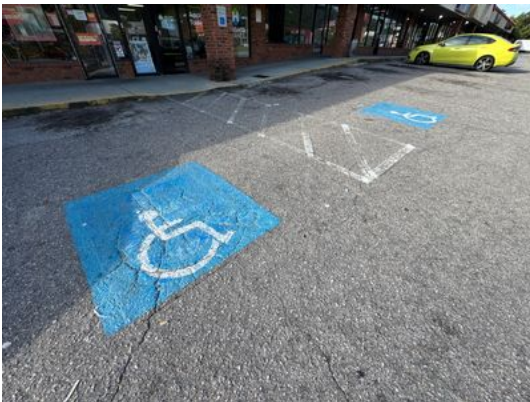
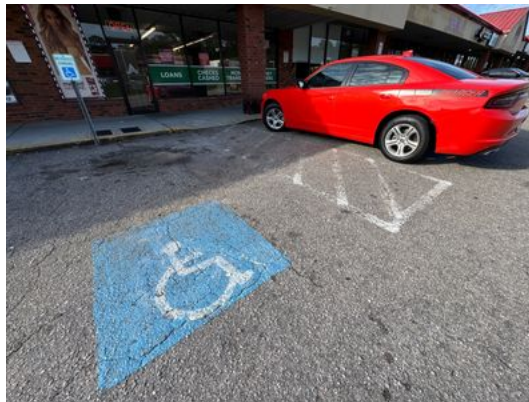
**Comment 8**

Handicap accessible parking spaces were in an acceptable condition, but some posted signage was missing. Consult with local code officials regarding compliance and install signage, as needed.

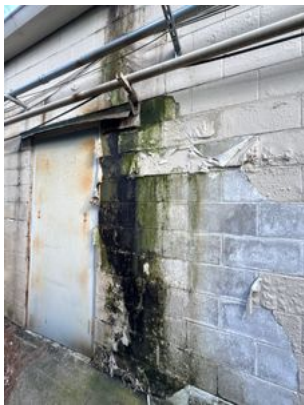
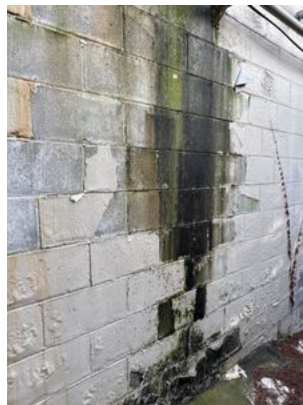
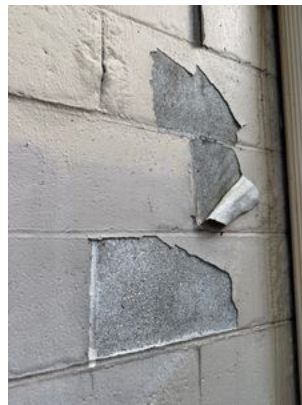
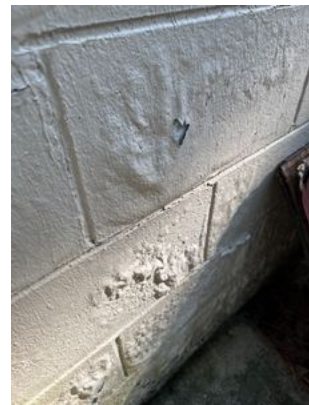
The paint along the rear or south wall is peeling. This is also visible from inside the spaces, to some degree. It is, most likely, a result of leaking gutters and roof system, over time. As a result, some of the interior spaces have developed, what appears to be, an environmental growth. After the gutters and roof repairs have been made, have a qualified painter clean, prep and paint/seal, as needed. This should include the remediation of any hazards or growths on the interior.

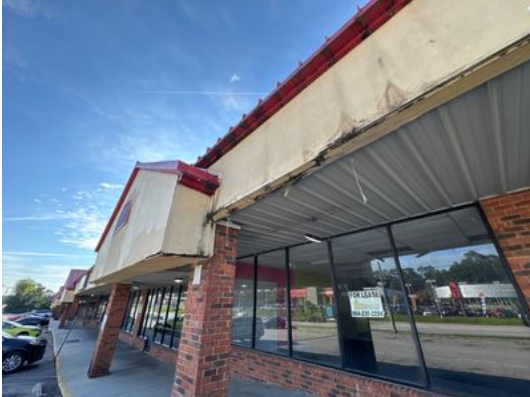
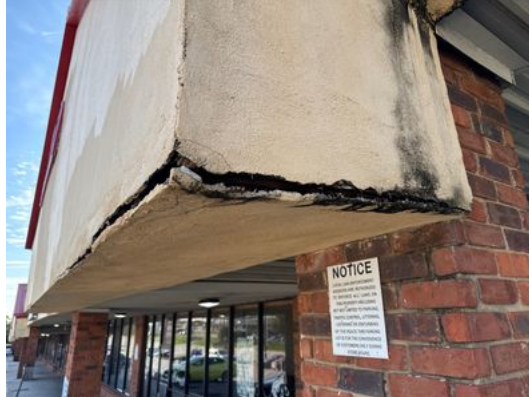
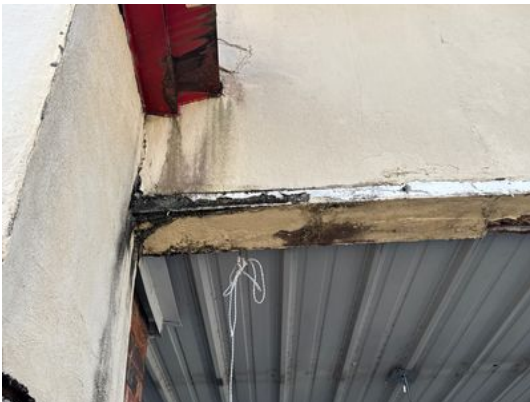
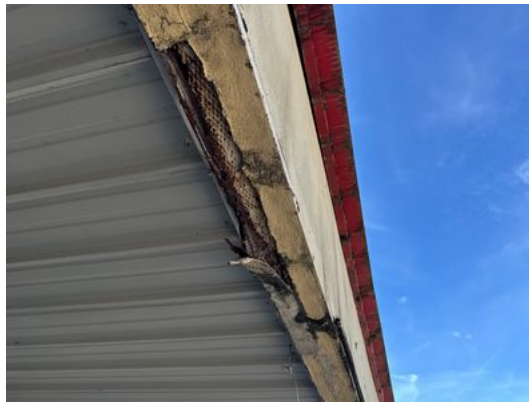
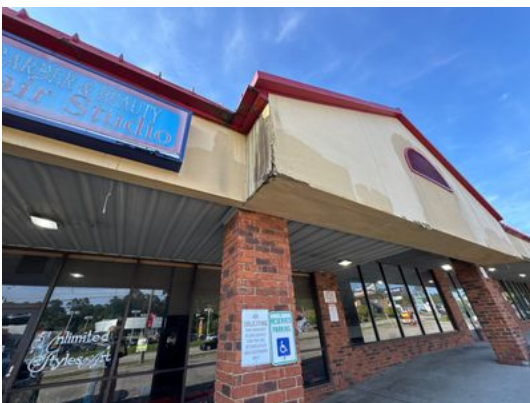
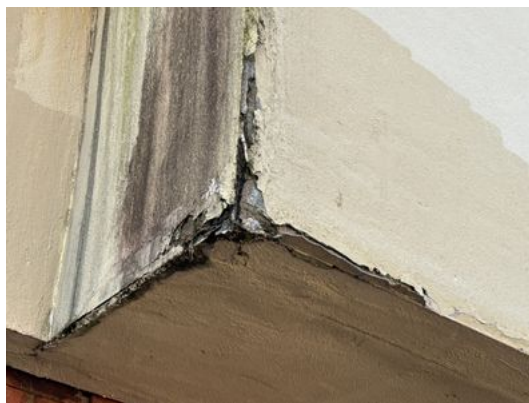
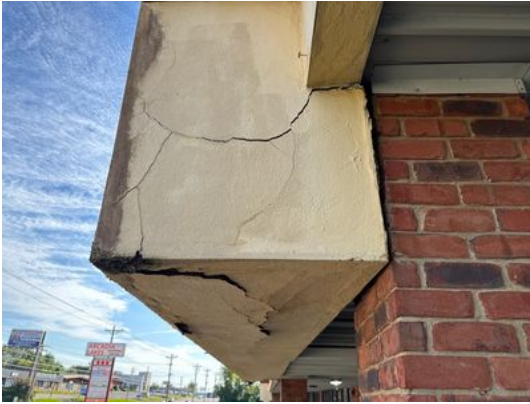
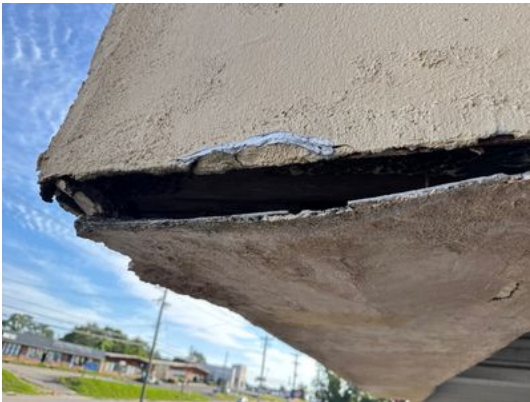
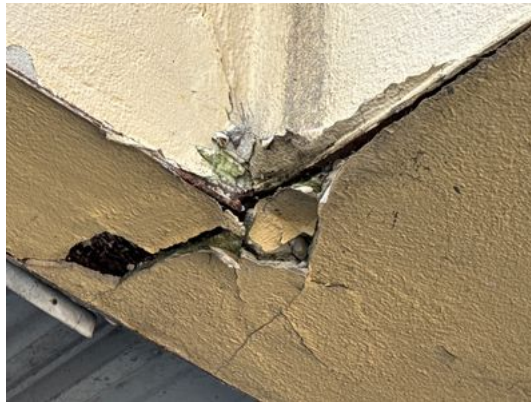
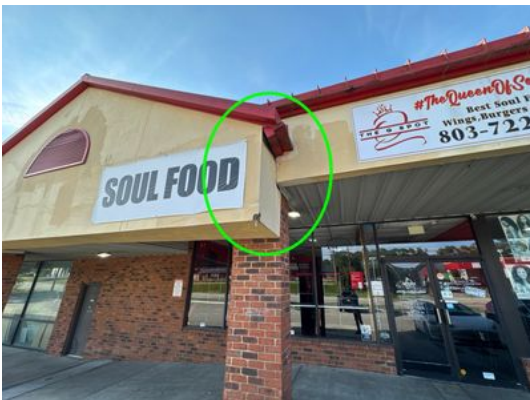
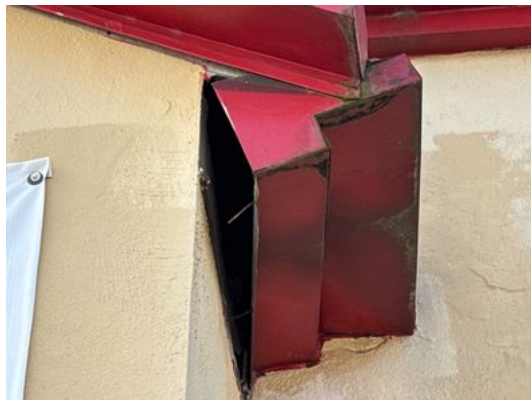
### Comment 11

EIFS (exterior insulation finishing system) is heavily damaged in a number of areas. In one area, near “The Queen of Soul,” the framing has pulled away from the structure. Have a qualified EIFS contractor evaluate and make any necessary repairs to prevent water intrusion and to improve the integrity of the system. This should include repairs to the structure and framing, as needed.

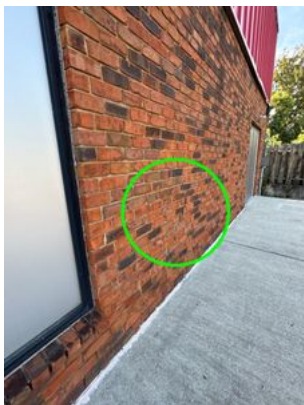
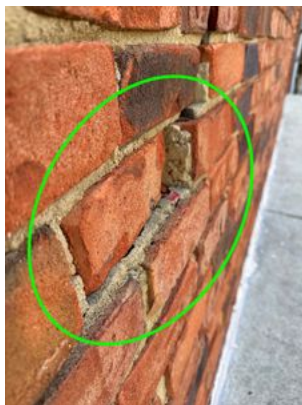
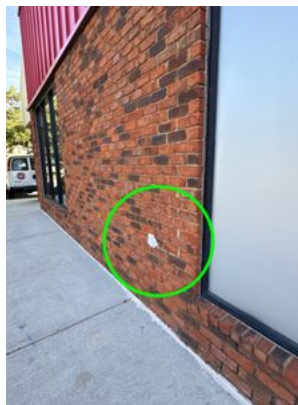
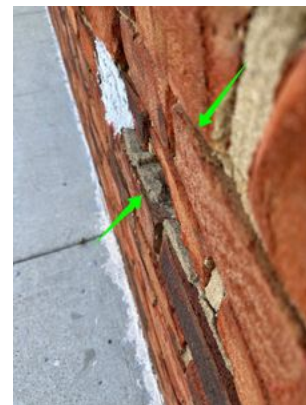
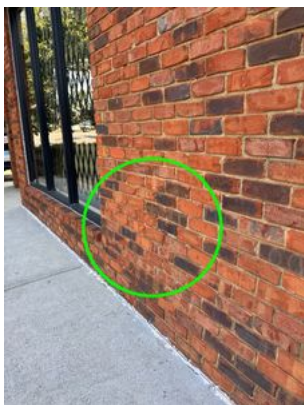
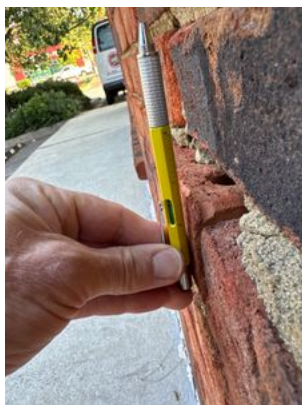
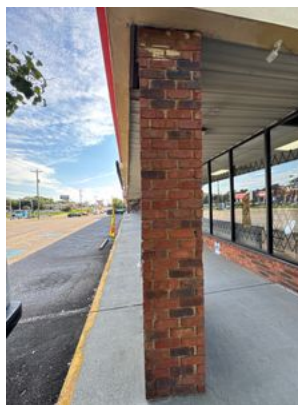
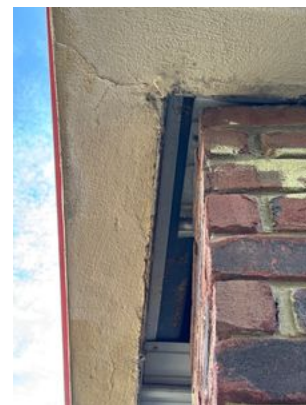
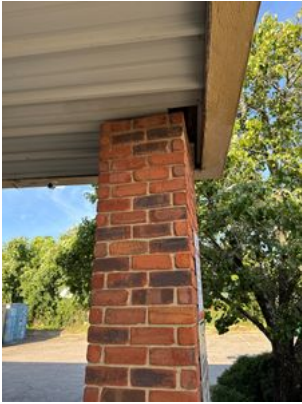
**Comment 12**  
**Deficiency**

The brick veneer has been damaged in three locations, along the west or right end (Rent-A-Center,) apparently, from vehicles. Have a qualified mason evaluate and repair, as needed.

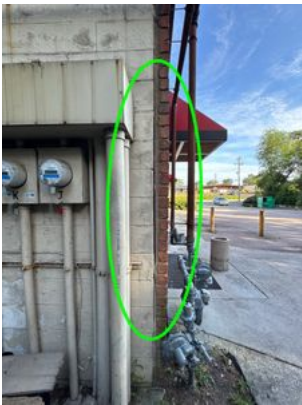
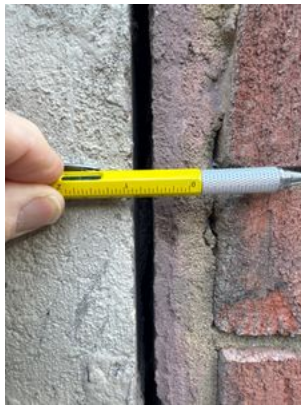
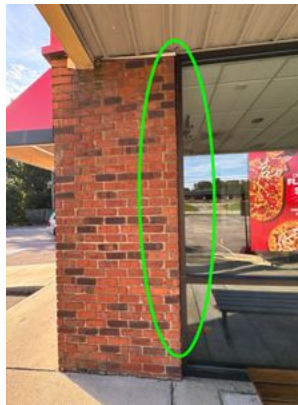
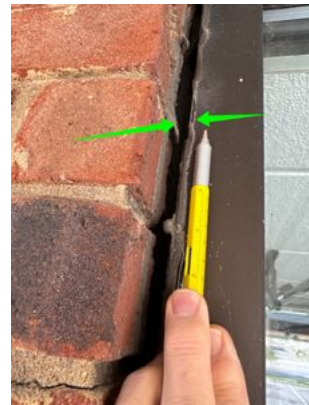
**Comment 13**  
**Deficiency**

The brick veneer, along the east or left end (Pizza Hut) of the building appears to be separating from the structure. This may be a result of the settling noted in the Structure section. After the structure and foundation has been evaluated and/or repaired, have a qualified mason repair the veneer, as needed.

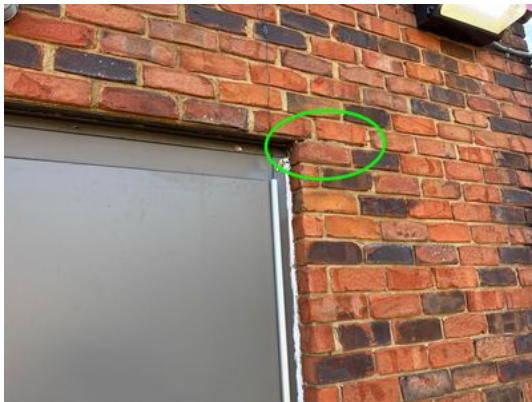
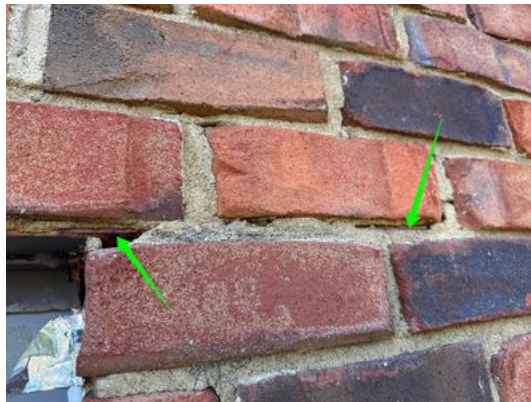
**Comment 14**

The steel lintels, above the windows and doors, have only been shop primed and are heavily rusted. In at least one location, the steel has flexed and pushed the grout out of position. Have a qualified professional repair, as needed, to prevent staining and to maintain the integrity of the veneer above.

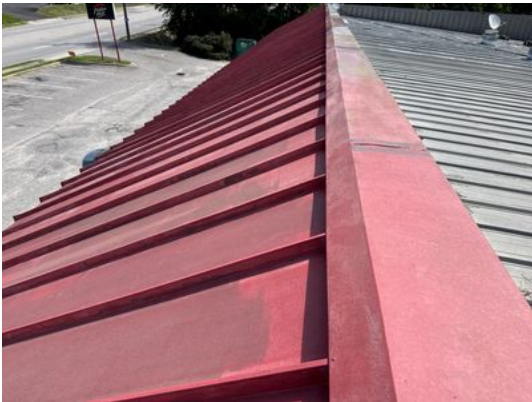
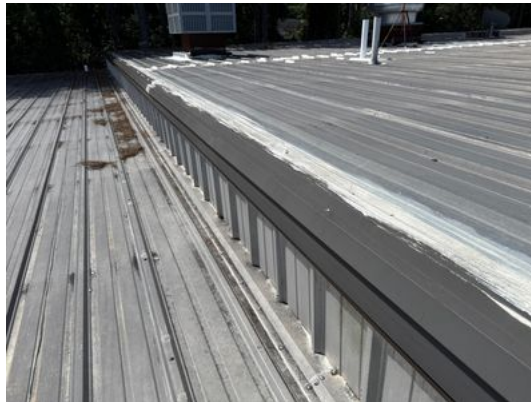
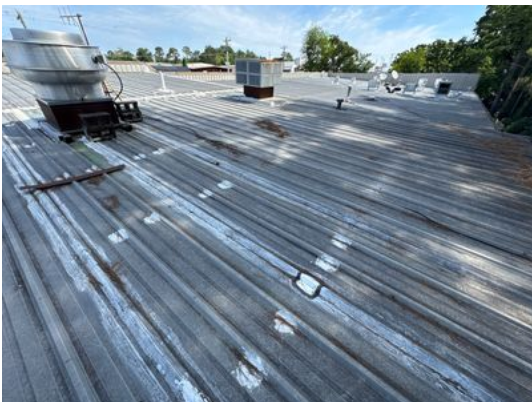
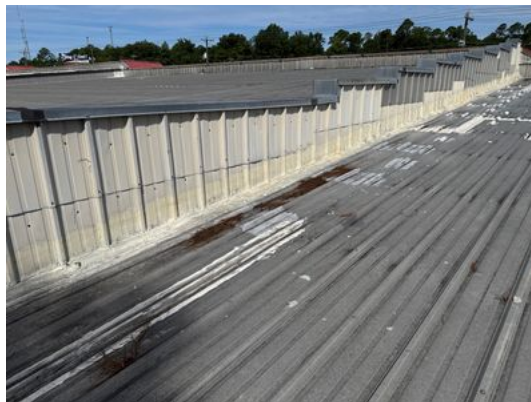
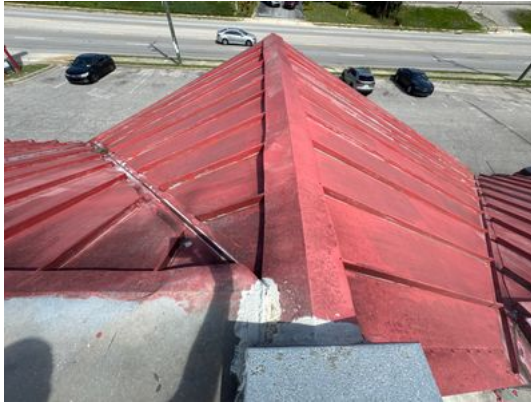
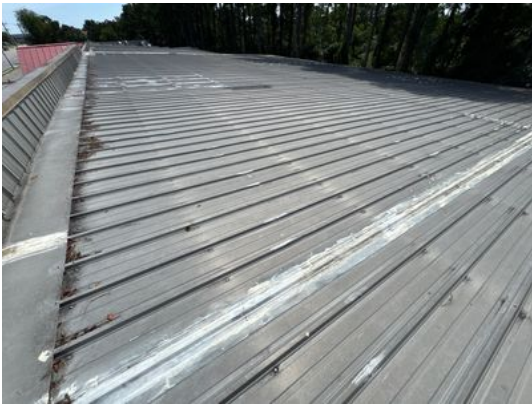
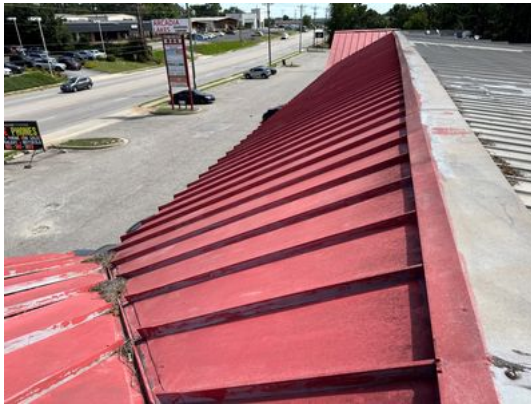
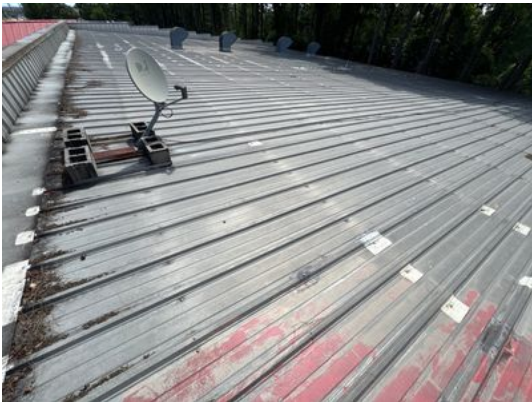
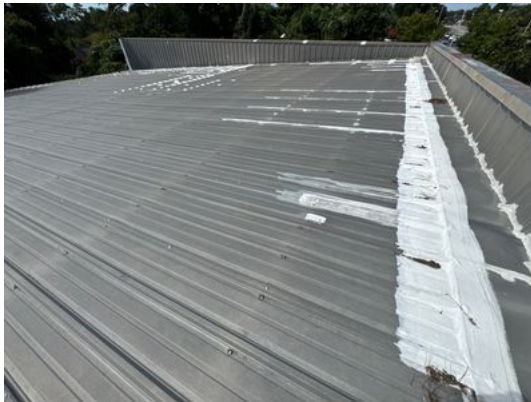
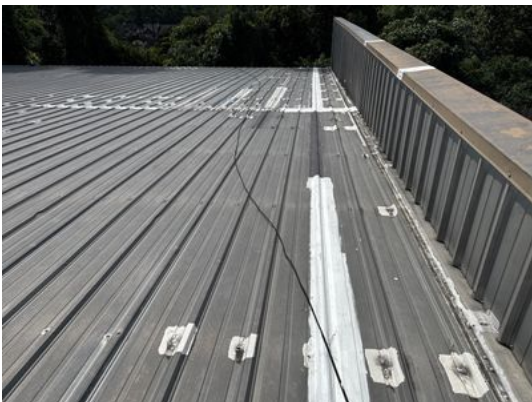
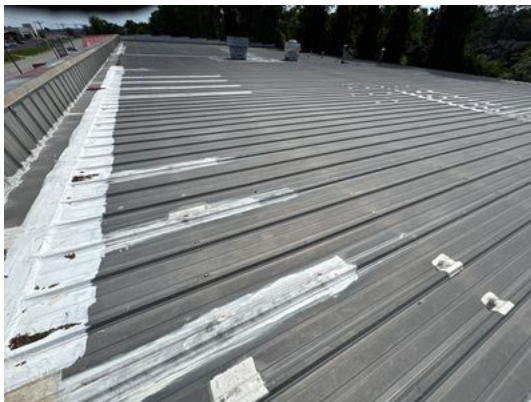
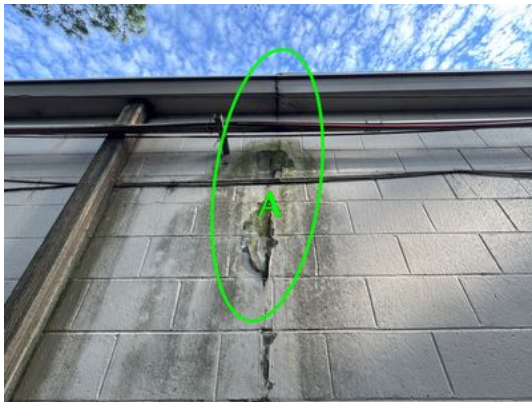
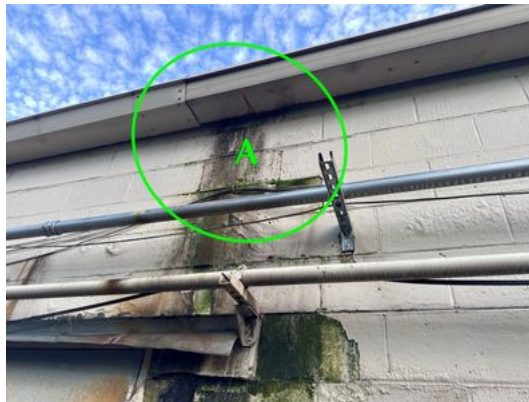
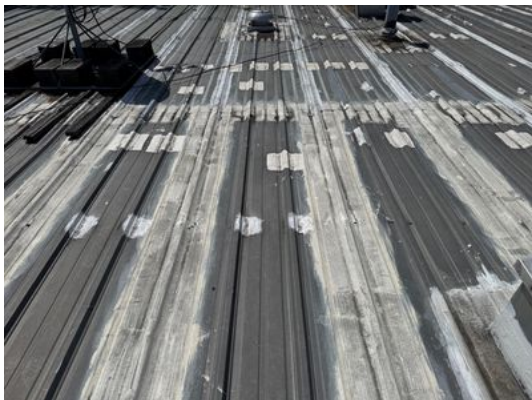
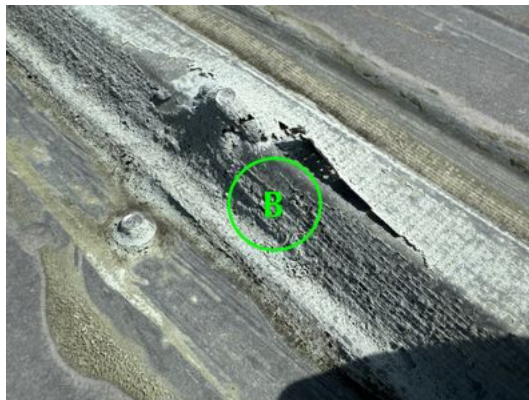
### Comment 16

The following deficiencies were noted on the roof:

- A) A number of the gutter joints are leaking, contributing to the paint damage, along the rear wall.
- B) The roof has been repaired in a number of areas, and some of those repairs are peeling or deteriorated.
- C) Some of the roof penetration sealants are dried and cracked.
- D) Some of the cap flashing has separated or been repaired and the repairs have separated.
- E) Several areas of the metal cap flashing and some minor areas of the roof panels, themselves, are rusted.
- F) The majority of the roof fasteners have been replaced, but not all. This is a typical maintenance item for metal roofs and should be included, as such.

Have a qualified roofer, familiar with metal panel repairs, repair items A-E, as needed.

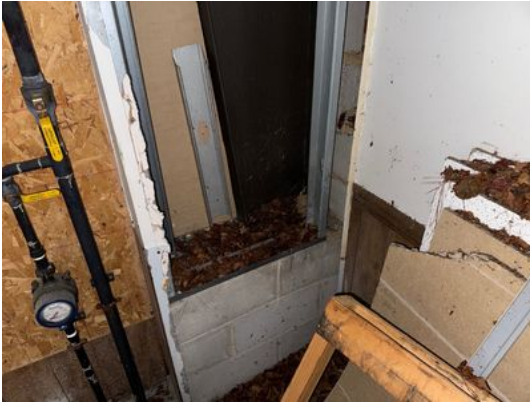
**Comment 18**  
**Deficiency**

There is some significant stair-step cracking in the concrete block walls and floor slab, running east to west (left to right,) or along the rear of the building, indicative of foundation failure or settlement. Some repairs have been made to the grout joints, but have opened again, indicating that the structure continues to move. In a couple of locations on the rear wall, there appears to be separation from the steel frame of approximately 2". There is, most likely, a correlation between the movement found here and in the rear retaining wall, noted in the Site section. Have a qualified foundation specialist evaluate and repair, as needed, to improve the integrity of the structure.

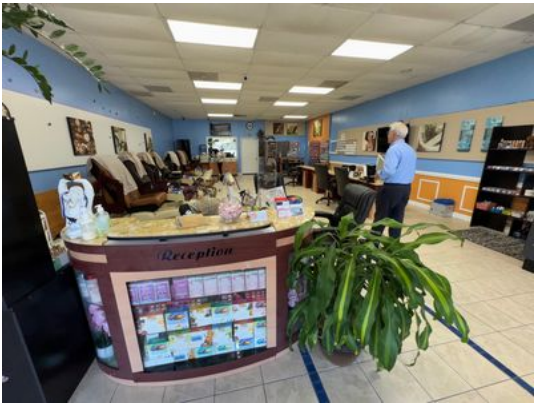
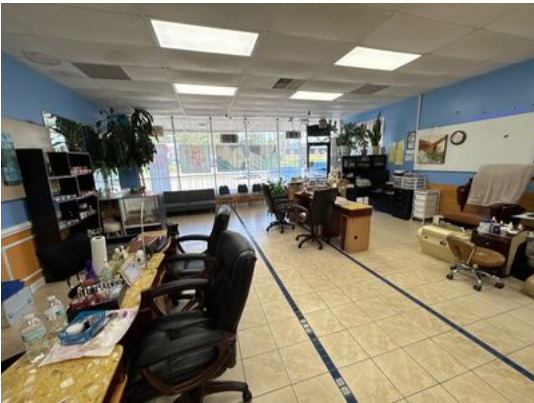
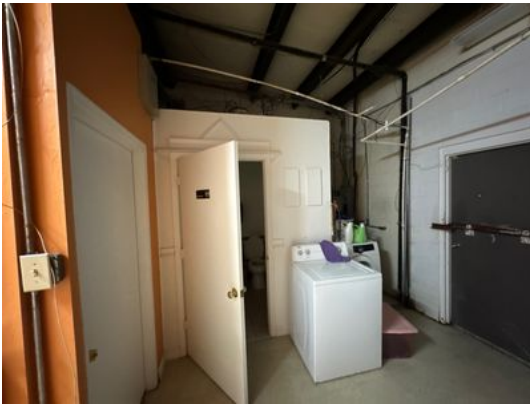
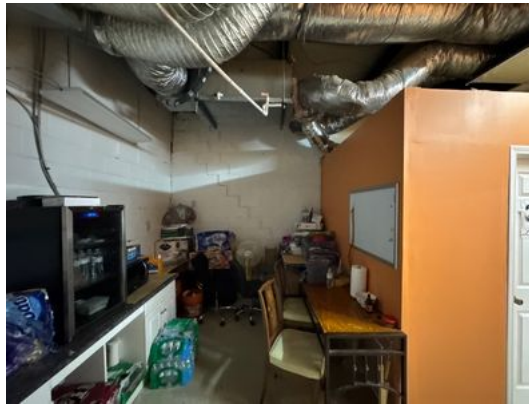
Comment 19  
Information

Unique Nails: Overview of the interior.

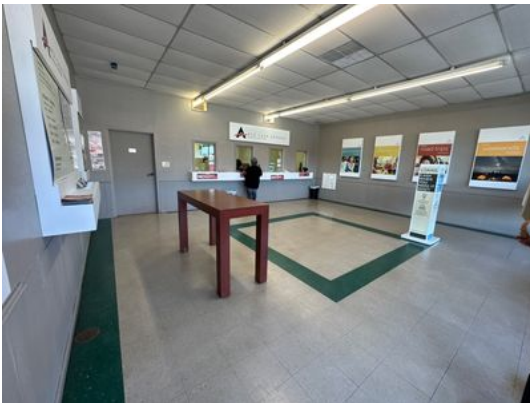
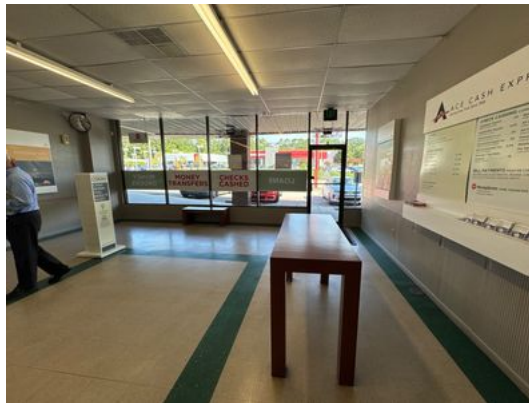
**Comment 20**  
**Information**

Ace Cash Express: Overview of the interior.

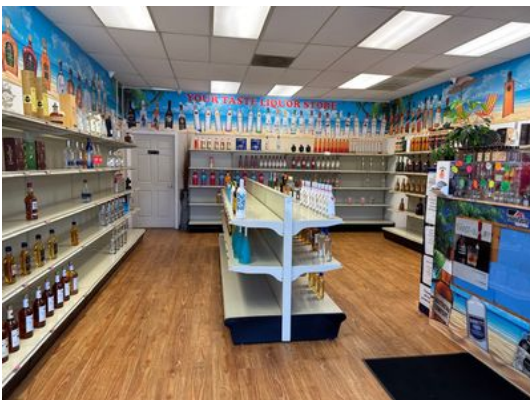
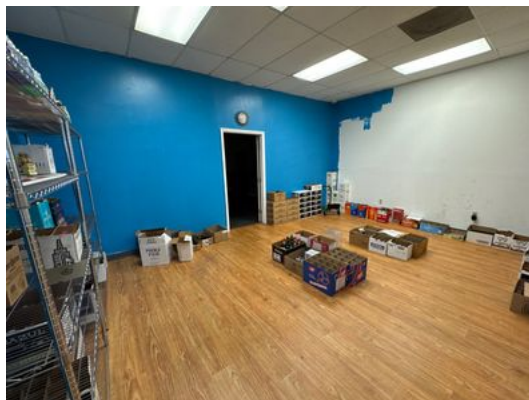
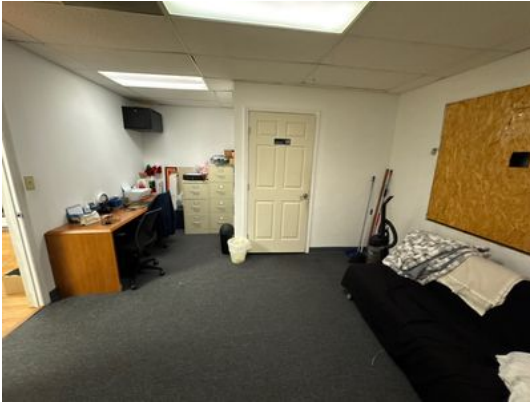
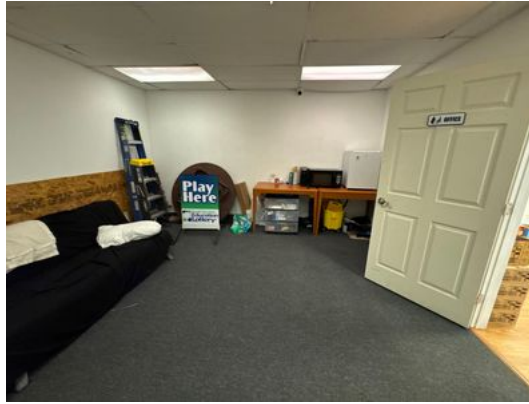
**Comment 21**  
**Information**

Your Taste Liquor: Overview of the interior.

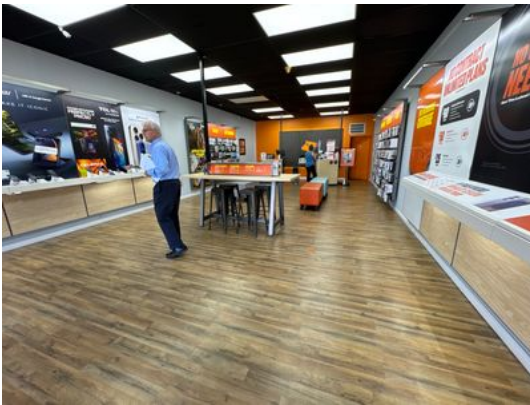
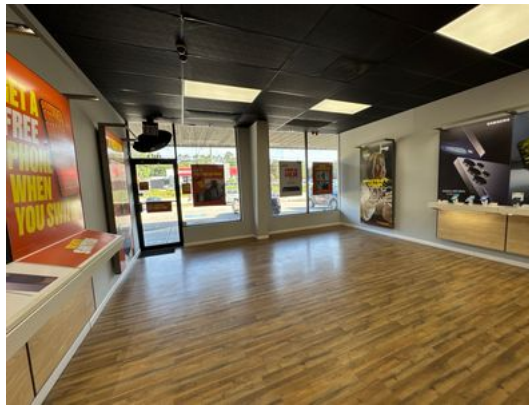
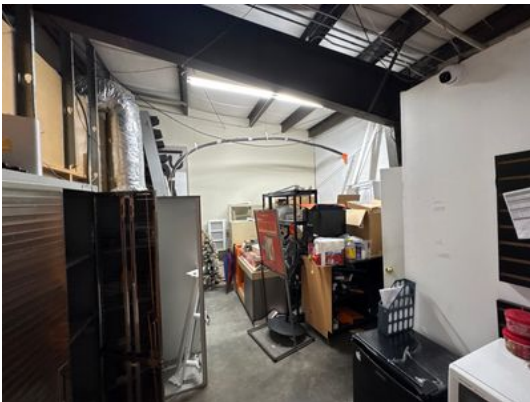
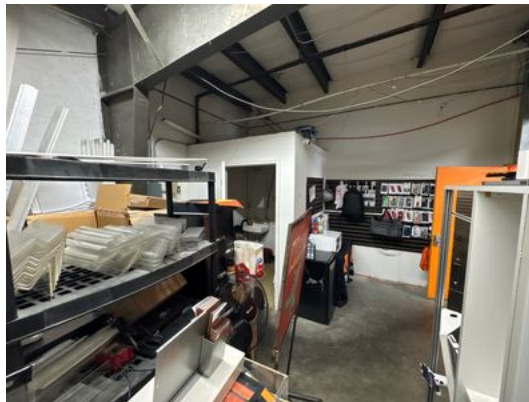
**Comment 22**  
**Information**

Boost Mobile: Overview of the interior.

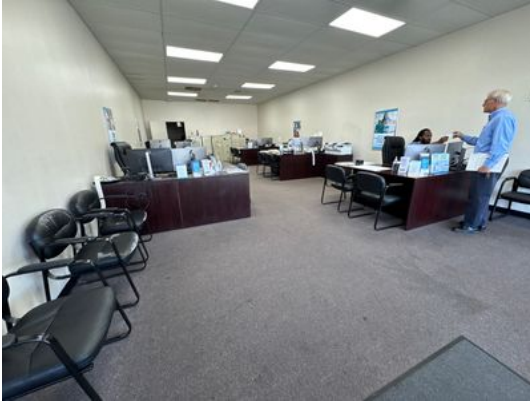
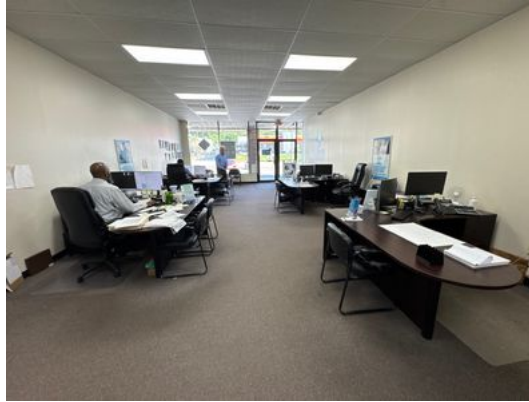
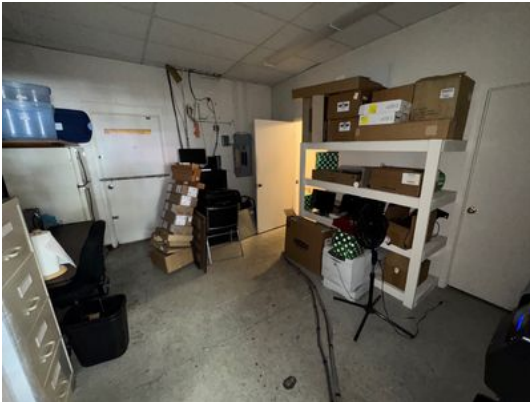
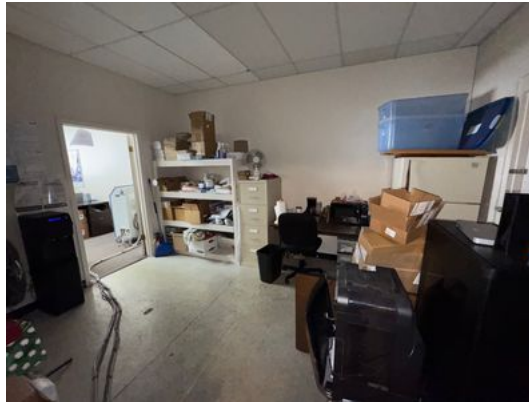
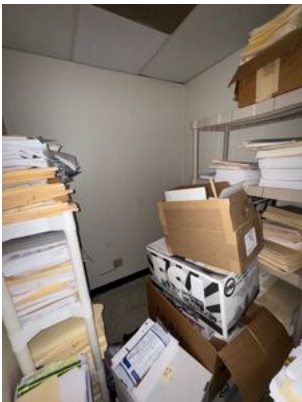
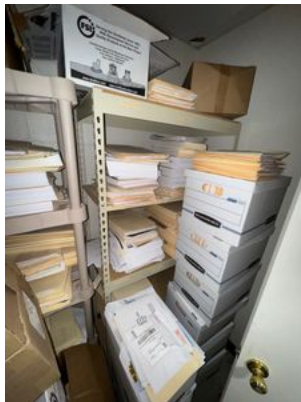
**Comment 23**  
**Information**

Heights Finance: Overview of the interior.

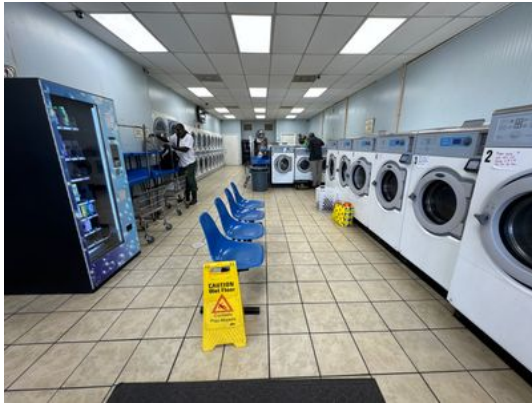
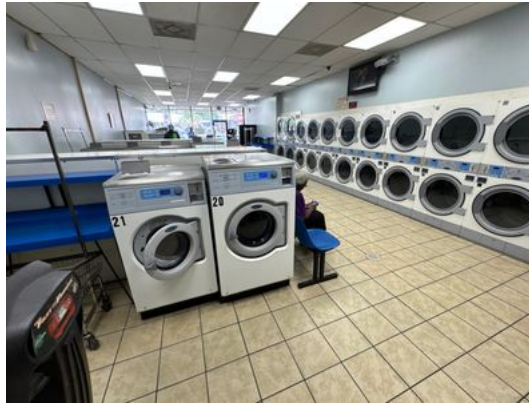
**Comment 24**  
**Information**

Spin City Coin Laundry: Overview of the interior.

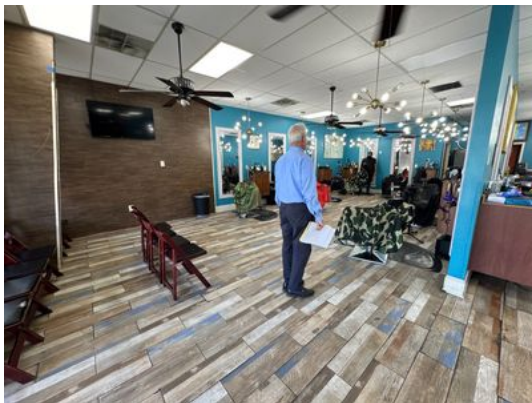
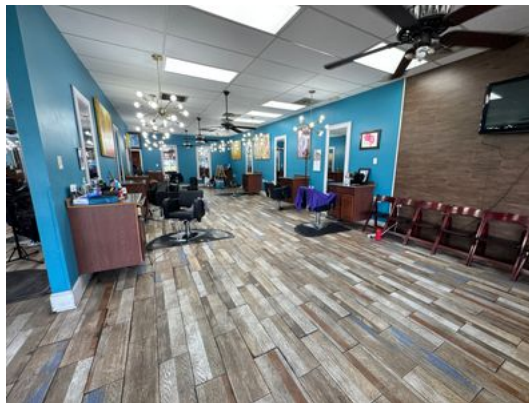
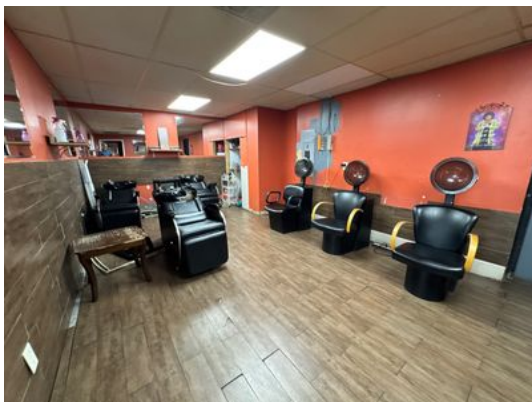
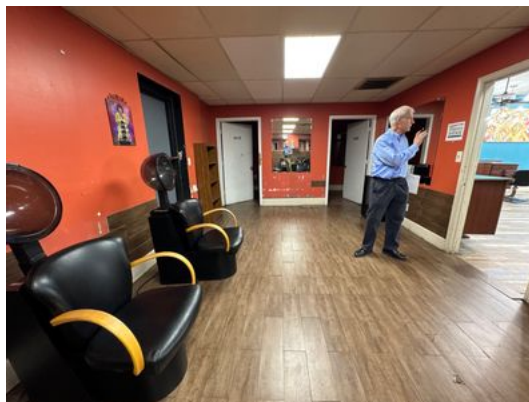
**Comment 25**  
**Information**

Unlimited Styles Salon: Overview of the interior.

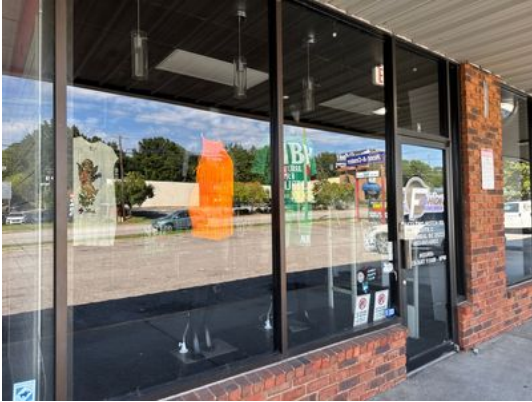
**Comment 26**  
**Information**

Fashion 103: Interior of the space was not accessed (closed on Tuesdays.)

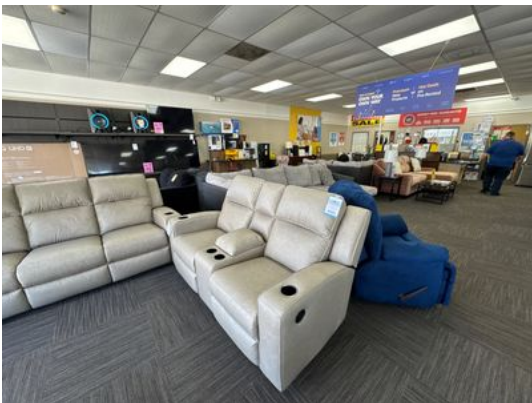
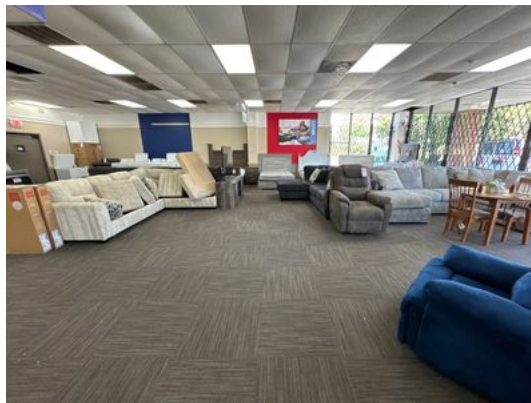
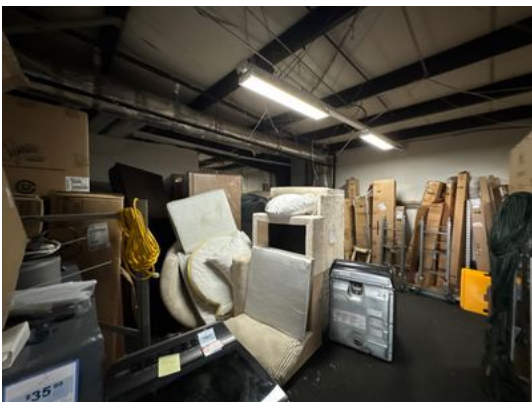
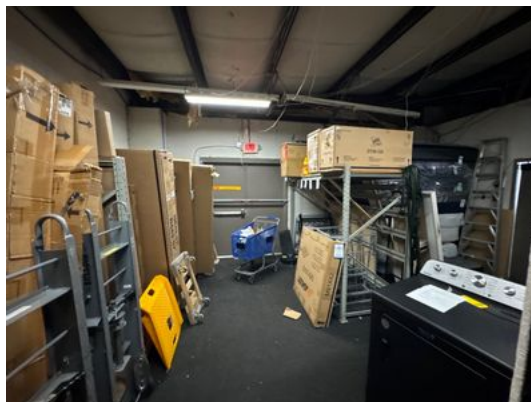
**Comment 27**  
**Information**

Rent-A-Center: Overview of the interior.
