502 Inspections, Inc.  
(502) 230-7233  
[www.502inspections.com](http://www.502inspections.com)

## Commercial Inspection

6432 Two Notch Rd  
"Arcadia Lakes"  
Columbia, SC 29223

Prepared For: [REDACTED]  
Inspected On Tue, Aug 26, 2025 at 9:00 AM

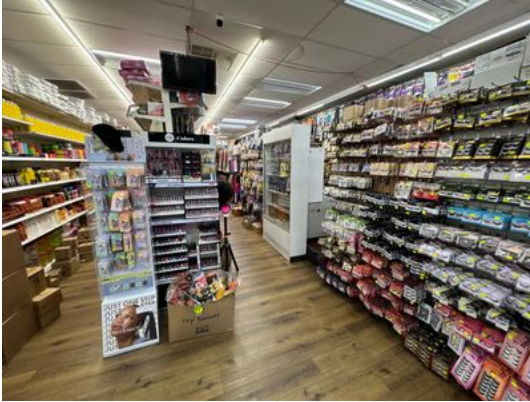
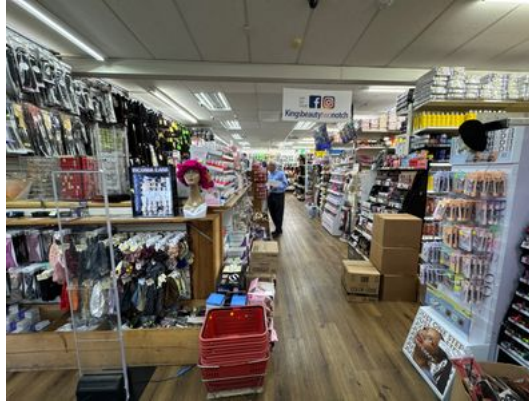
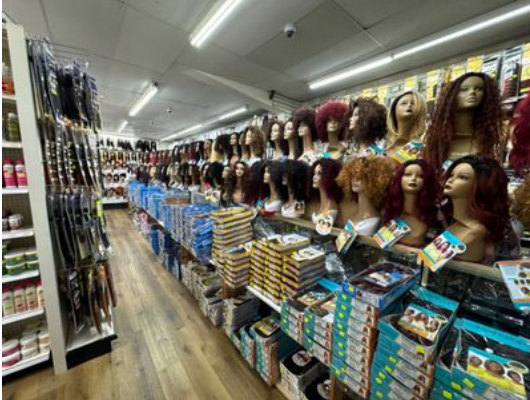
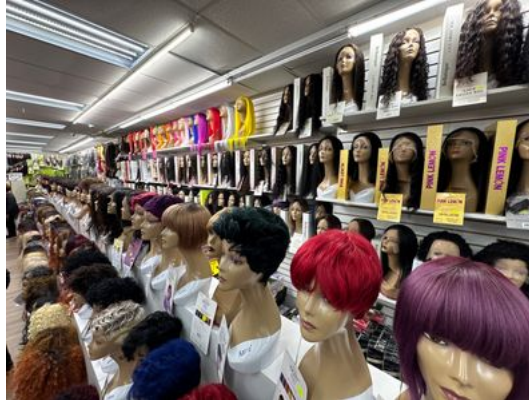
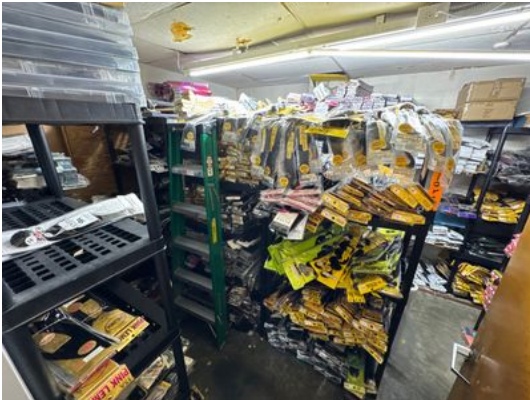
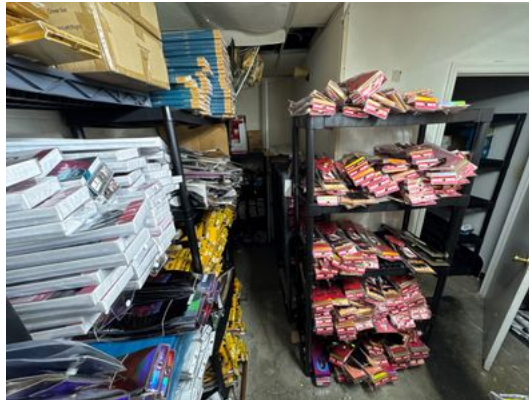
Kings Beauty Supply: Overview of the interior.

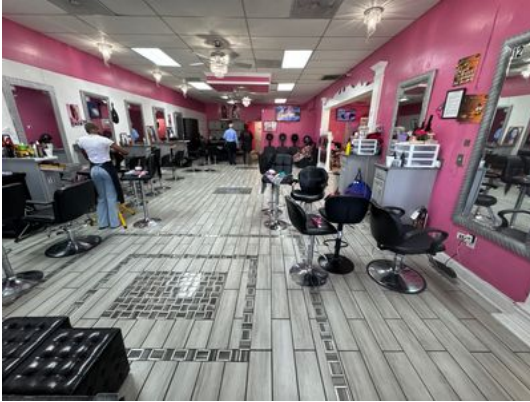
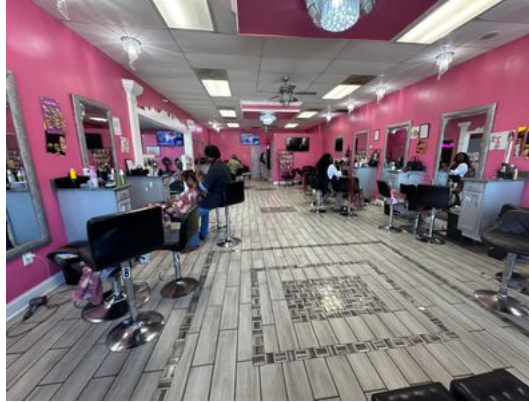
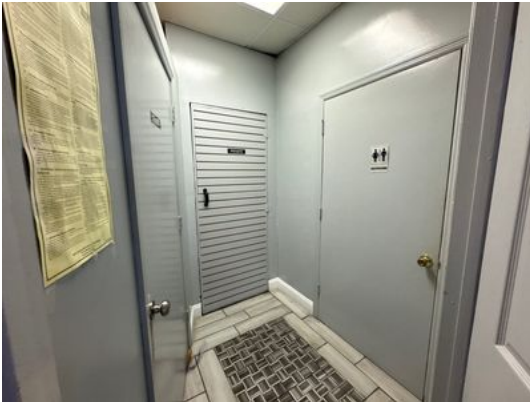
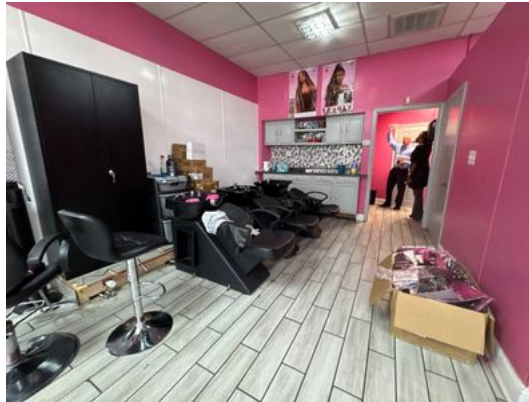
Touba: Overview of the interior.

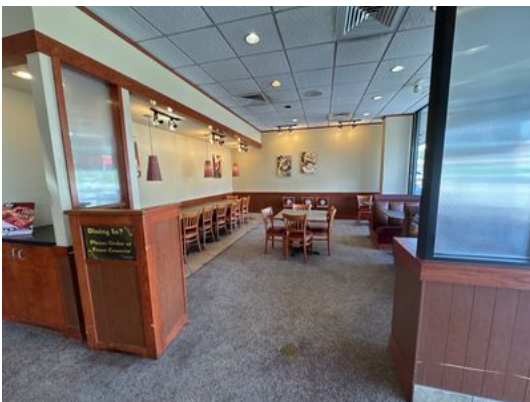
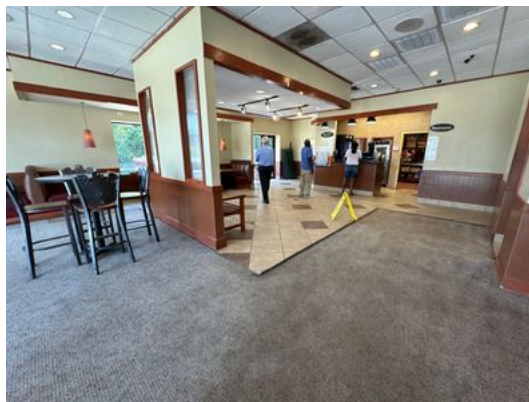
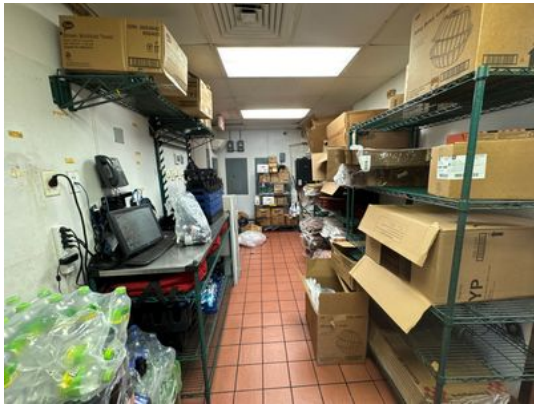
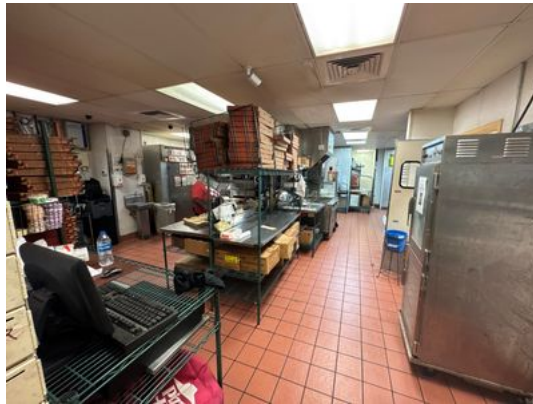
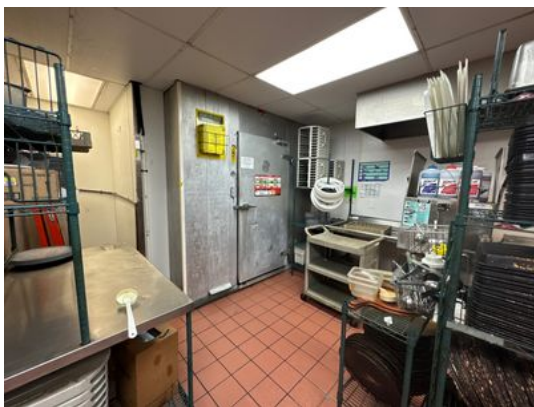
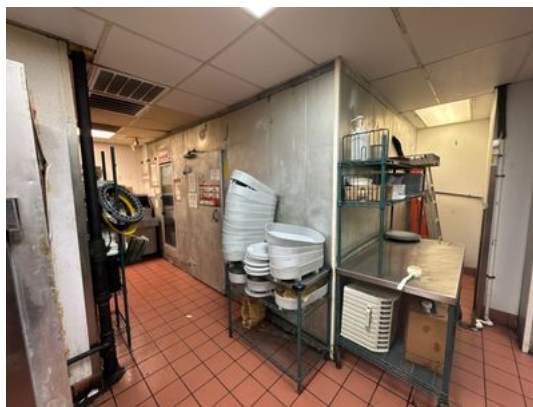
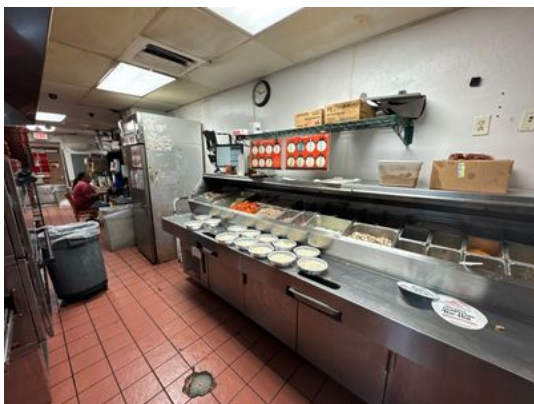
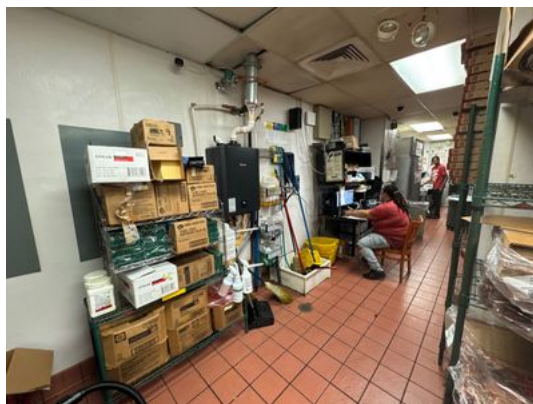
Pizza Hut: Overview of the interior.

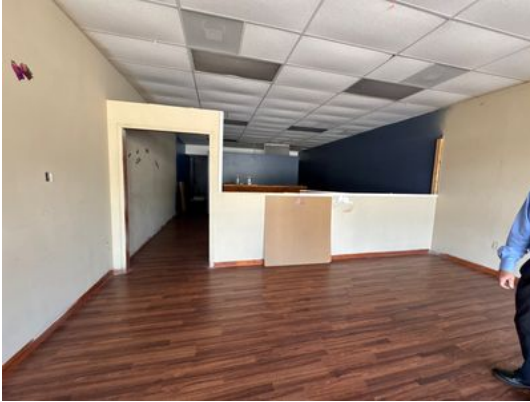
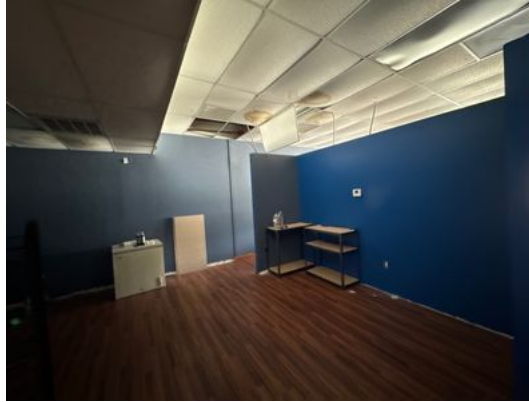
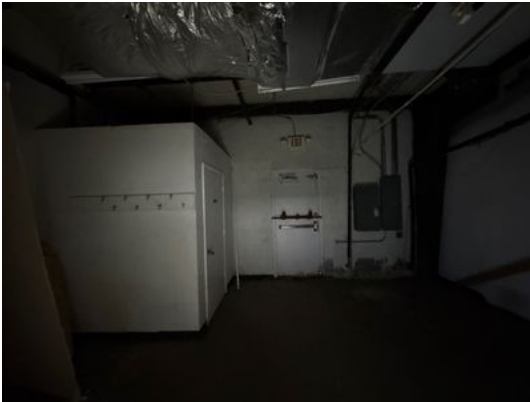
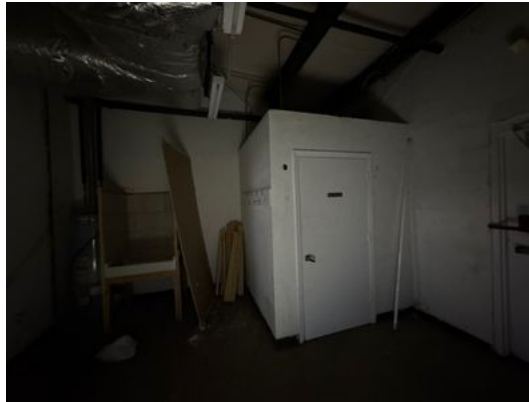
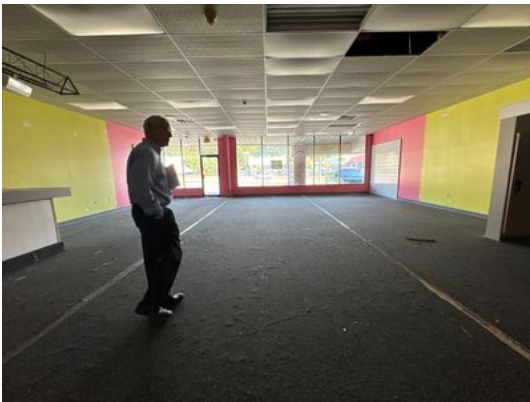
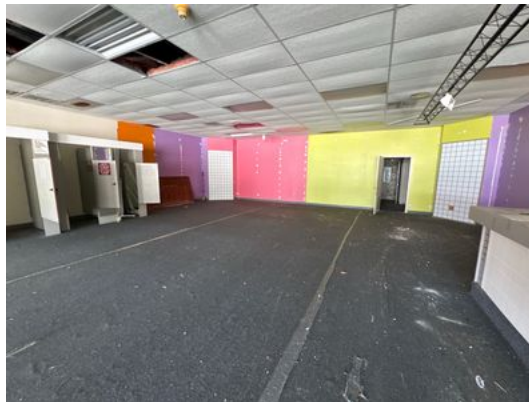
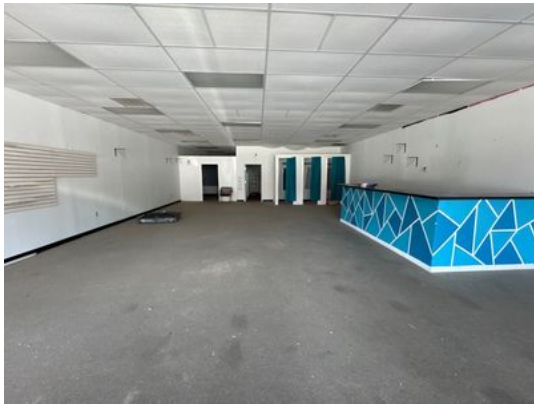
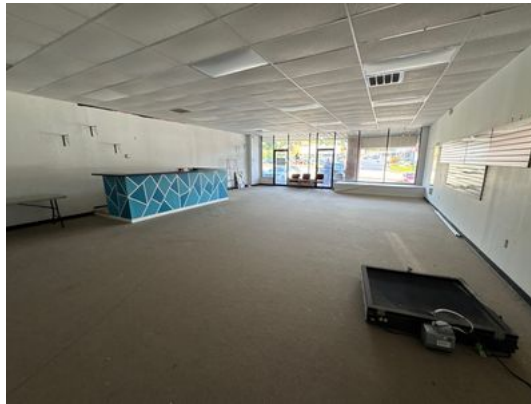
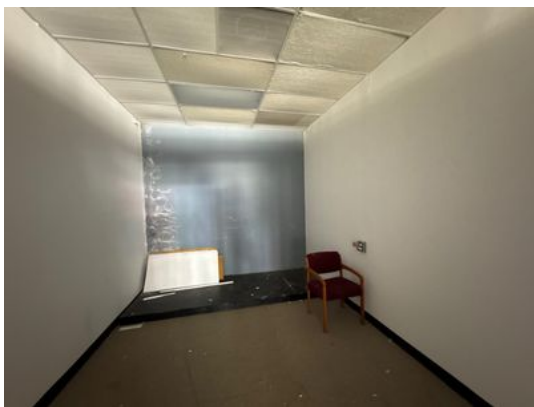
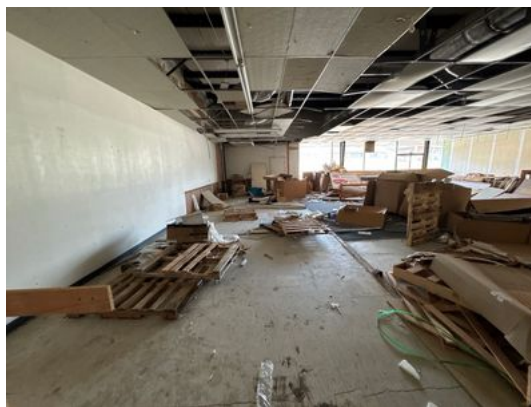
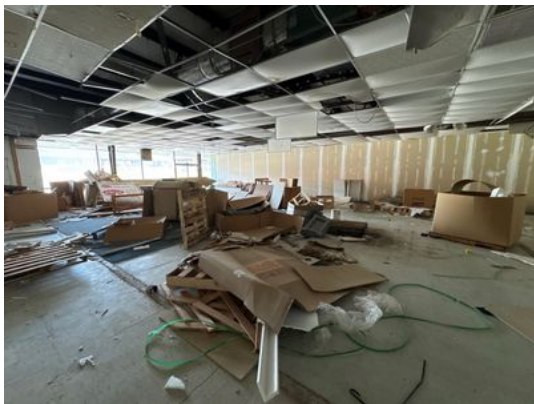
Vacant Spaces: Overview of the interior.

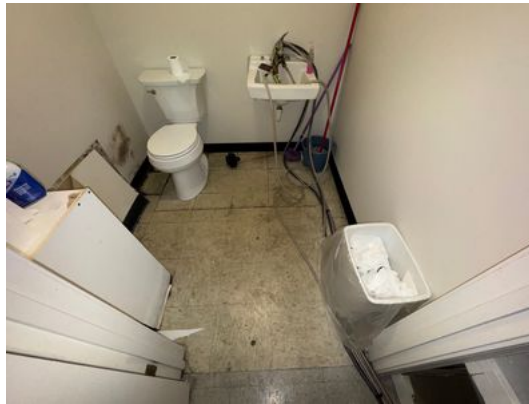
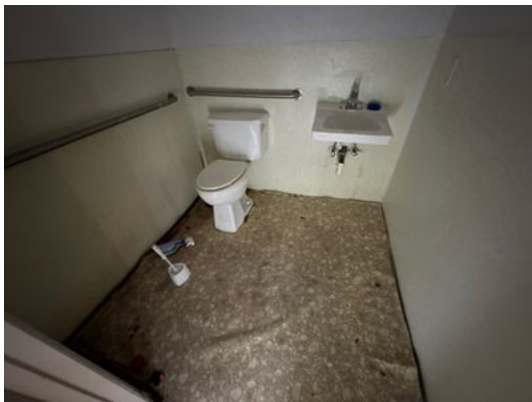
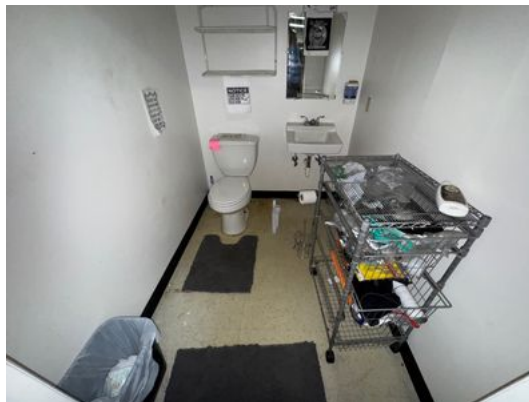
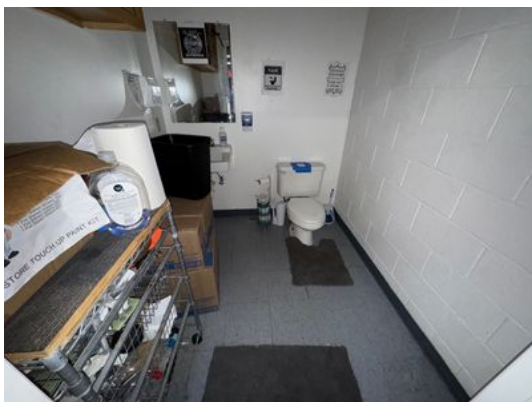
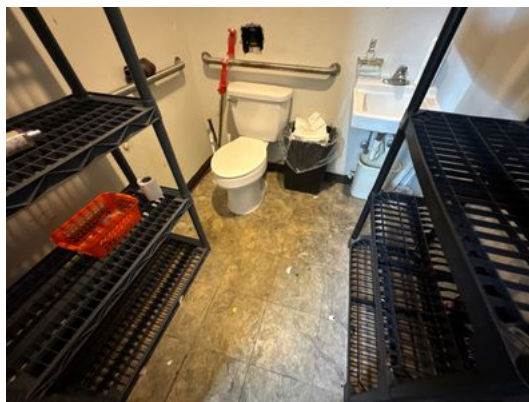
Overview of the tenant restrooms. There was a compliant of sewer gas odors, when the toilet was flushed, in Boost Mobile, but none noted at the time of the inspection. A couple of the toilets ran continuously, but overall, the plumbing fixtures were operating as expected. Listing agent claims that water heaters and all other major equipment, is the responsibility of the tenant for maintenance and replacement. These appliances were not tested.

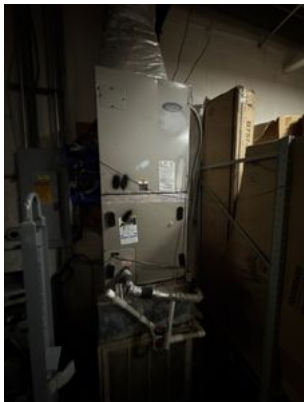
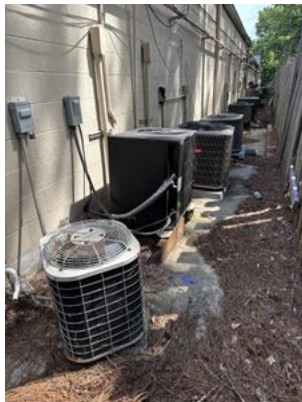
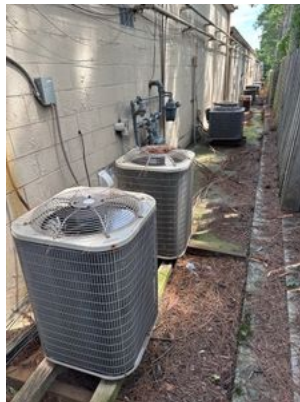
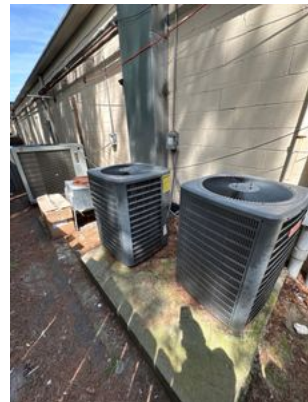
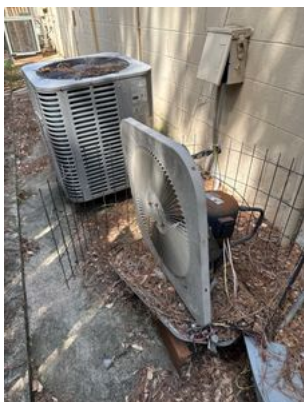
The listing agent stated that the HVAC systems are the tenants responsibility to maintain and replace (generally, installed by the seller, upon occupancy or build-out.) These systems were not inspected further.

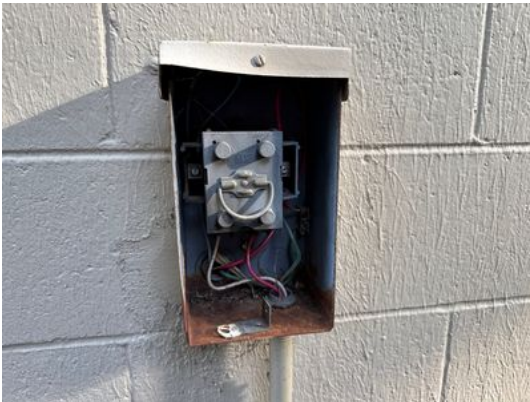
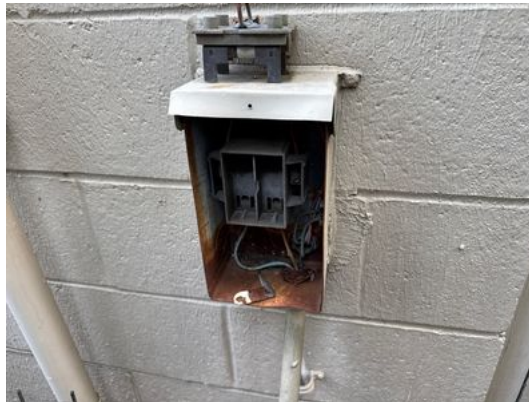
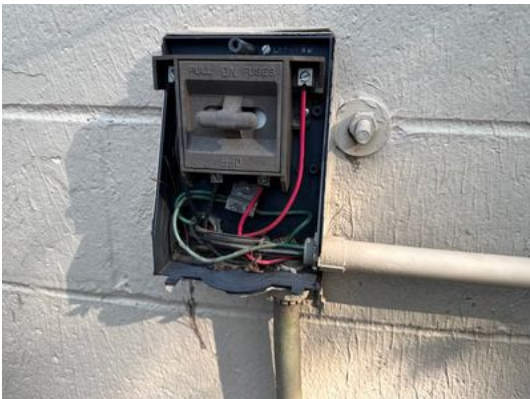
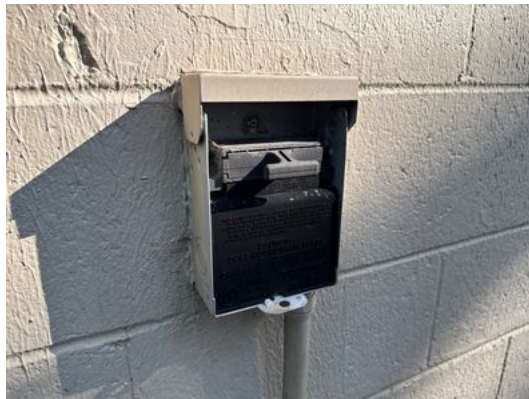
**Comment 37**  
**Deficiency**

There are a number of AC disconnects that are missing covers and/or dead fronts. Have a qualified professional repair all, for safety.

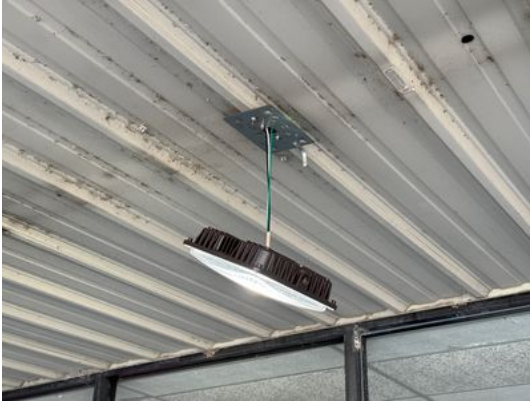
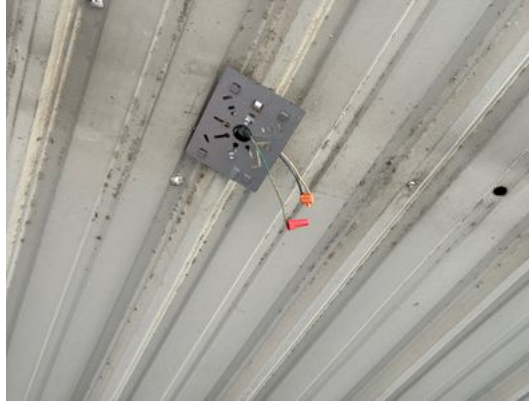
**Comment 38**

A couple of the front canopy fixtures are loose or missing. Have a licensed electrician repair or replace, as needed.

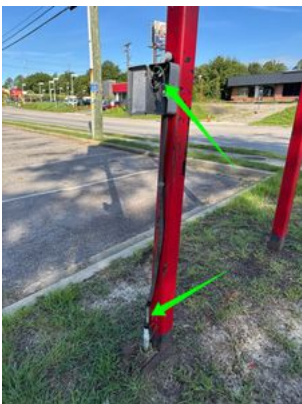
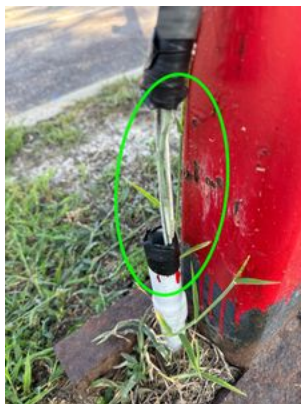
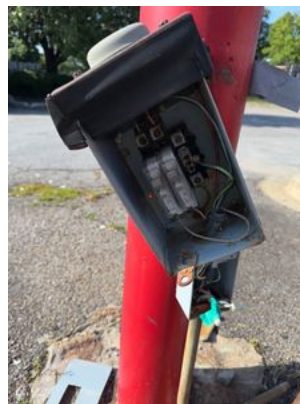
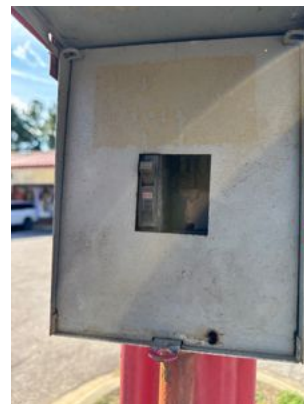
**Comment 39**

The electrical service to the marquee signage was not energized, but the cabling was exposed and the disconnects were not secured to the structure. Have a licensed electrician verify that the circuits have been permanently abandoned or repair, as needed, for safety.
