## Home Inspection Report

108 Kenton Dr  
Bardstown, KY 40004

Inspected By: Mike Meurer, KY License #102913;  
IN License #HI01900074; CCPIA-000572

Prepared For: [REDACTED]  
Inspected On Tue, Oct 6, 2026 at 9:00 AM

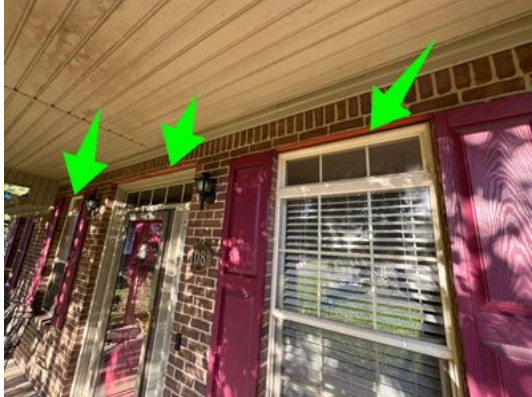
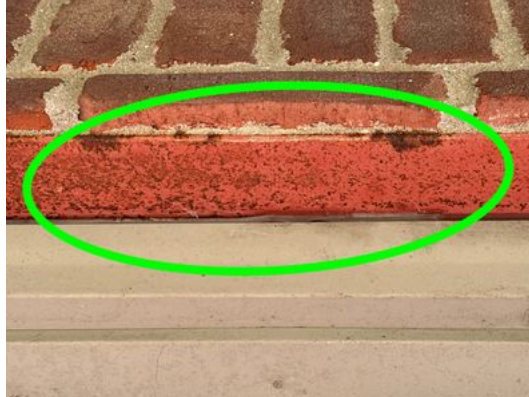
The steel brick lintels above the front door and windows have not been finish painted or covered, only shop primed, and are beginning to corrode. A portion of the lintel, on the right side, was not properly bedded in grout and is exposed. Have a qualified professional prep and paint and seal the bearing ends, to prevent rust from affecting the integrity of the steel and staining doors and windows below.

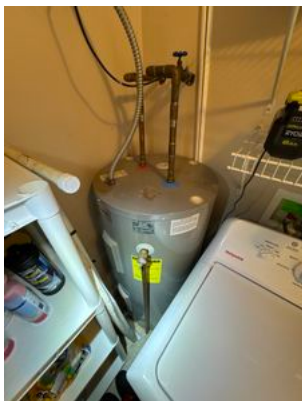
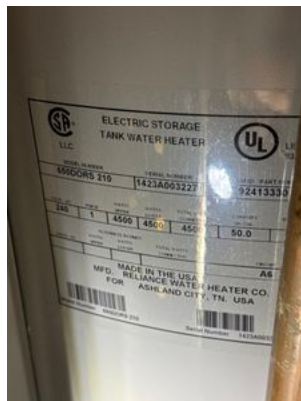
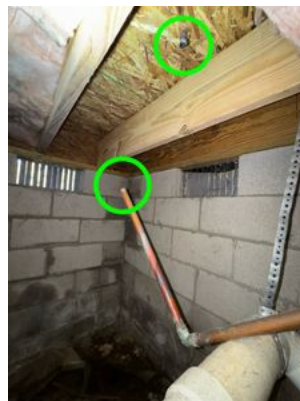
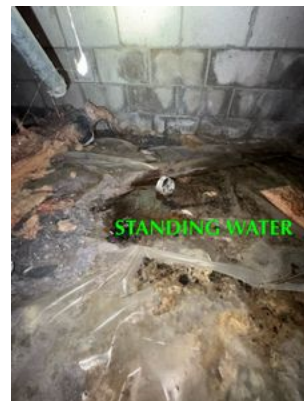
Water heater was operating as expected, but is at the end of its life expectancy of 10-12 years. Approximately 12 years old.

There was a constant drip from the TPR valve into the crawl space, and its pipe was not connected. Have a licensed plumber repair/replace, as needed. Recommend budgeting for new. NOTE: There is no drain pan beneath the heater. Recommend adding a pan and drain line to prevent damage to the subfloor and finishes, in the event of a leak, when the unit is replaced.

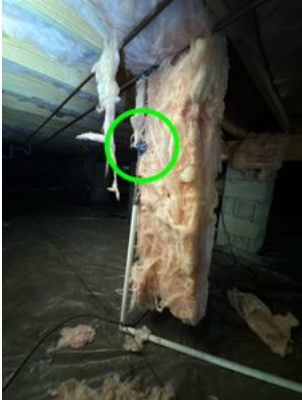
The main water shut off is located in crawl space. It is recommended to have a licensed plumber install a readily accessible valve for convenience and in the event of a plumbing emergency.

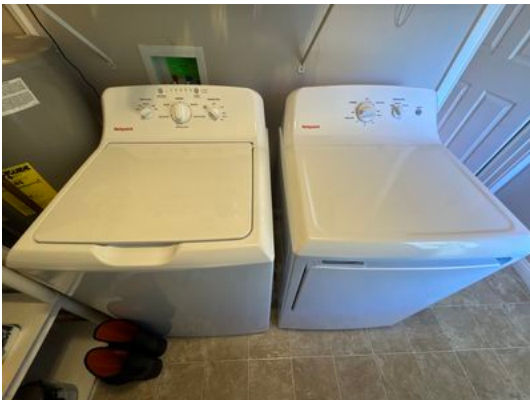
Laundry area was acceptable. NOTE: The washer and dryer were not operated or included as part of this inspection.

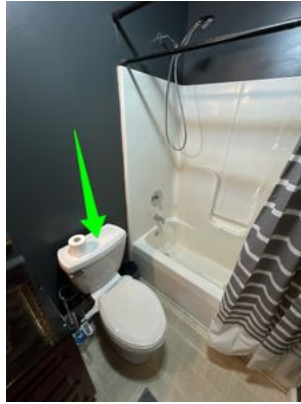
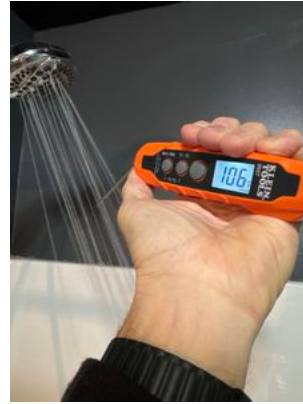
Hallway bath plumbing fixtures were operating as expected, but the toilet assembly had to be manually operated to flush. Additionally, the ribbed/corrugated drain piping traps hair, debris, grease, and bacteria, leading to frequent clogs and poor drainage. Recommend that a qualified professional replace that section with a proper p-trap in smooth-walled piping. Have a qualified professional repair/replace the toilet assembly, as needed.

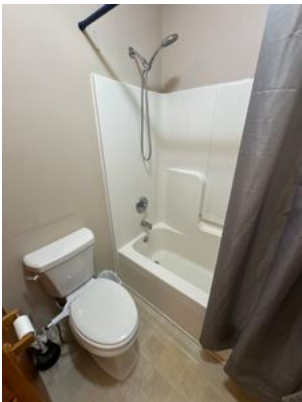
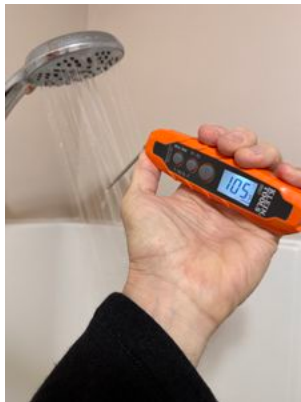
Bedroom bath plumbing fixtures were operating as expected.

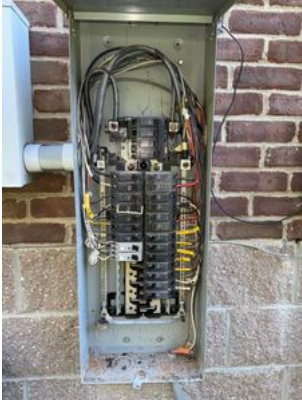
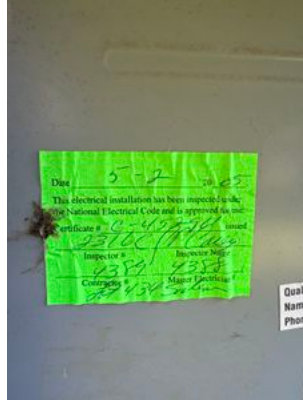
Inside the electrical panel and final inspection sticker. Ok.

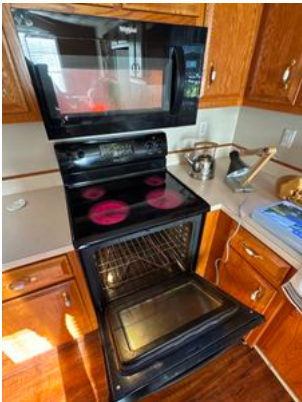
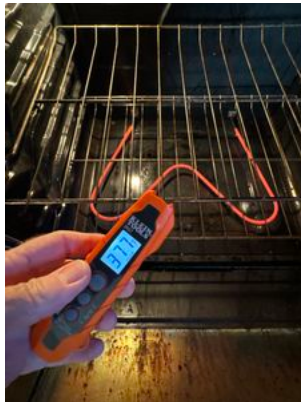
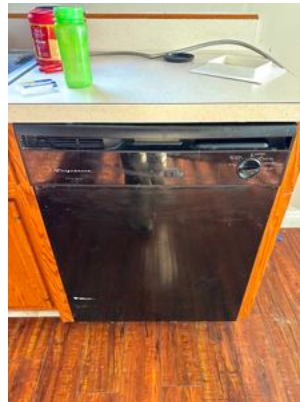
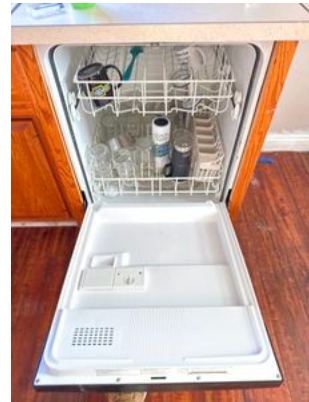
Appliances were operating as expected.
